Johnson  
BO-028.000  
Pic #1  
8/30/16

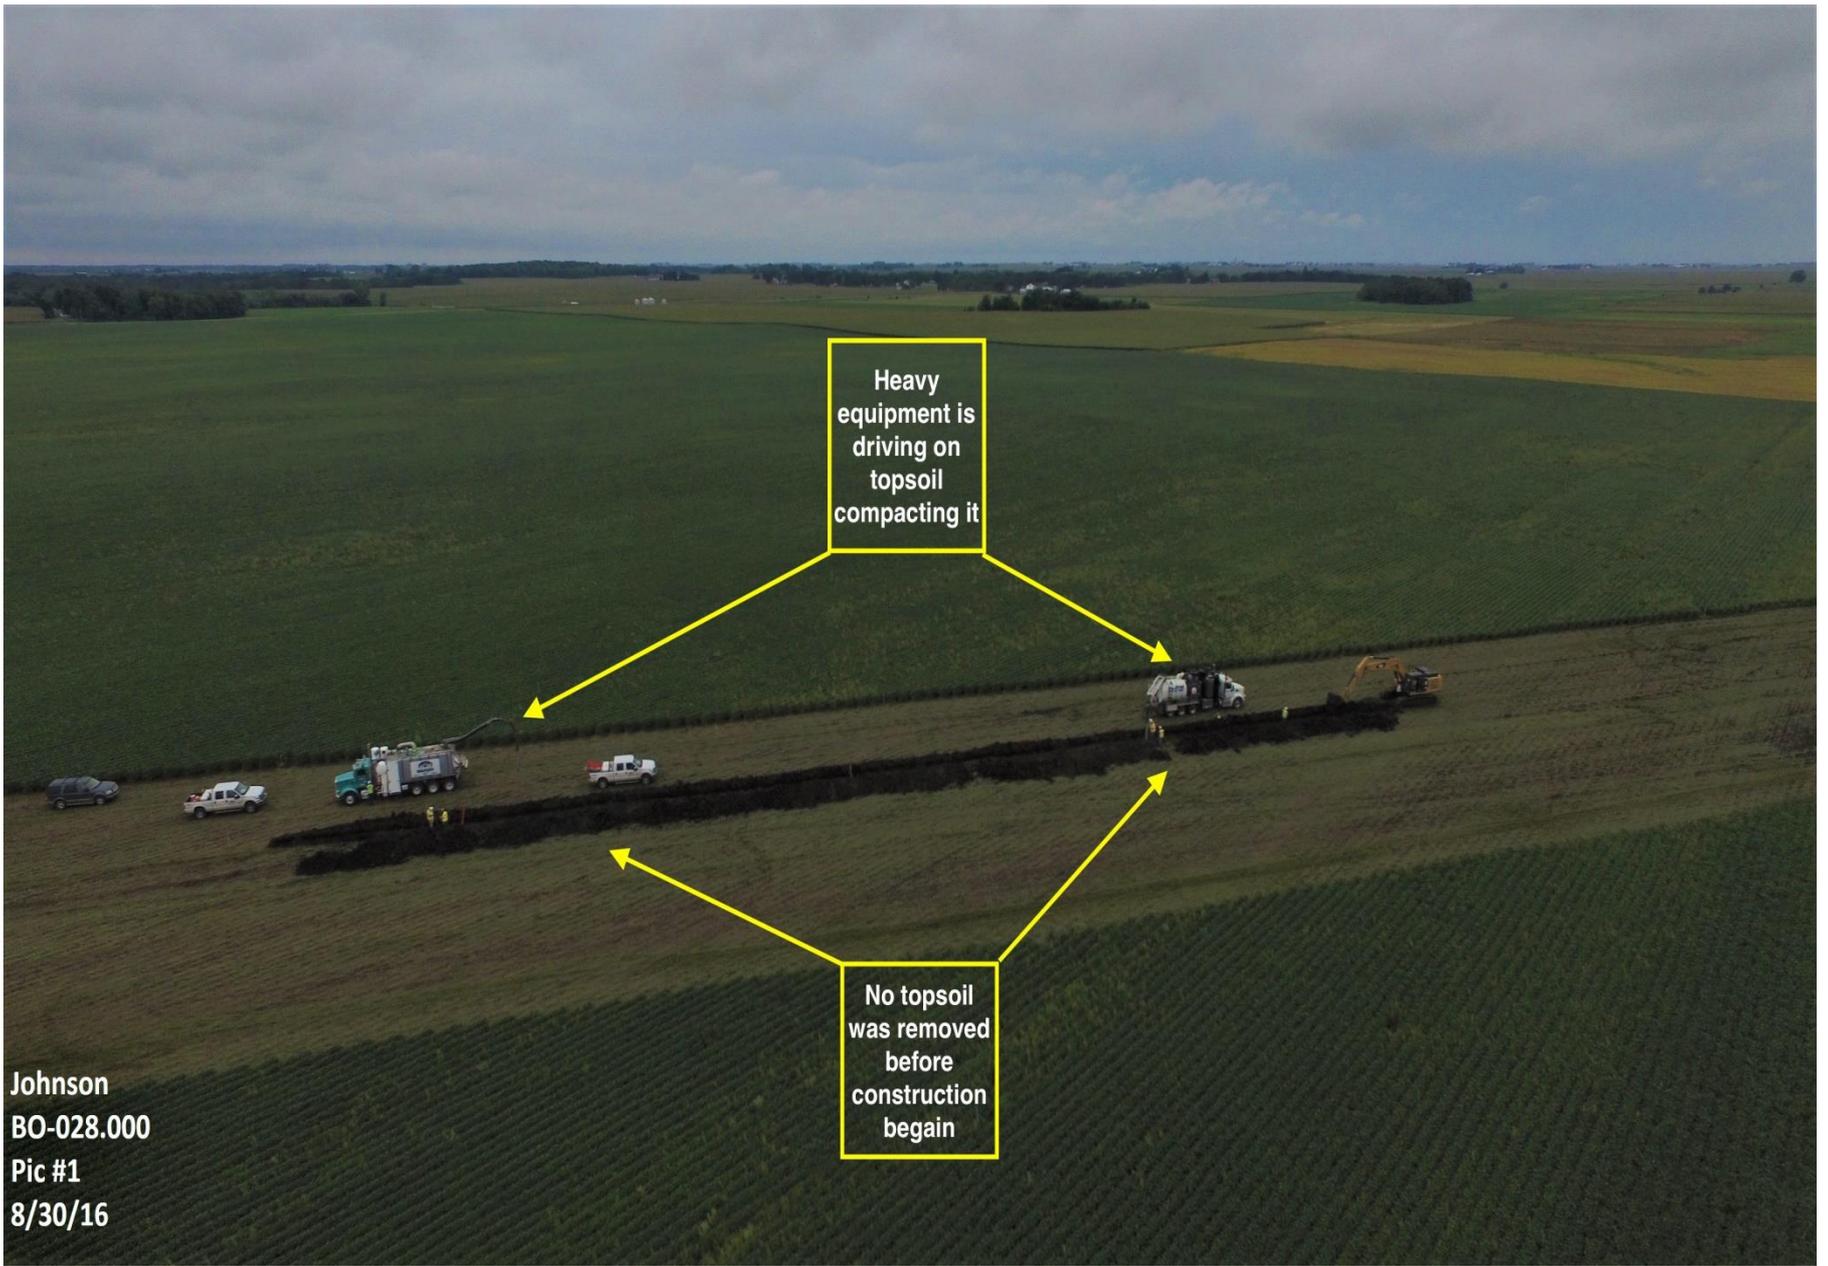
Heavy  
equipment is  
driving on  
topsoil  
compacting it

No topsoil  
was removed  
before  
construction  
began

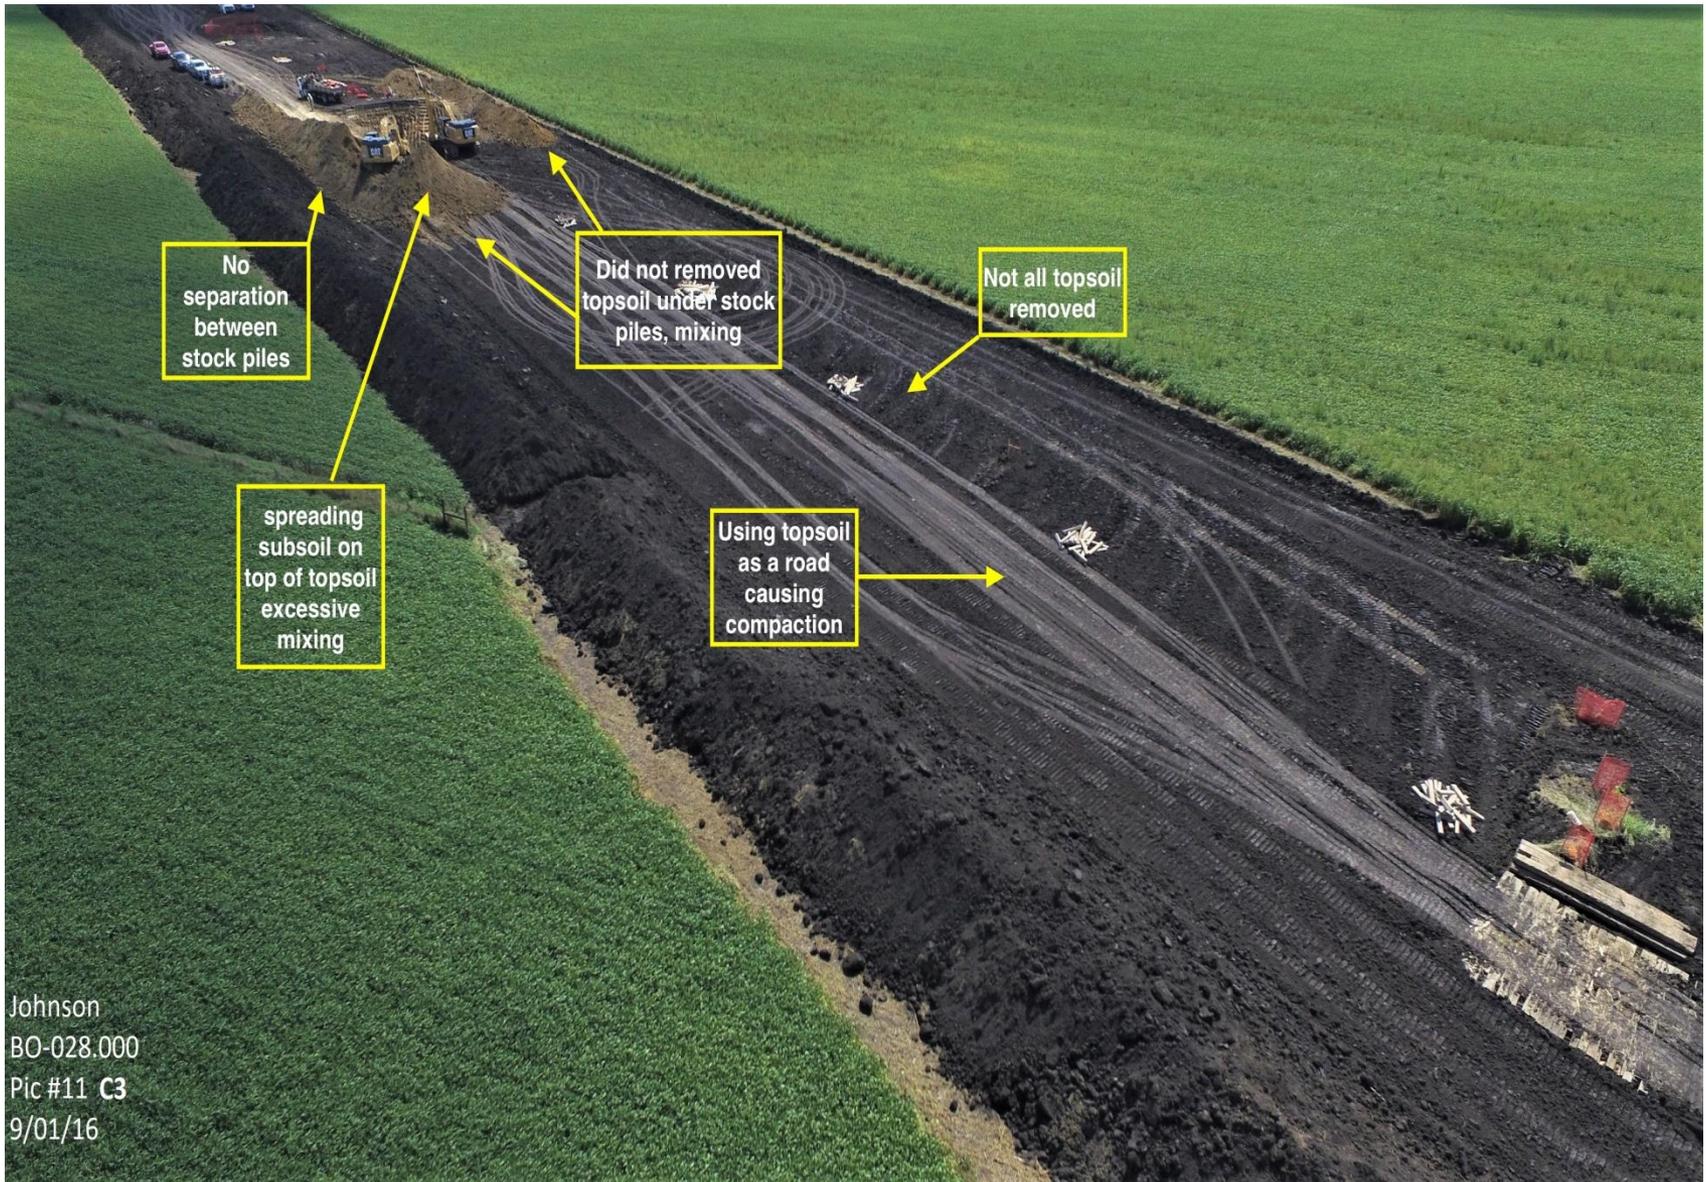
Johnson  
BO-028.000  
Pic #11 C3  
9/01/16

No separation between stock piles

Did not removed topsoil under stock piles, mixing

Not all topsoil removed

spreading subsoil on top of topsoil excessive mixing

Using topsoil as a road causing compaction

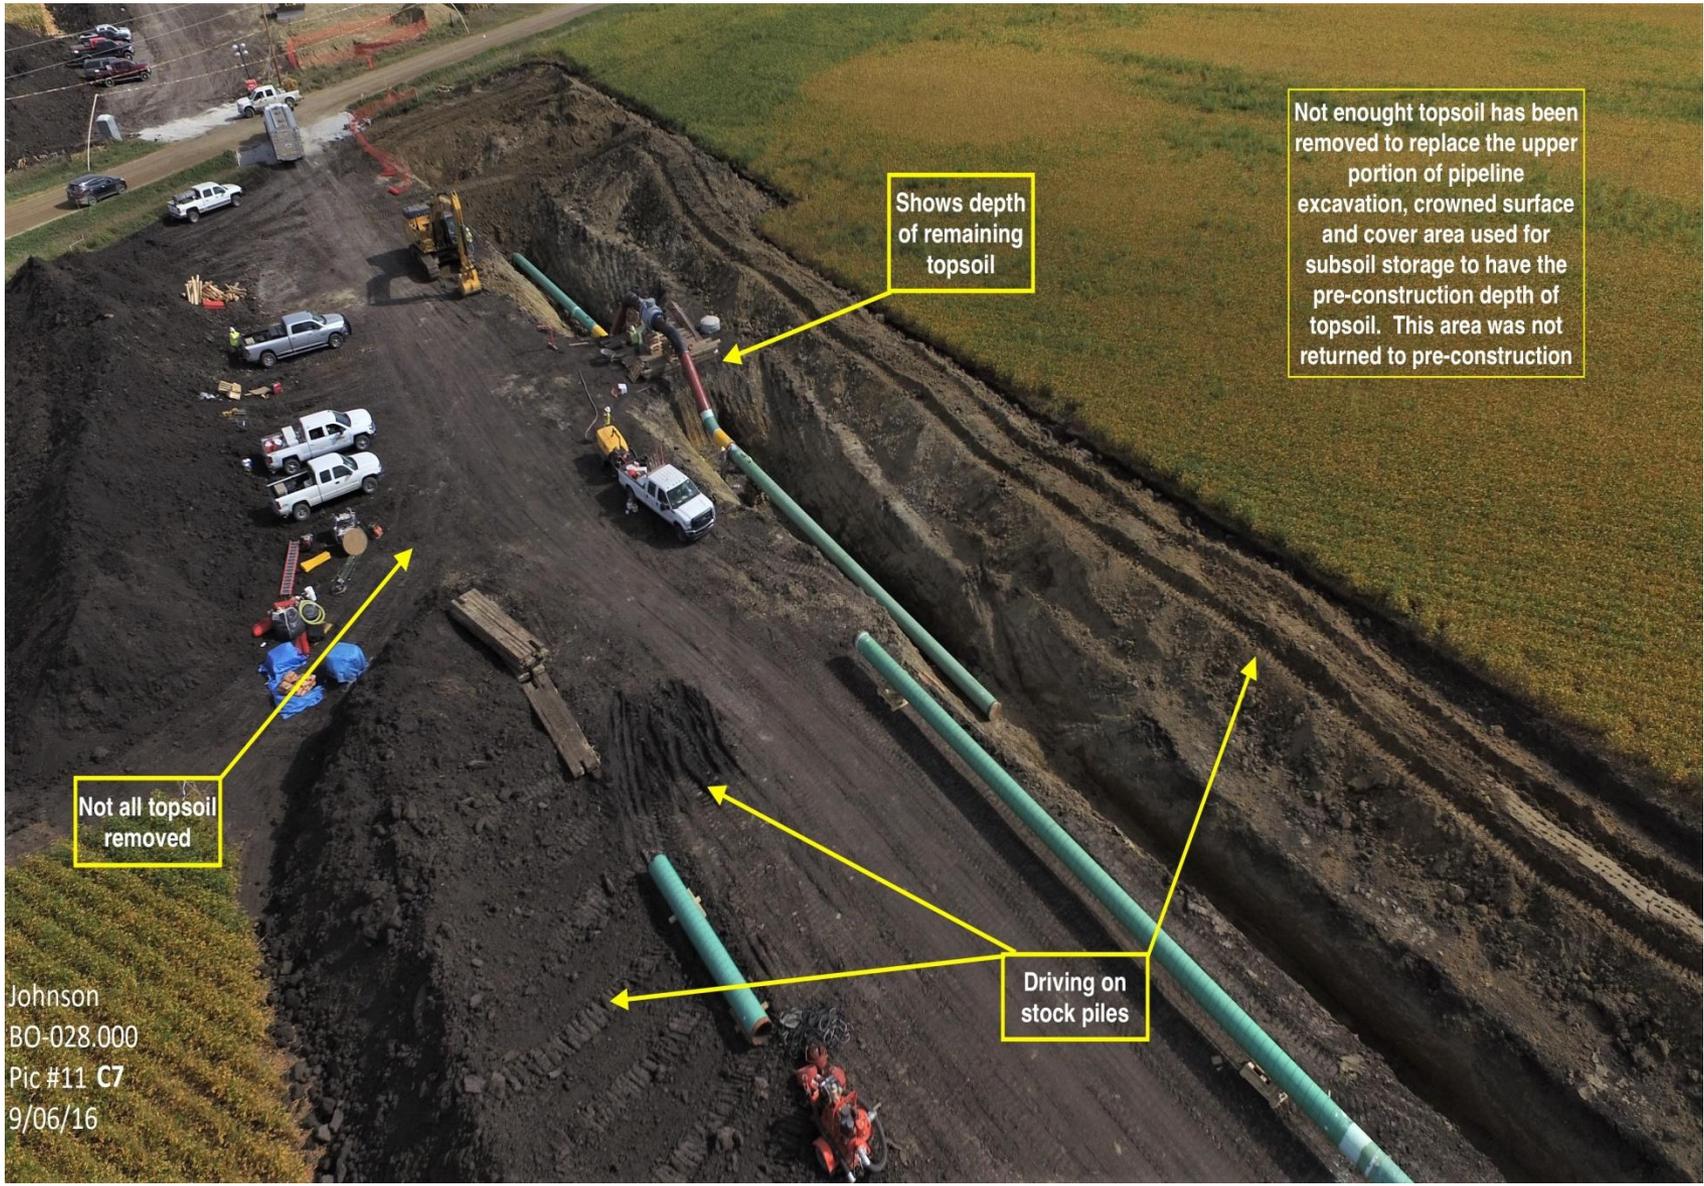
Johnson  
BO-028.000  
Pic #11 C7  
9/06/16

Shows depth of remaining topsoil

Not enough topsoil has been removed to replace the upper portion of pipeline excavation, crowned surface and cover area used for subsoil storage to have the pre-construction depth of topsoil. This area was not returned to pre-construction

Not all topsoil removed

Driving on stock piles

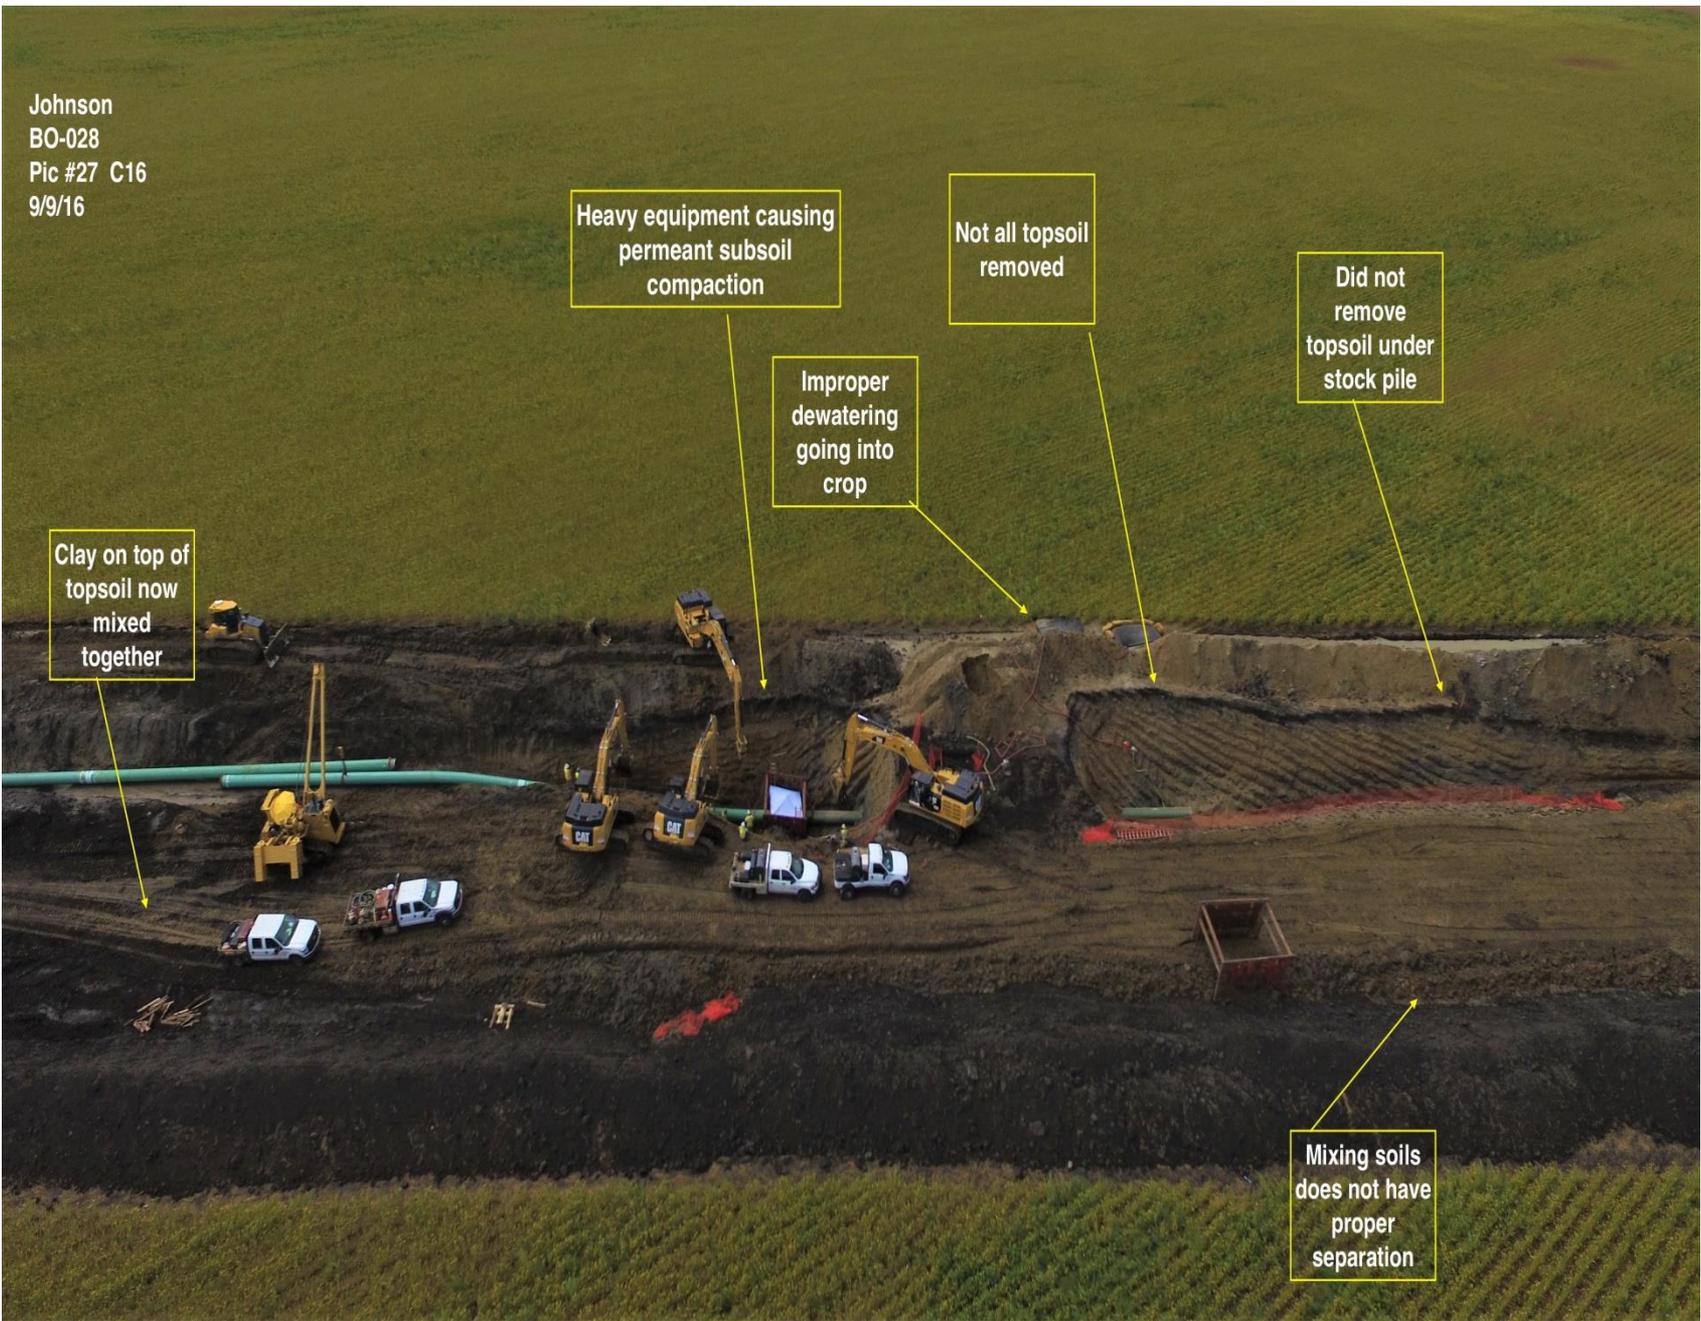
Removal of topsoil in wet conditions, not all topsoil removed

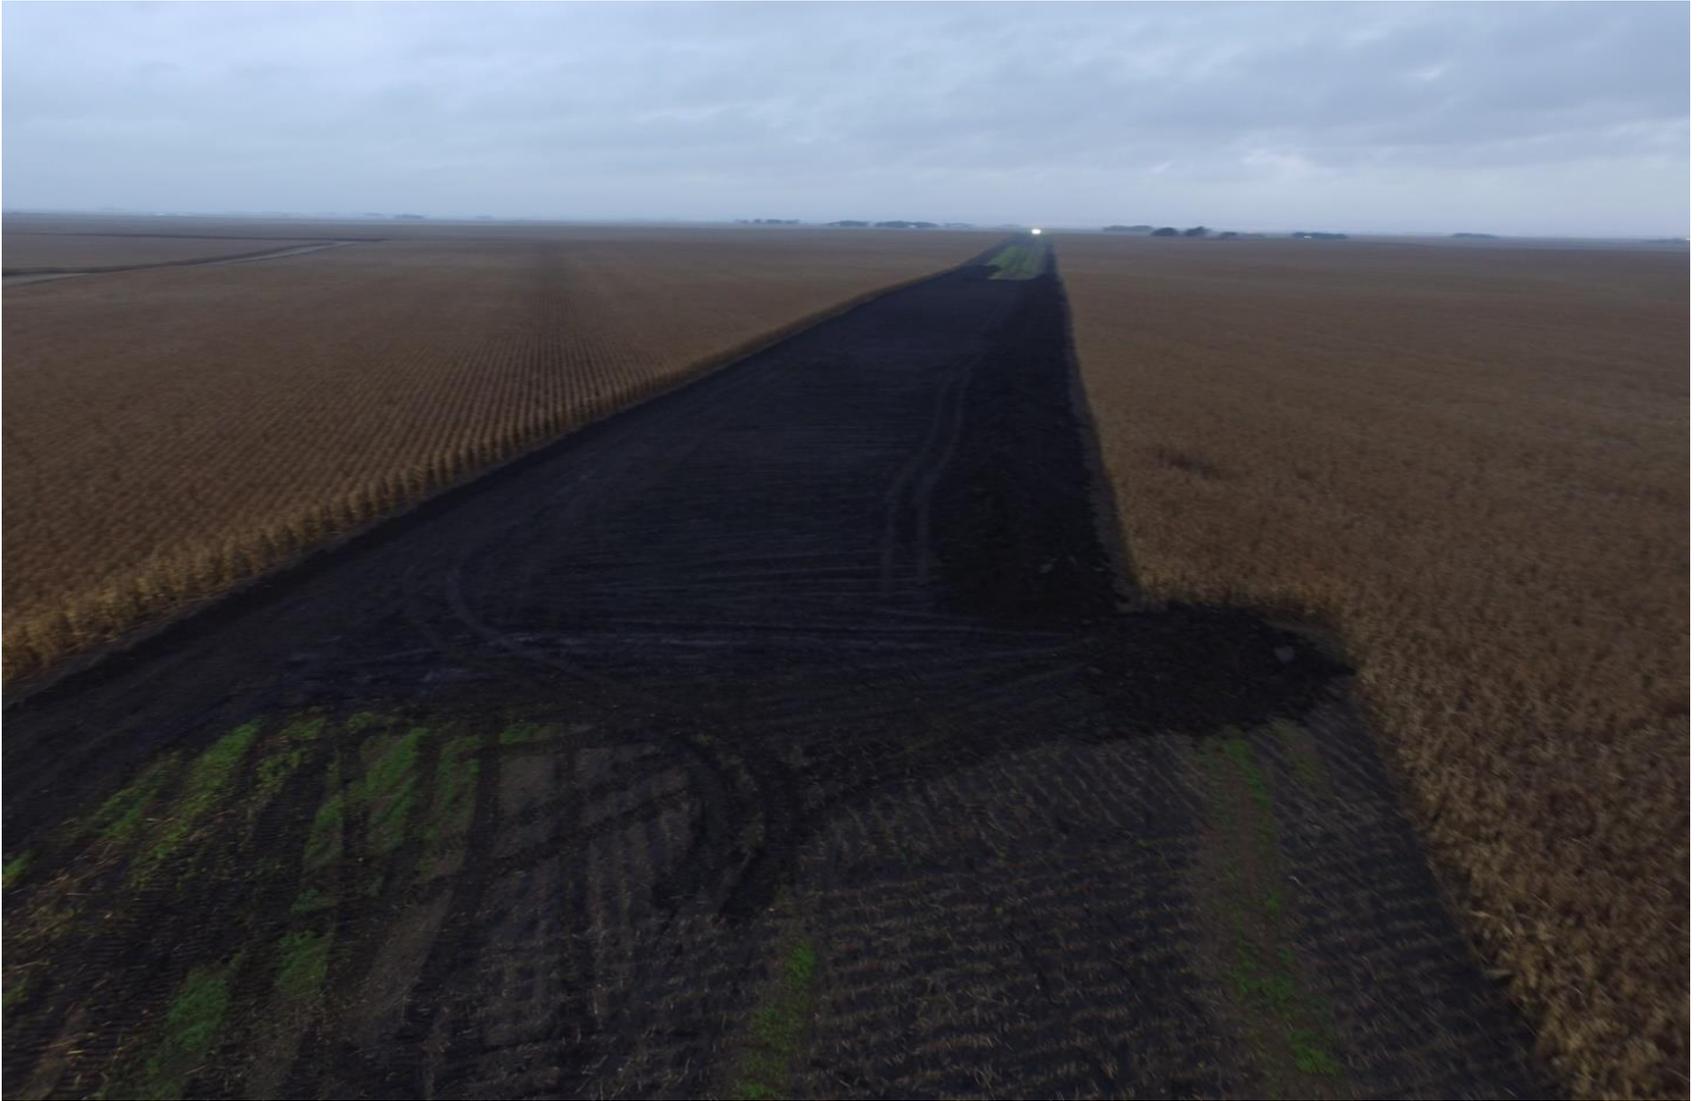
Driving off ROW compacting soil as ROW is too wet to drive on

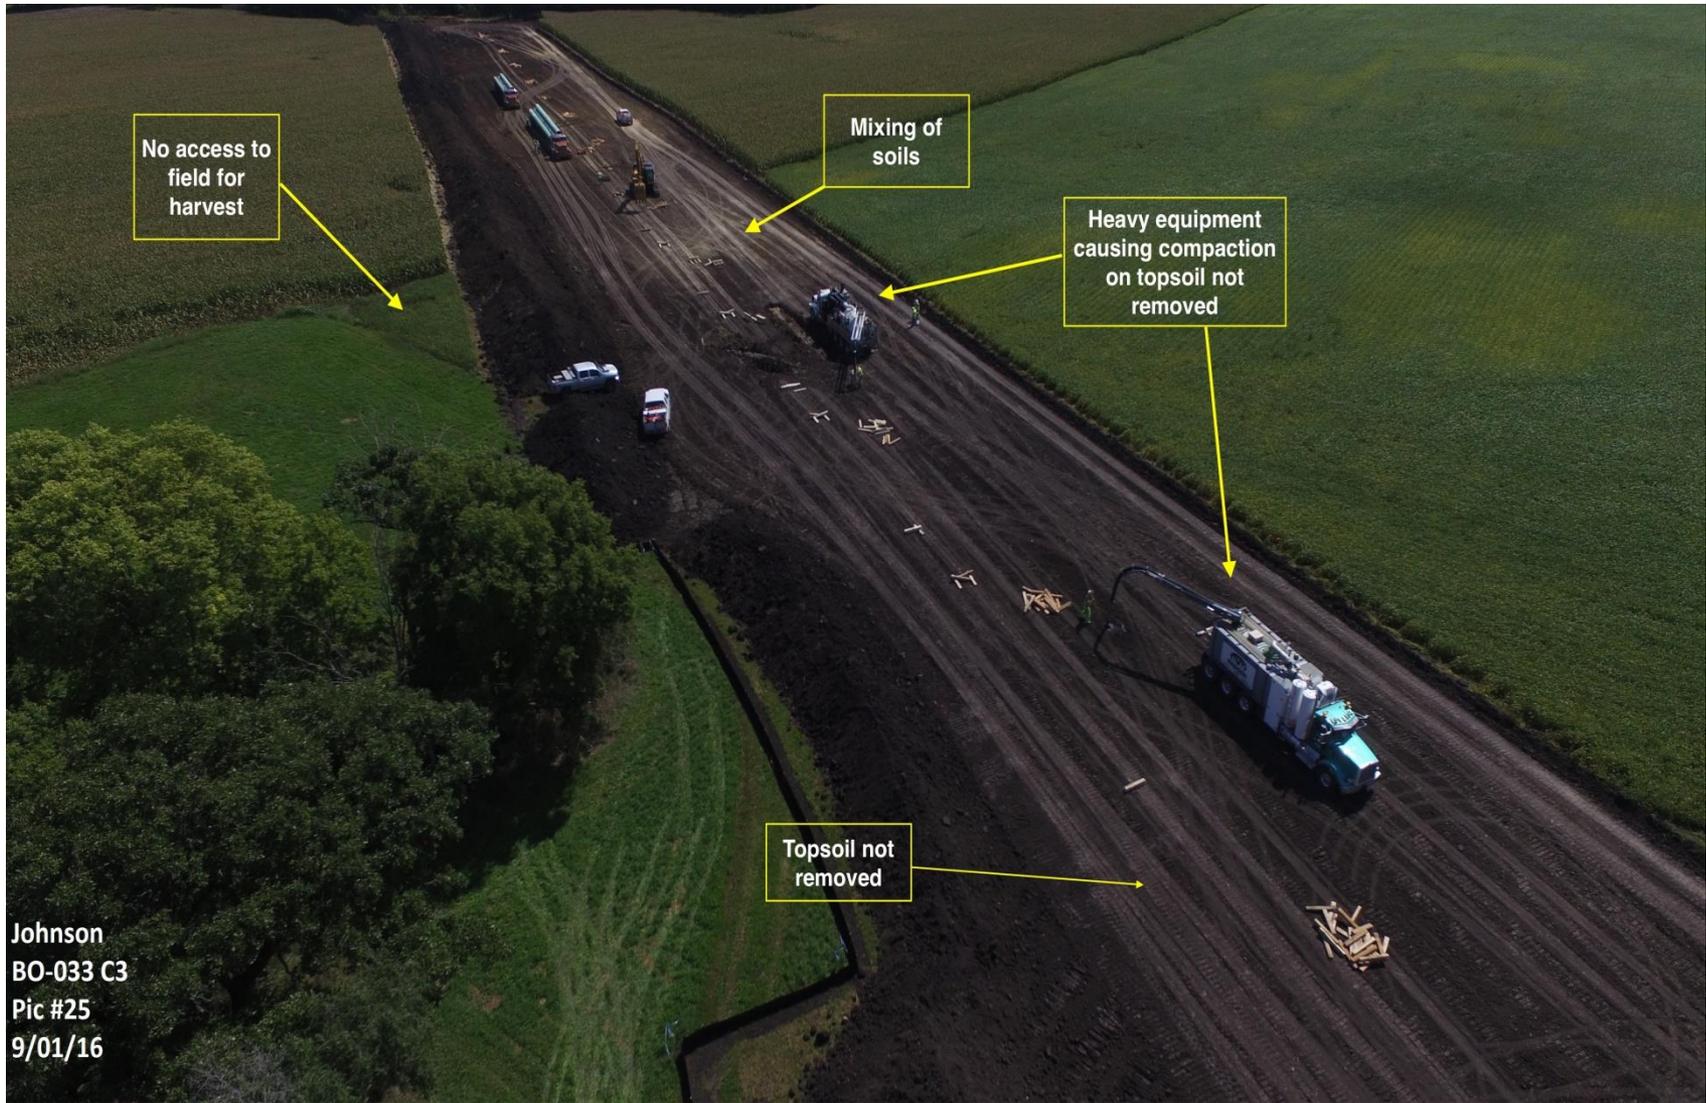
Johnson  
BO-033 C3  
Pic #25  
9/01/16

No access to field for harvest

Mixing of soils

Heavy equipment causing compaction on topsoil not removed

Topsoil not removed

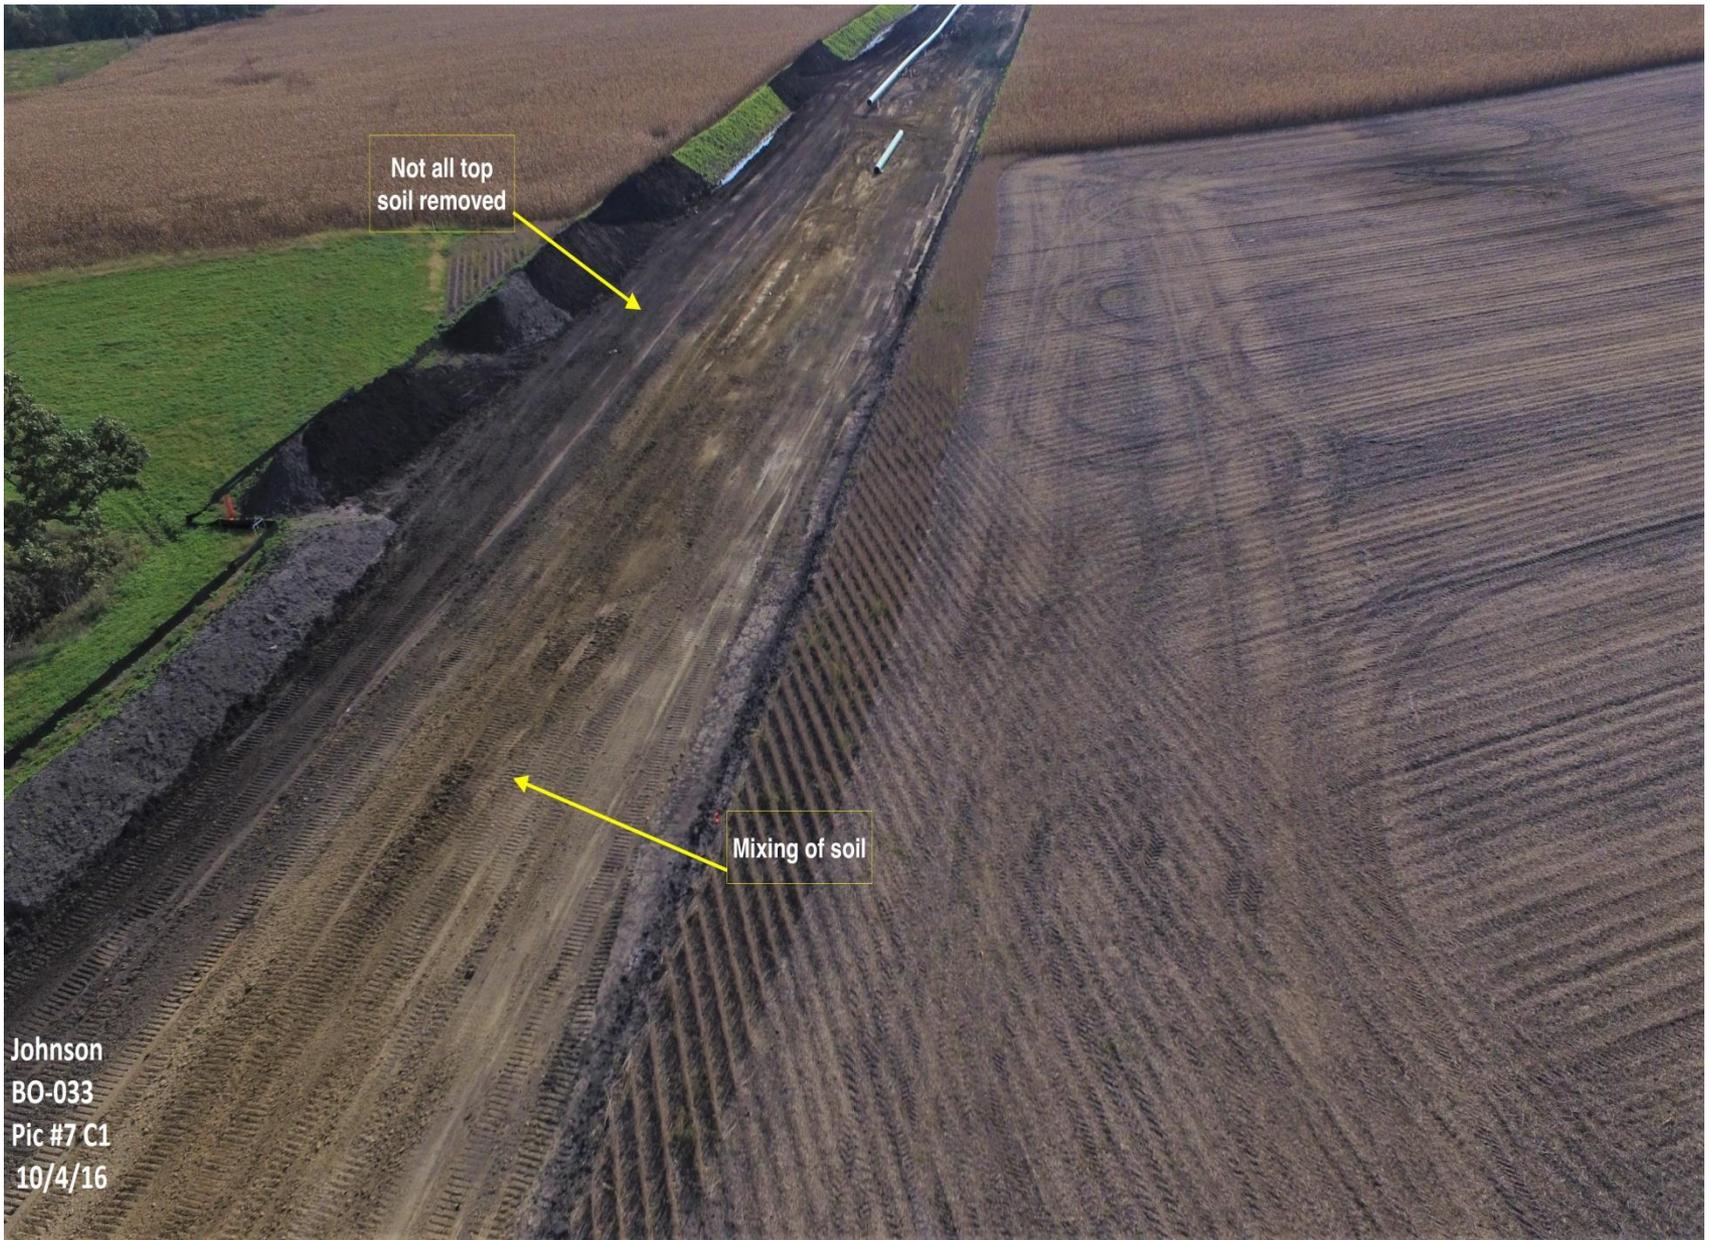
Johnson  
BO-033  
Pic #7 C1  
10/4/16

Not all top  
soil removed

Mixing of soil

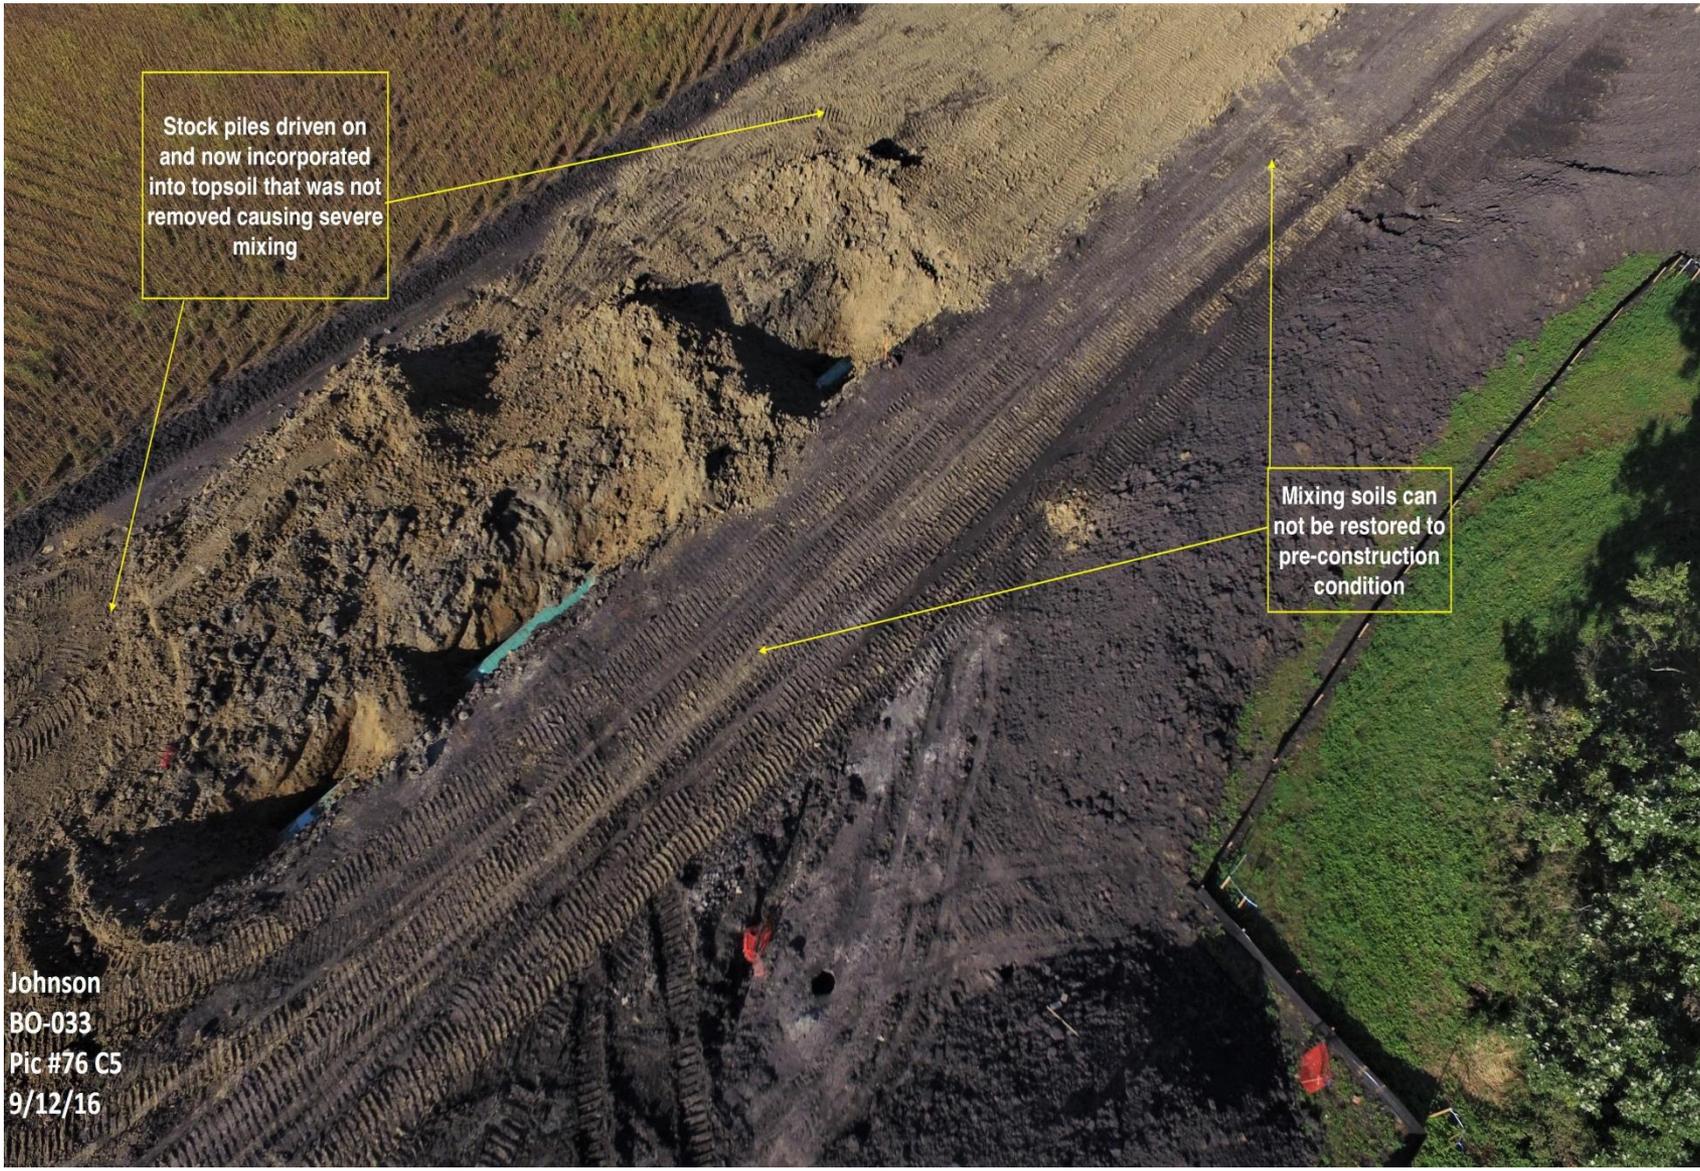
Johnson  
BO-033  
Pic #76 C5  
9/12/16

Stock piles driven on and now incorporated into topsoil that was not removed causing severe mixing

Mixing soils can not be restored to pre-construction condition

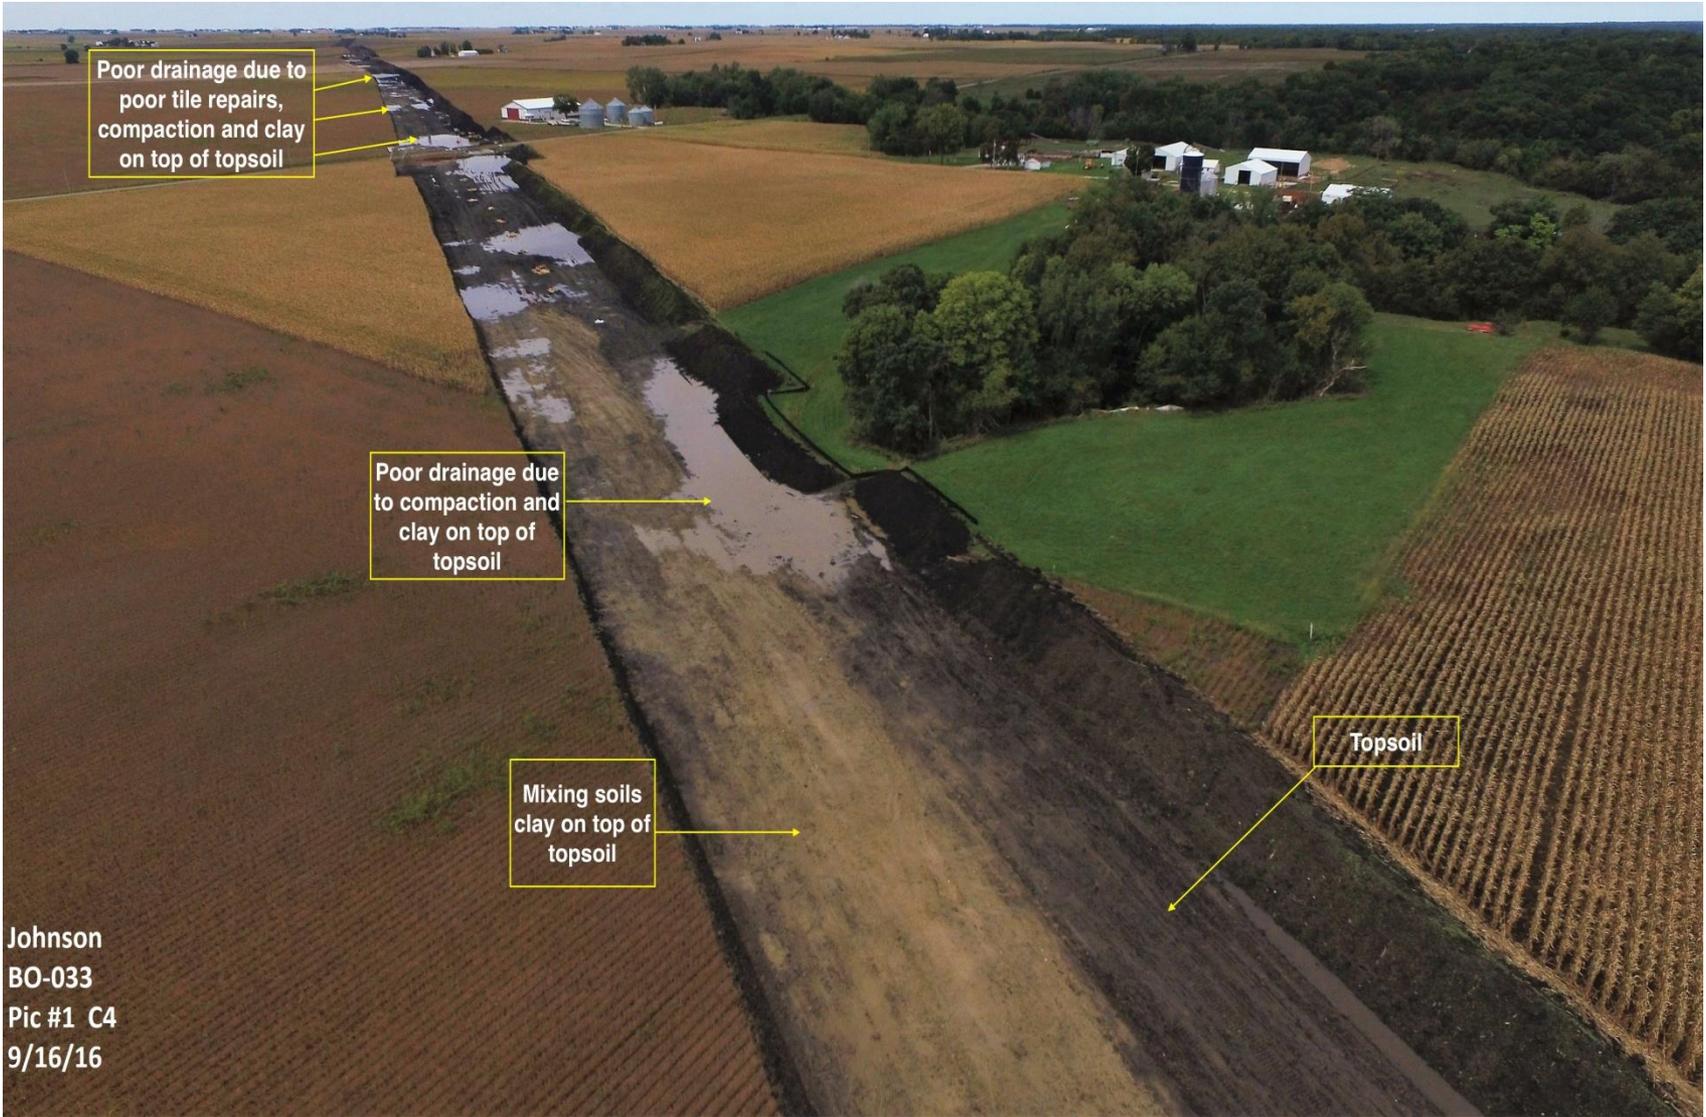
Johnson  
BO-033  
Pic #1 C4  
9/16/16

Poor drainage due to poor tile repairs, compaction and clay on top of topsoil

Poor drainage due to compaction and clay on top of topsoil

Mixing soils clay on top of topsoil

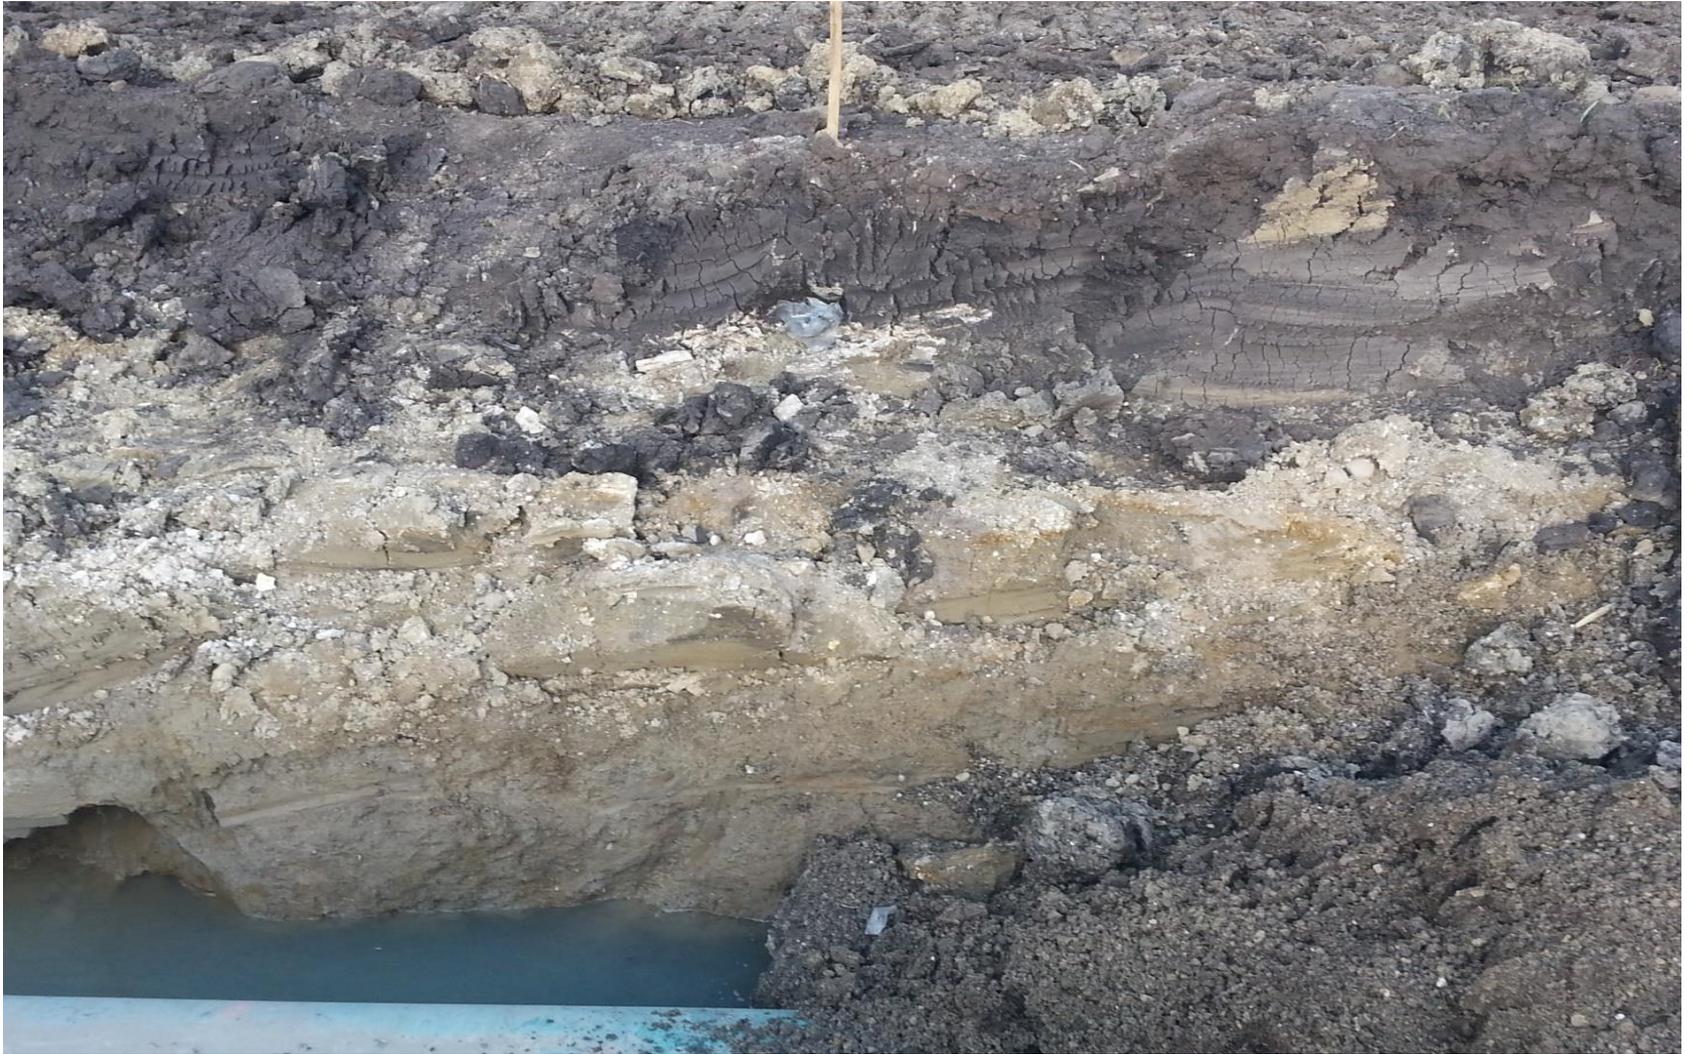
Shows 3 feet of topsoil not removed

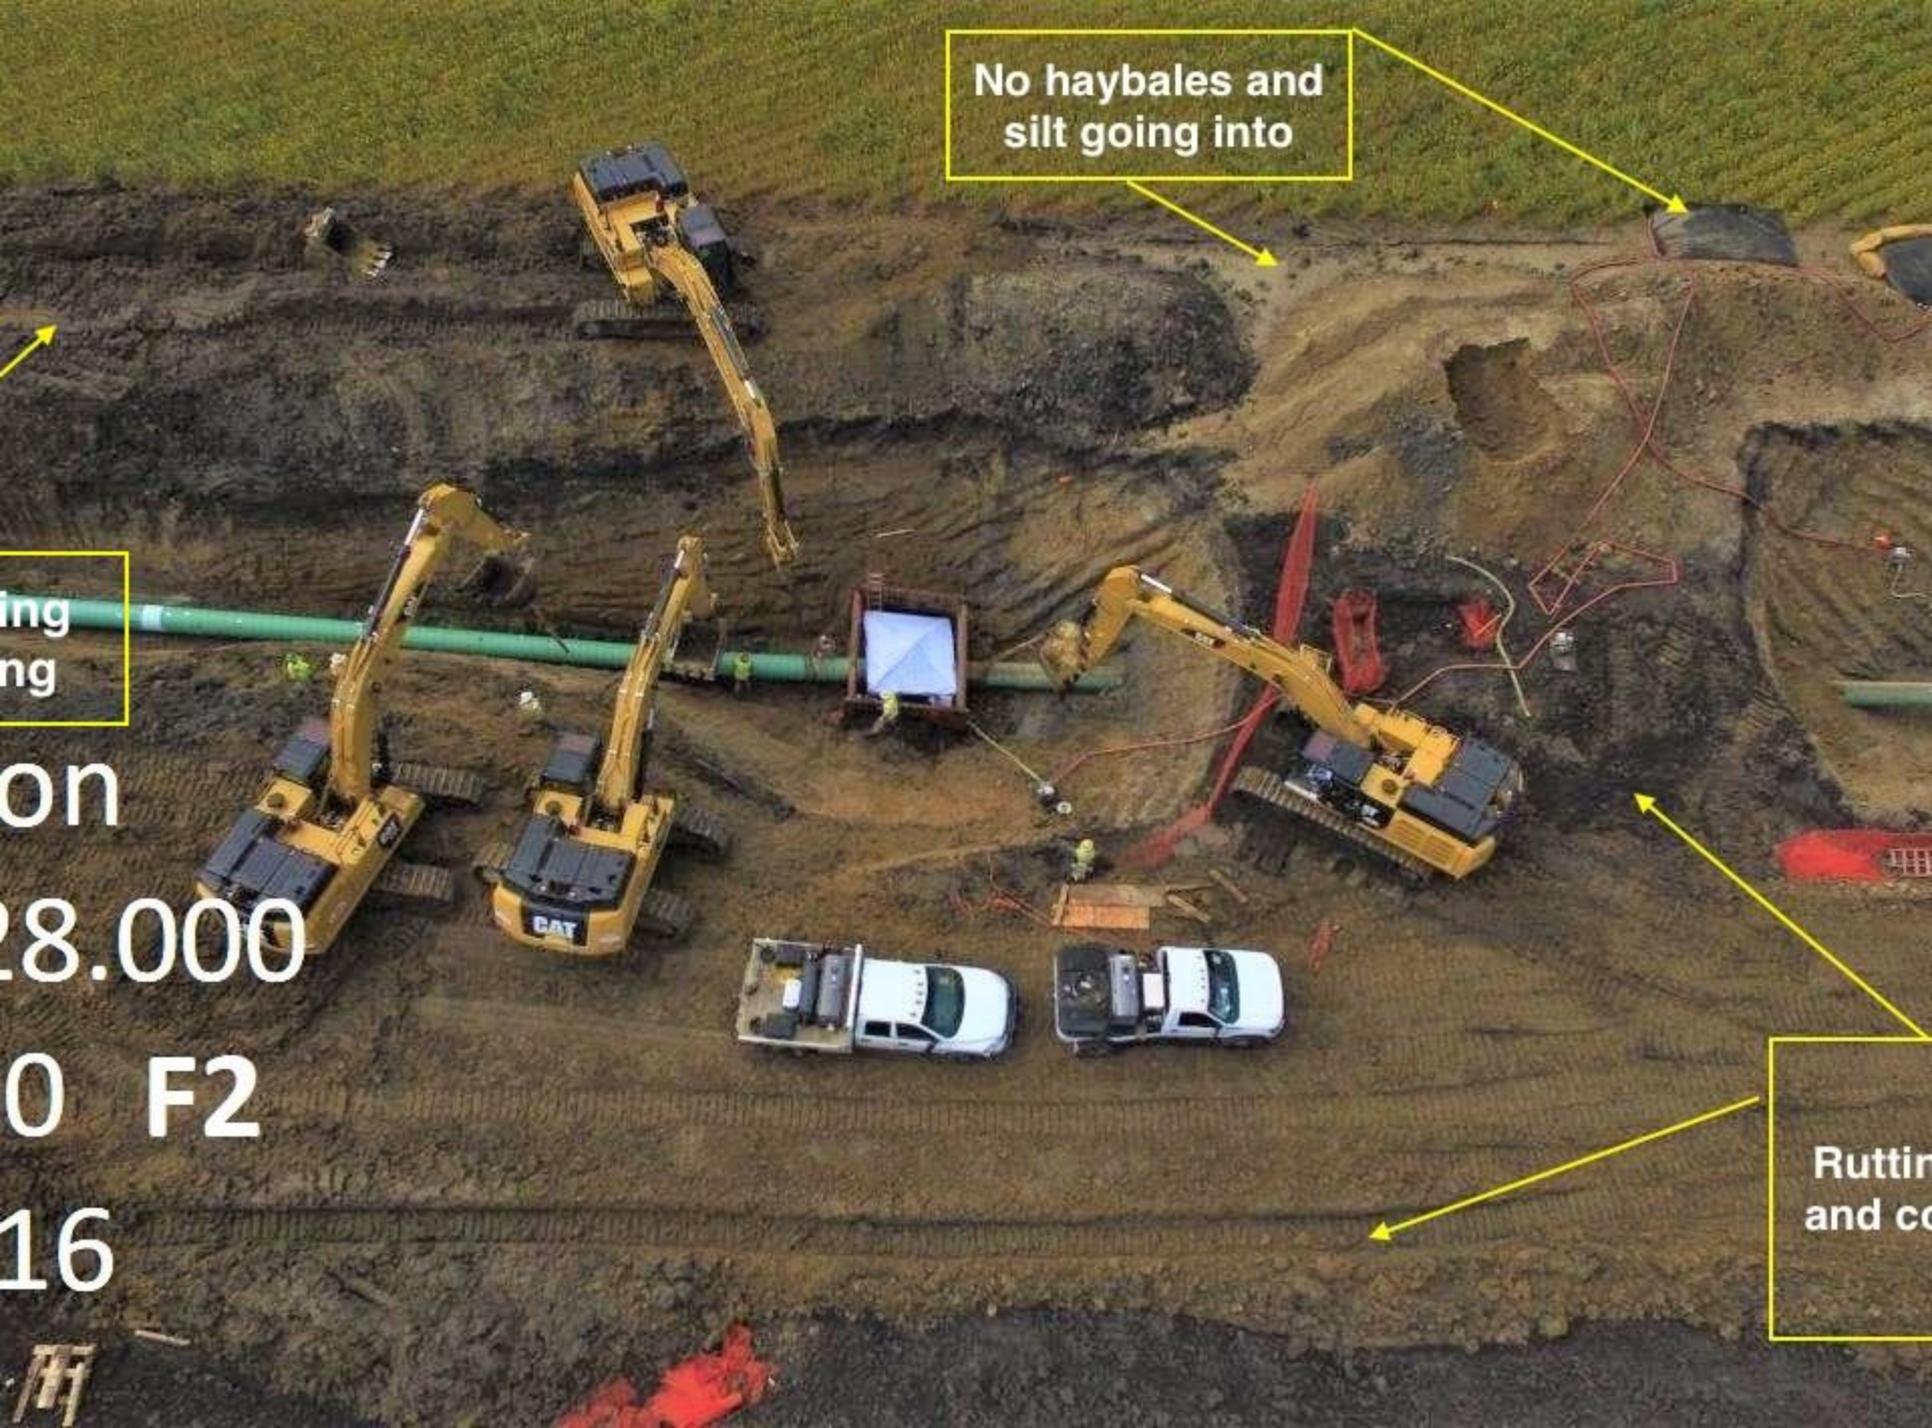
Not all top soil removed and driving on it to mix the soil and compacting it. Stacking broken matting on topsoil pile
