Johnson  
BO-028.000  
Pic #1  
8/30/16

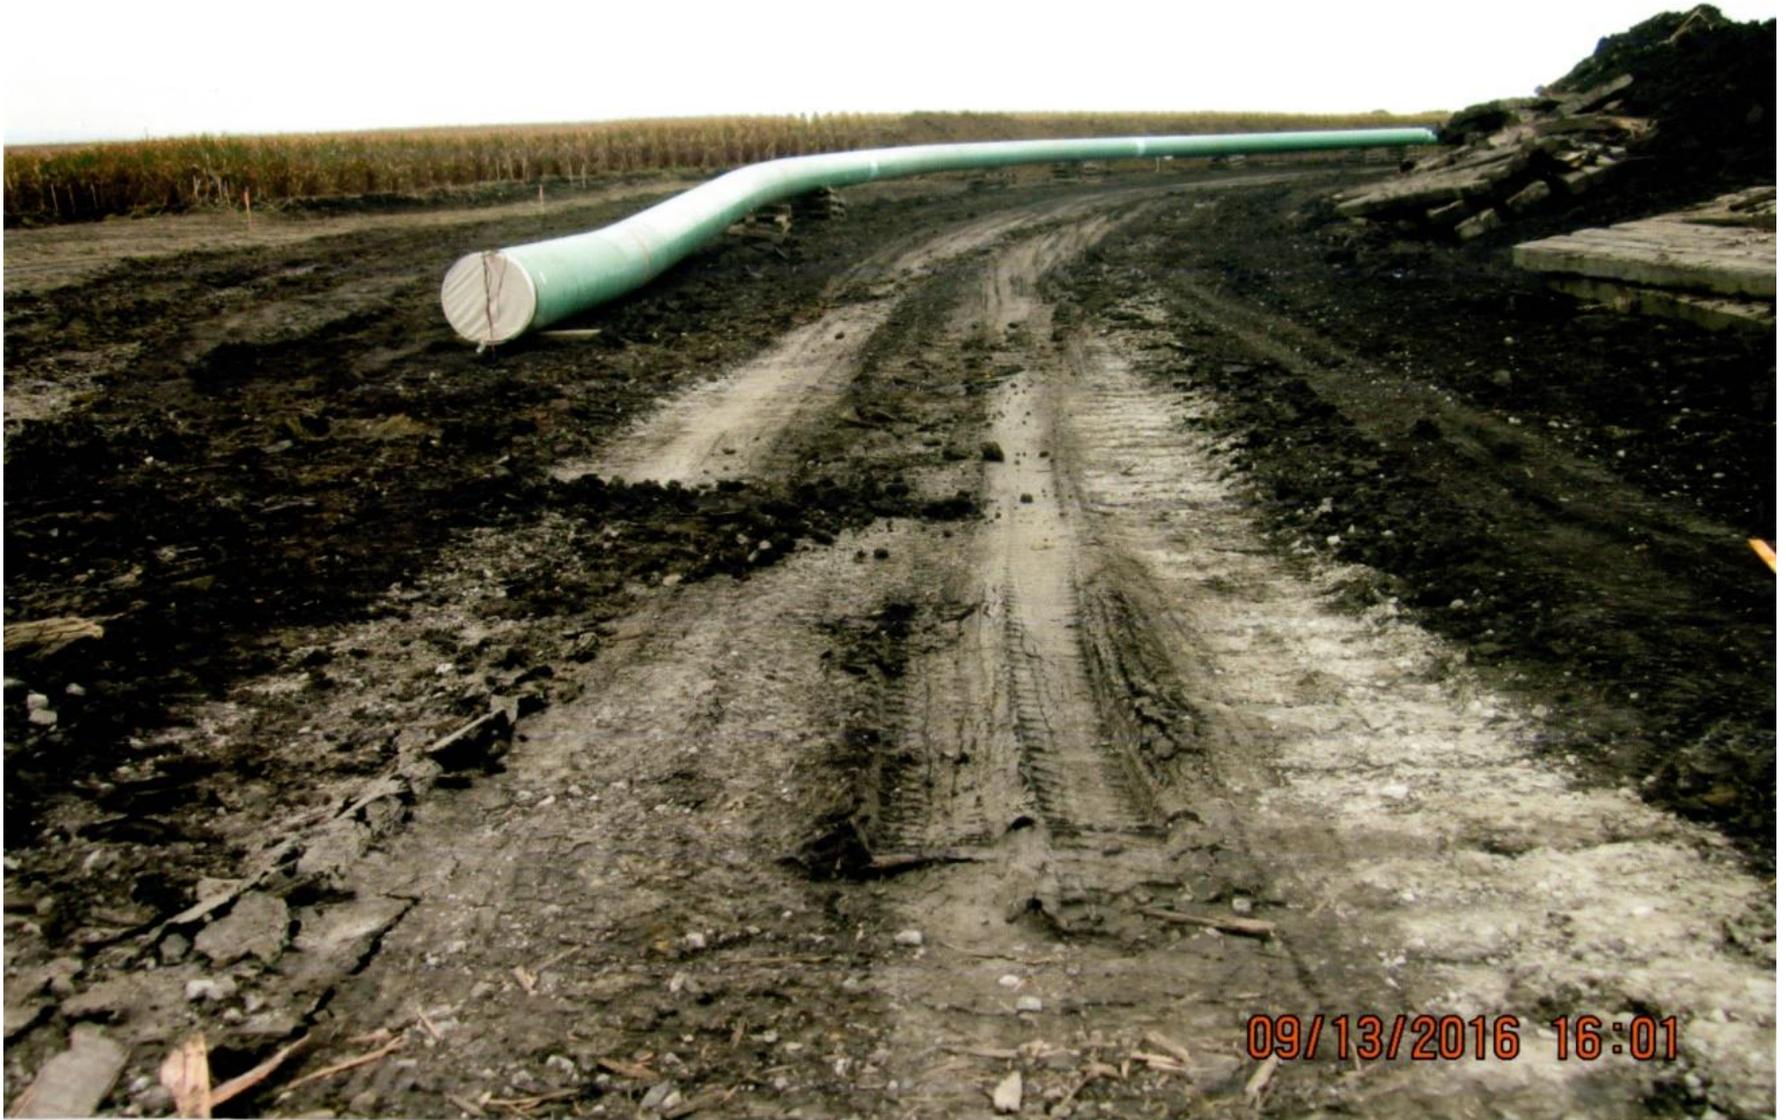
Working in wet condition. They call it soft soil

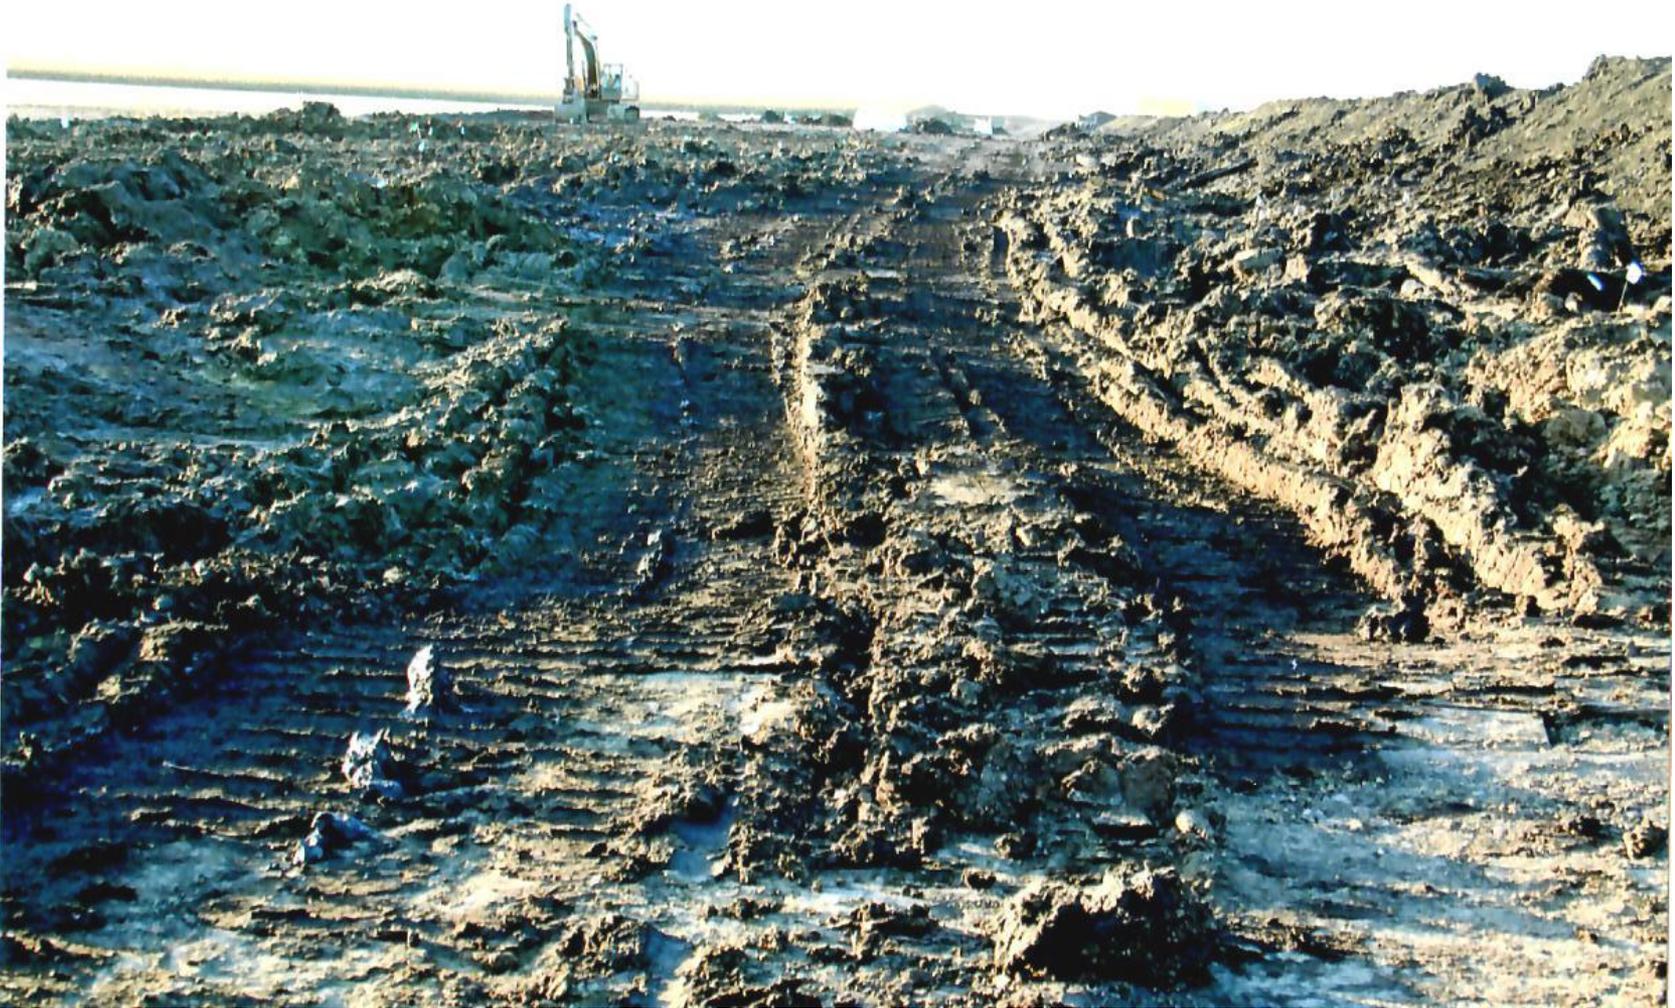
## Repairing tile in wet conditions on topsoil compaction it more

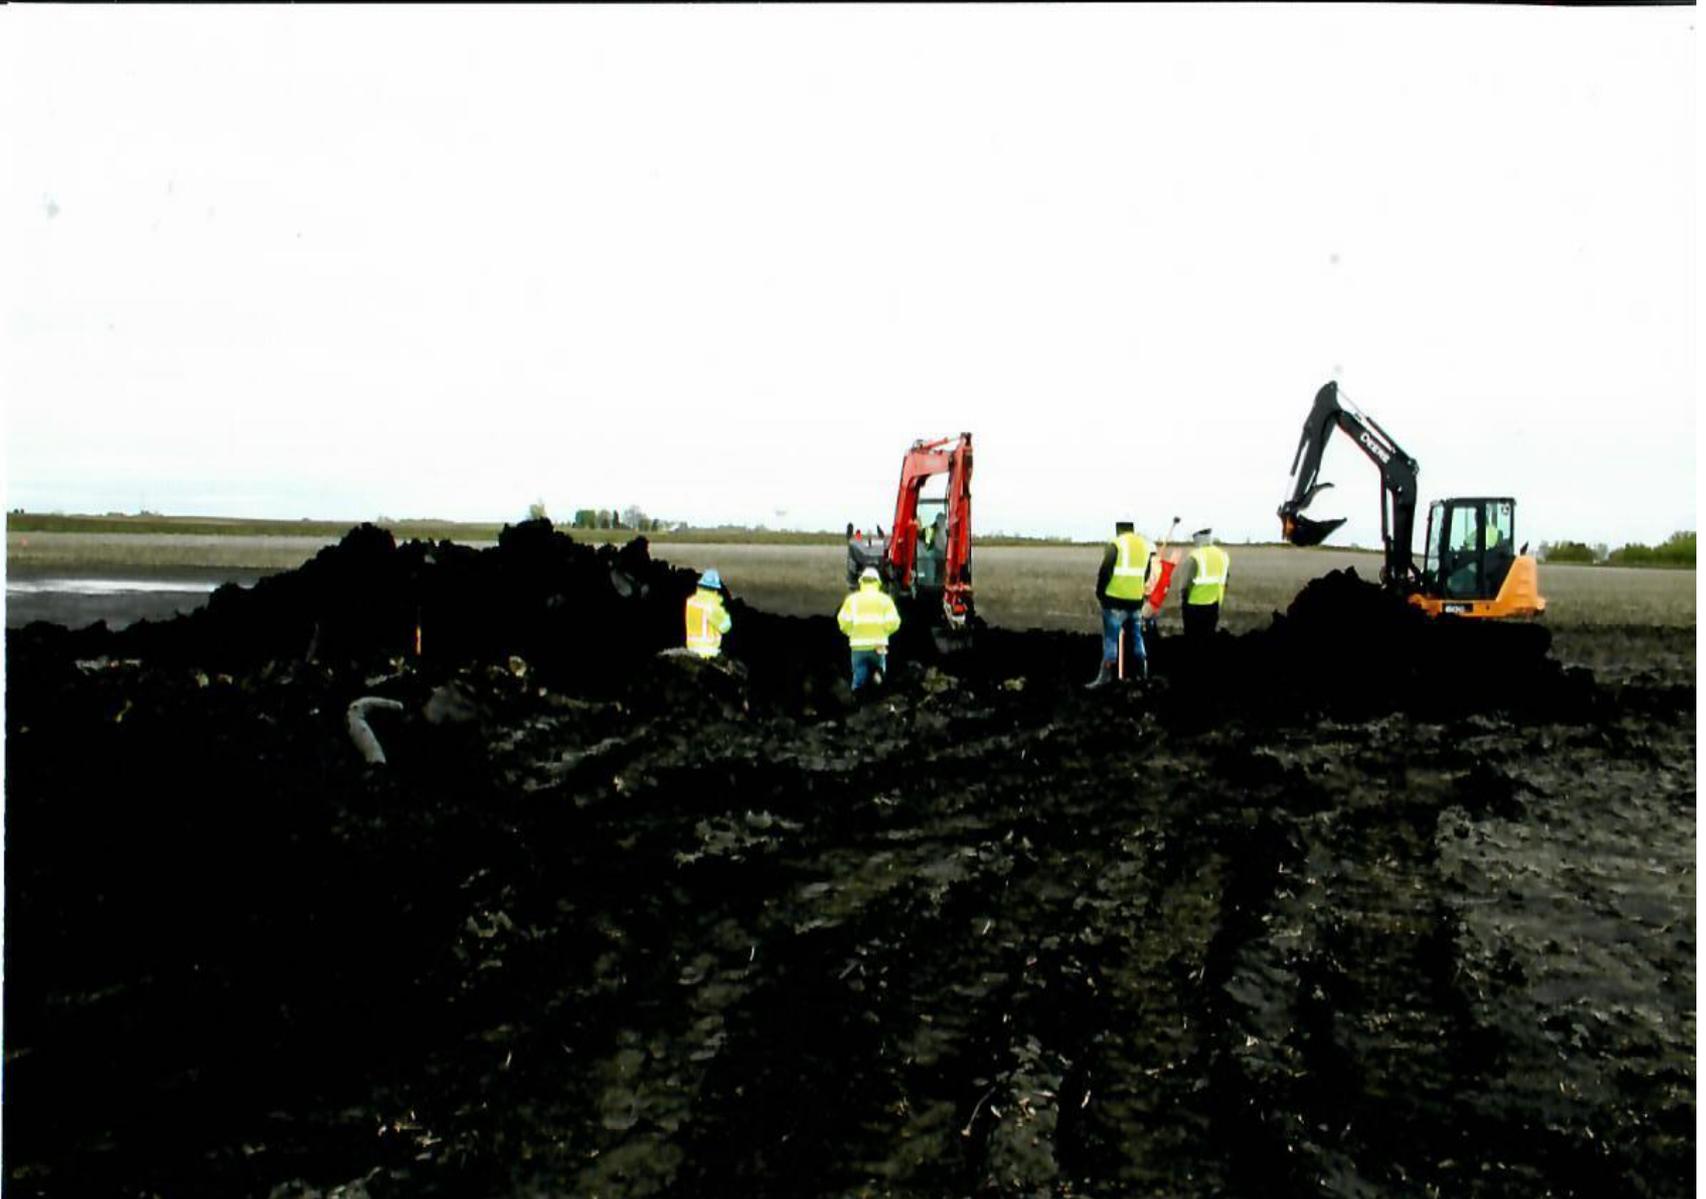
Working in wet conditions causing compaction, mixing and ruts

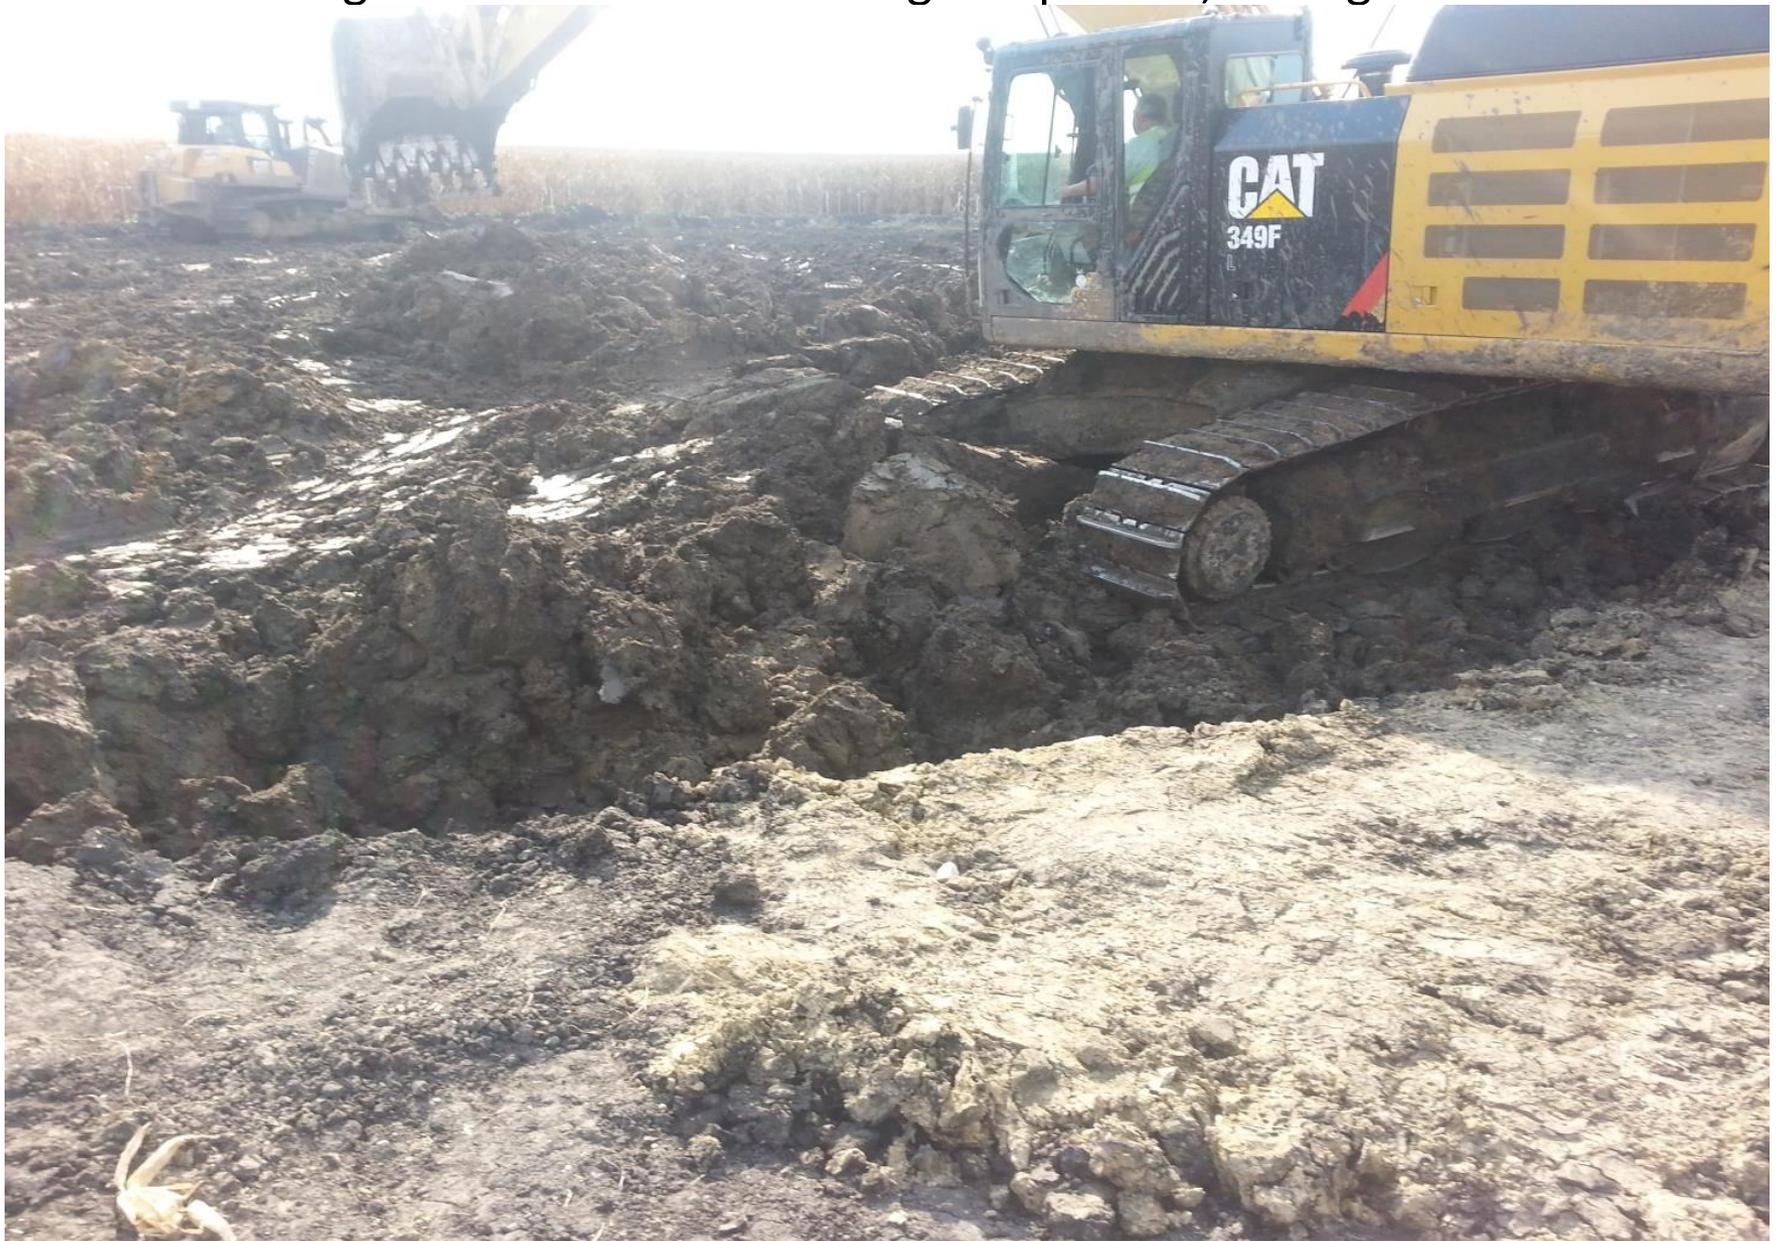
## Driving off ROW compacting soils

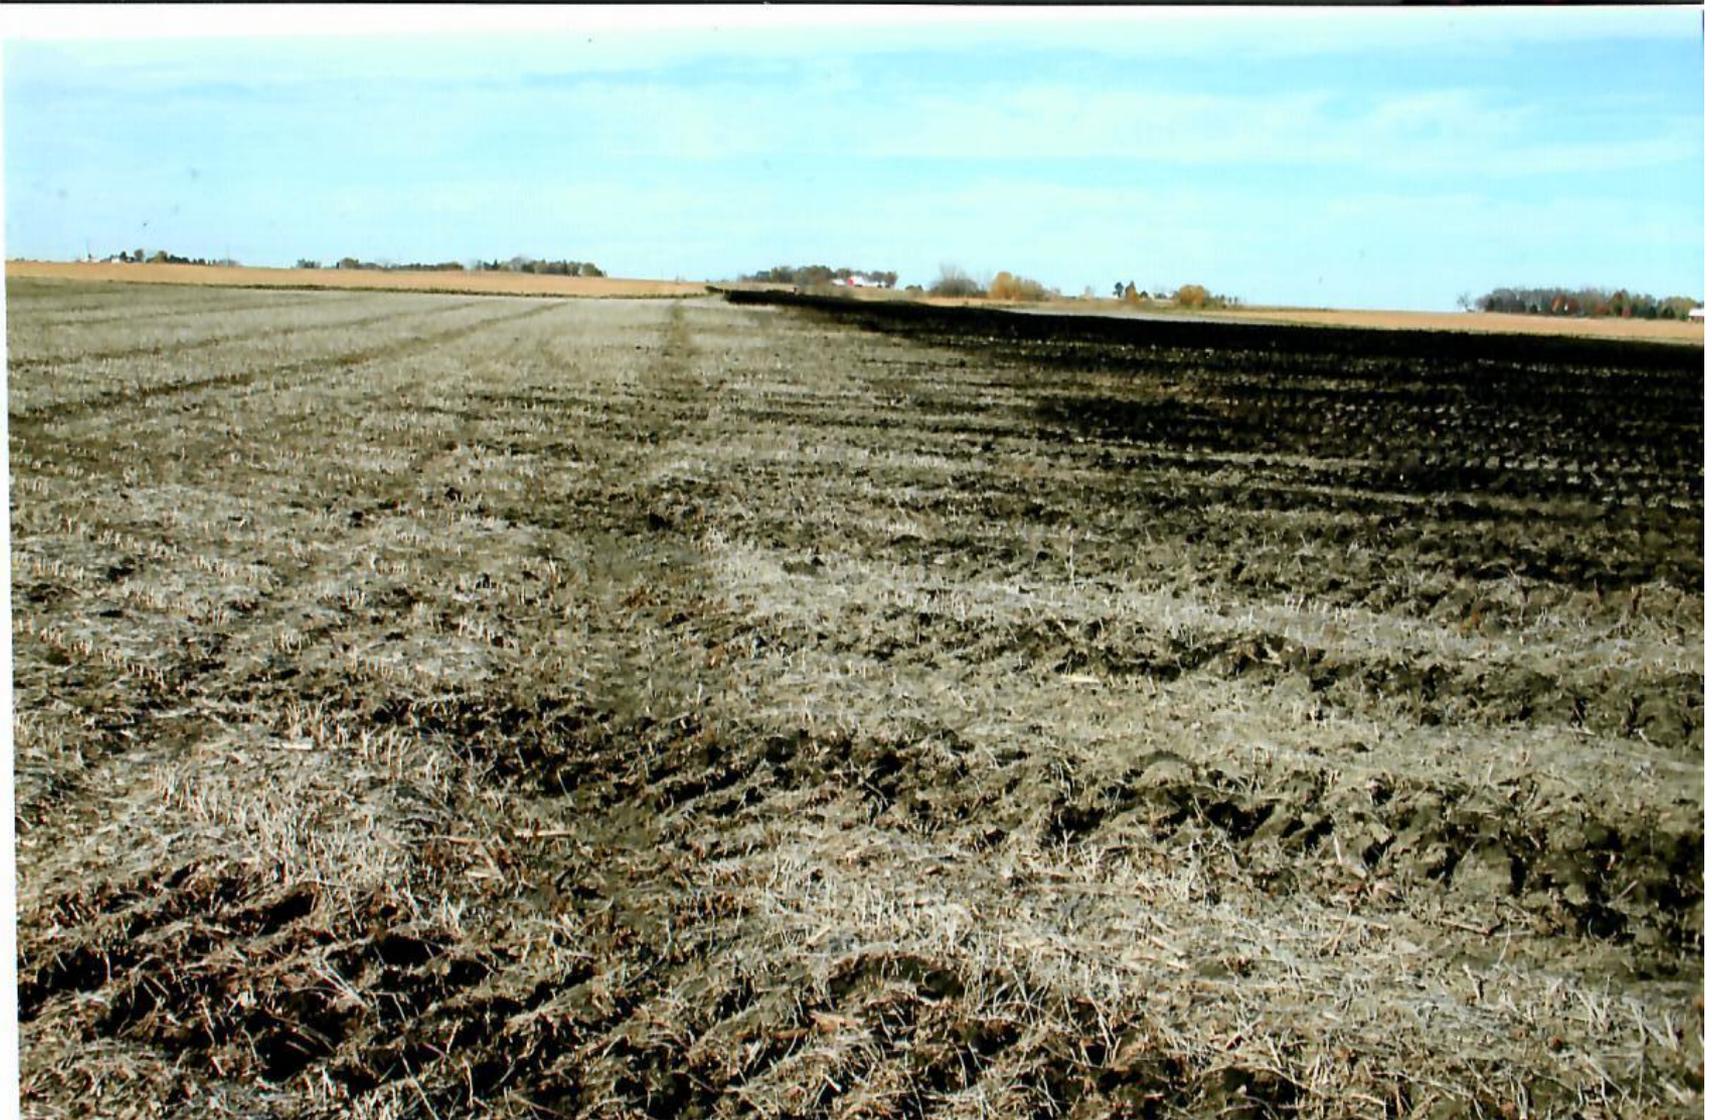
Driving off ROW all over field

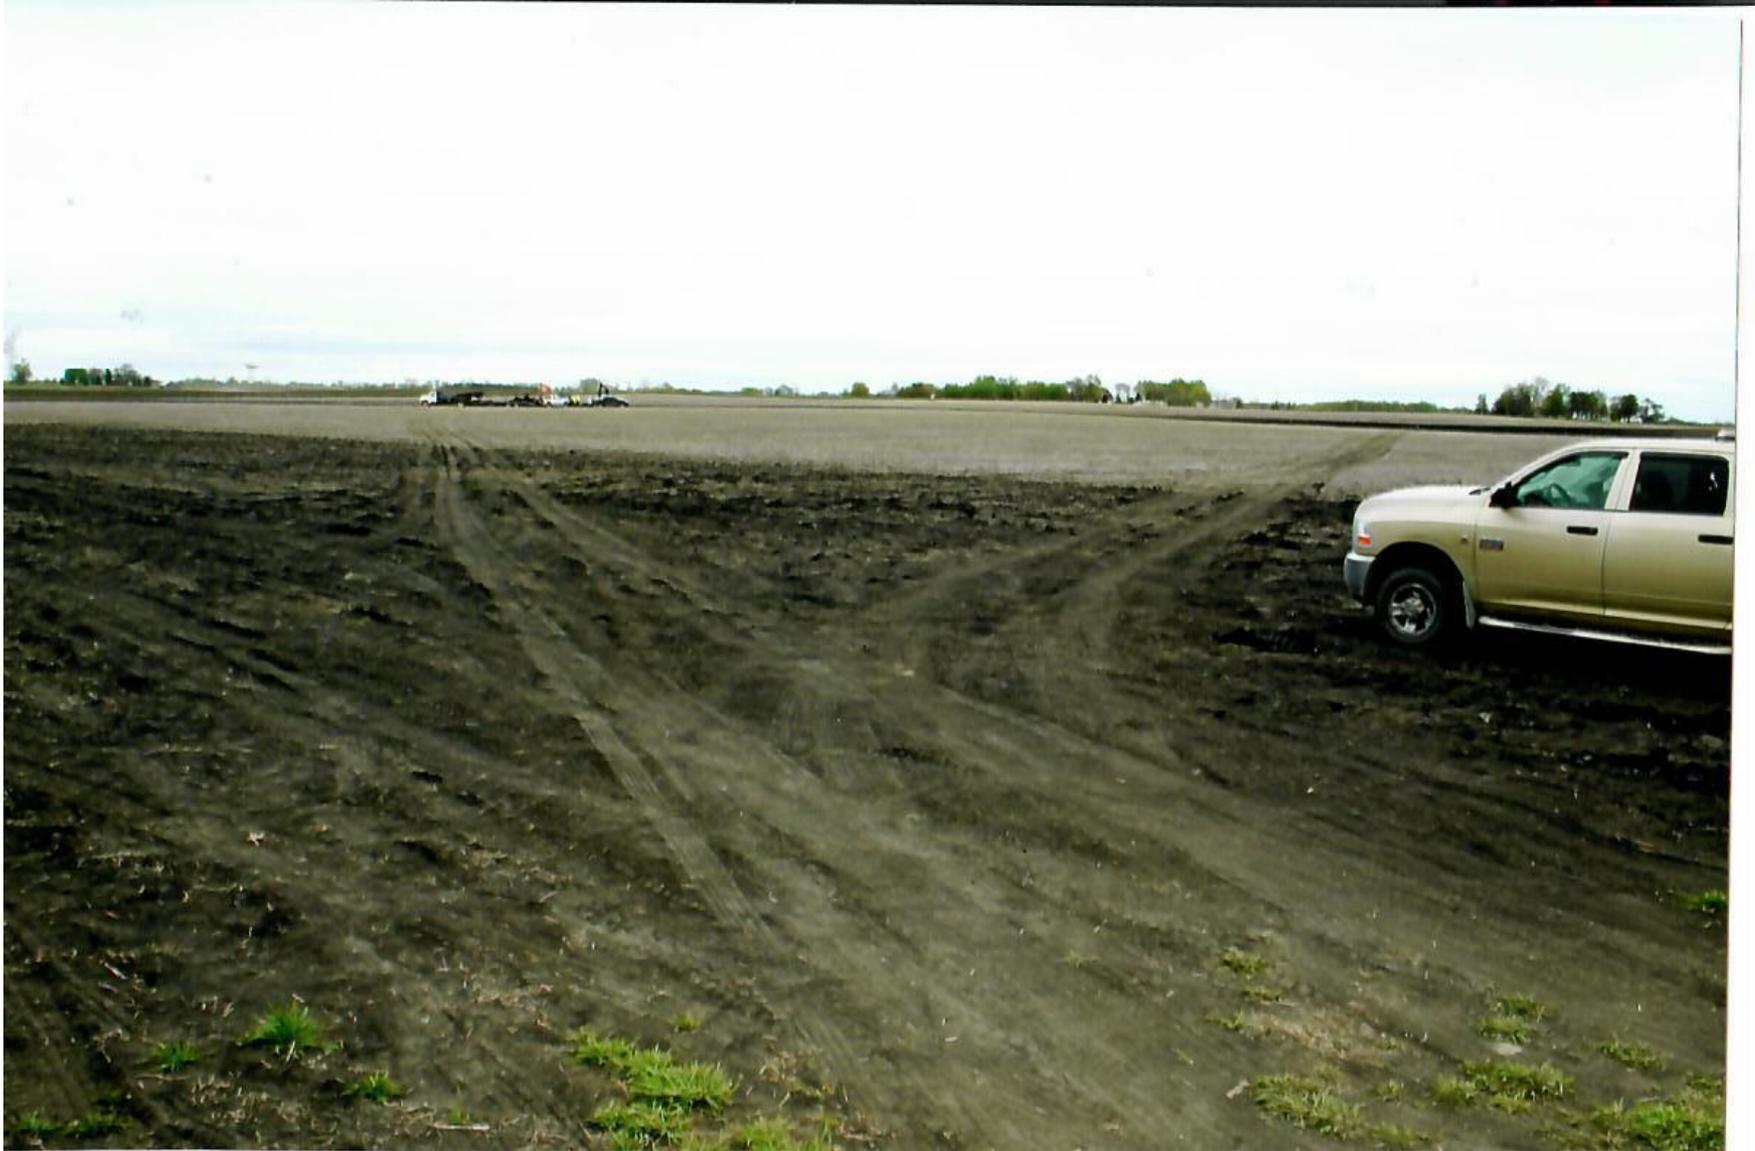
Working in wet condition repaired tile and driving on topsoil pile compacting it

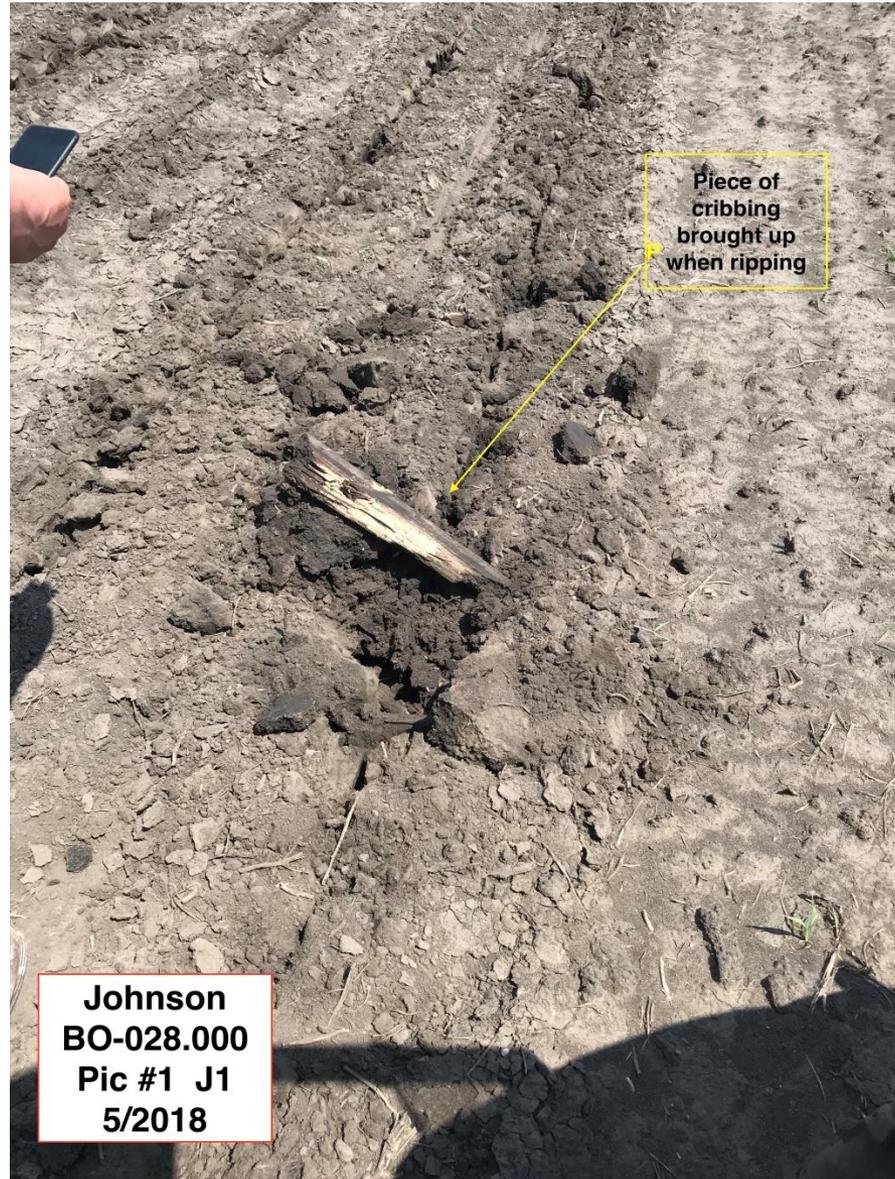
Johnson  
BO-028.000  
Pic #1 J1  
5/2018

Piece of  
cribbing  
brought up  
when ripping

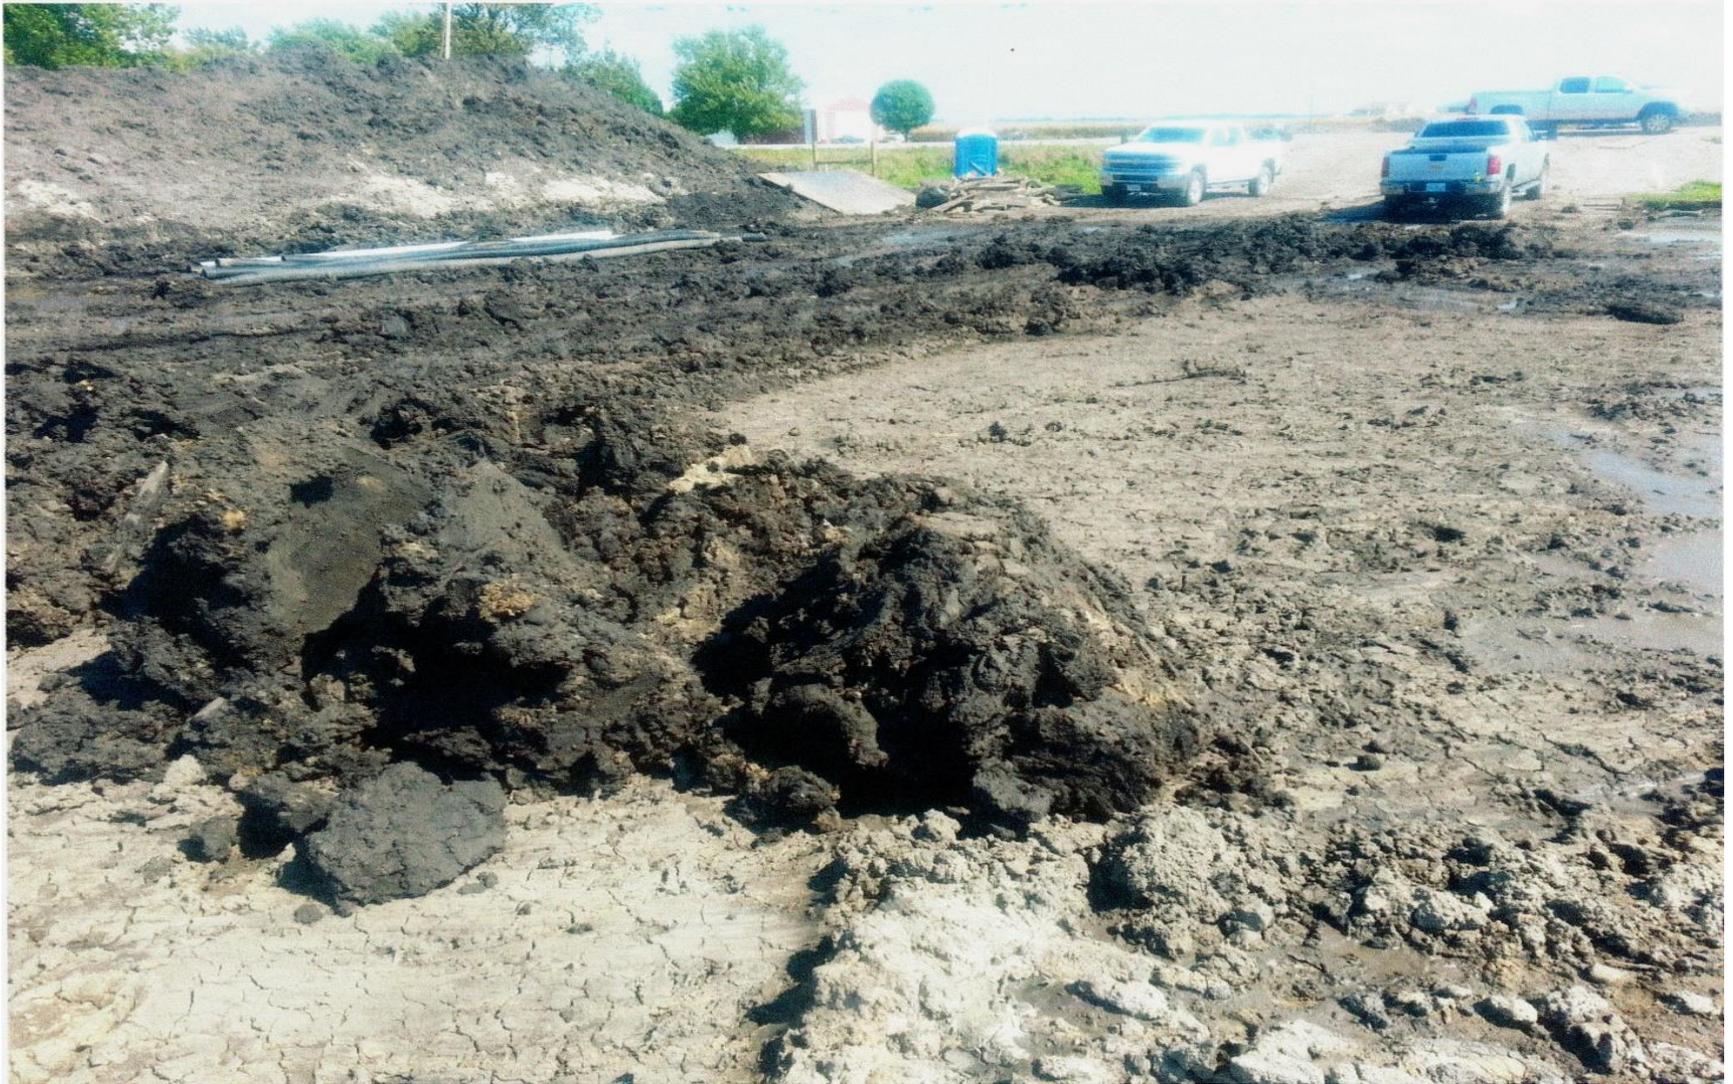
Drying topsoil causing HUGE clots

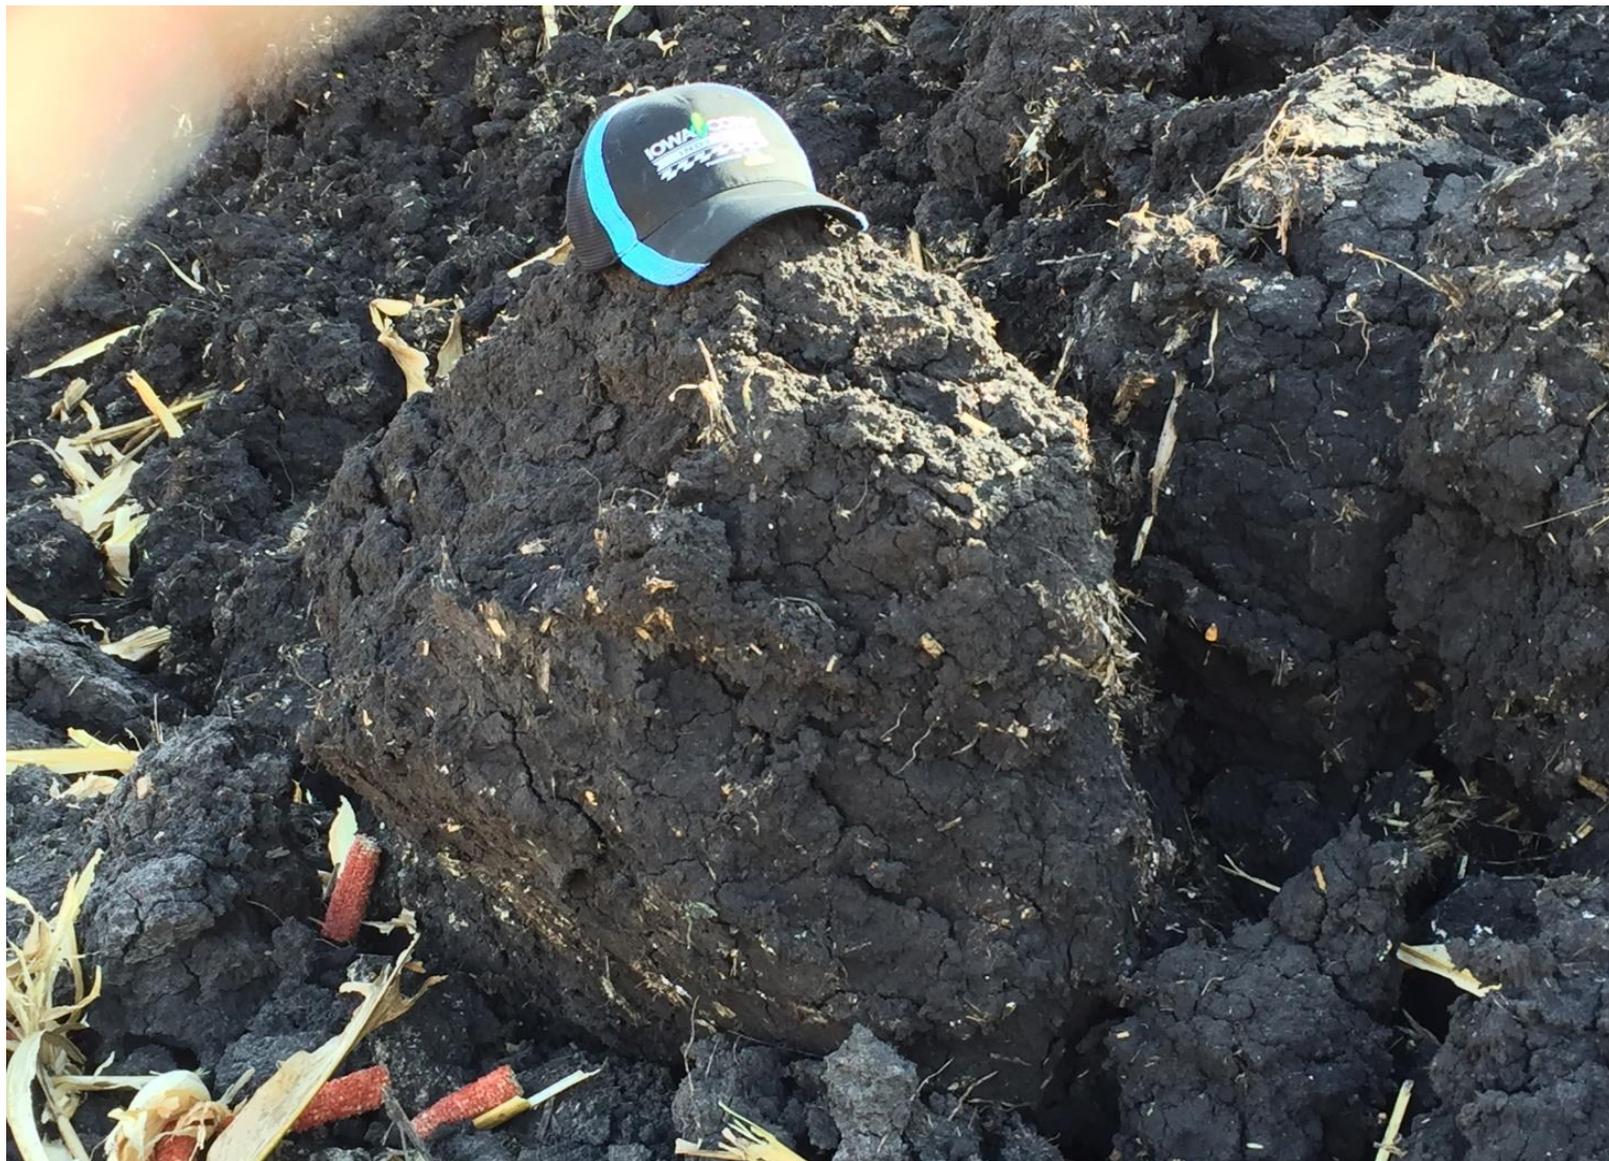
Broken tile due to matting buried in mud, compaction topsoil and mixing

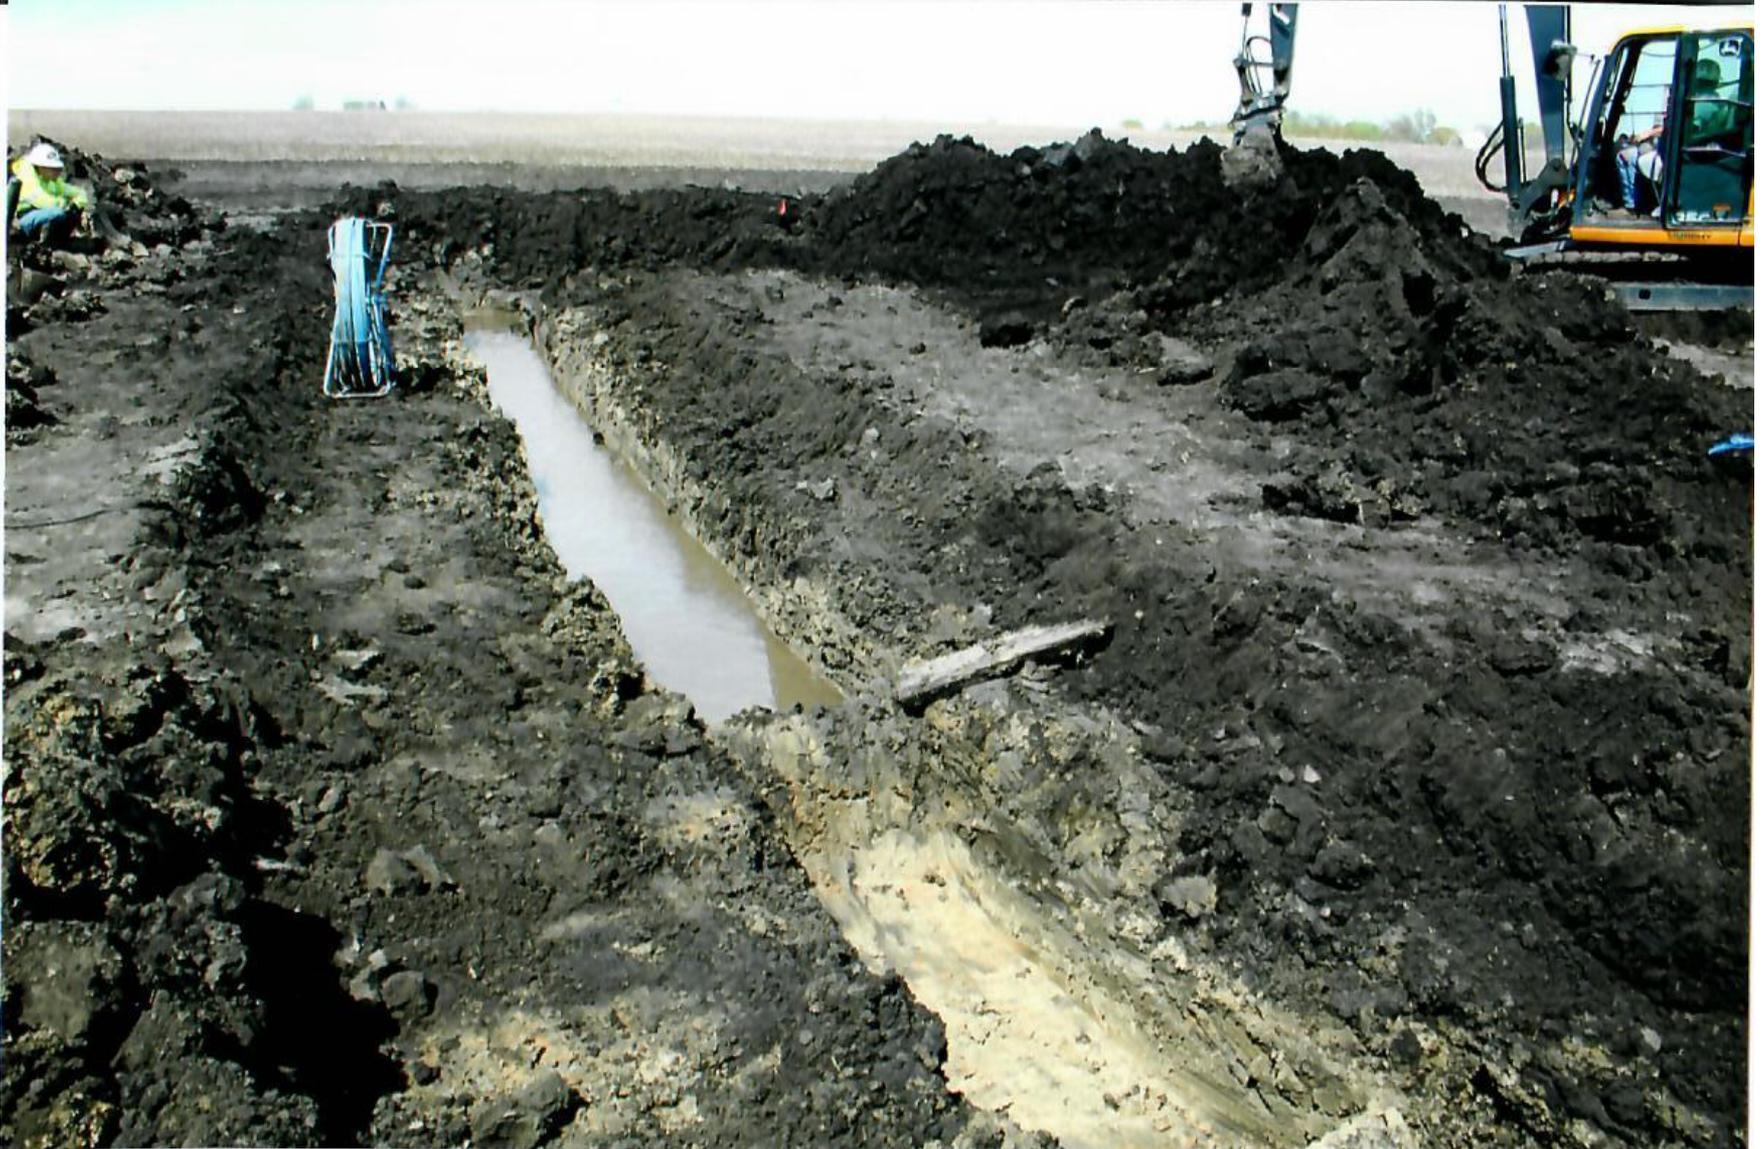
Tile ripped out of the ground when work field

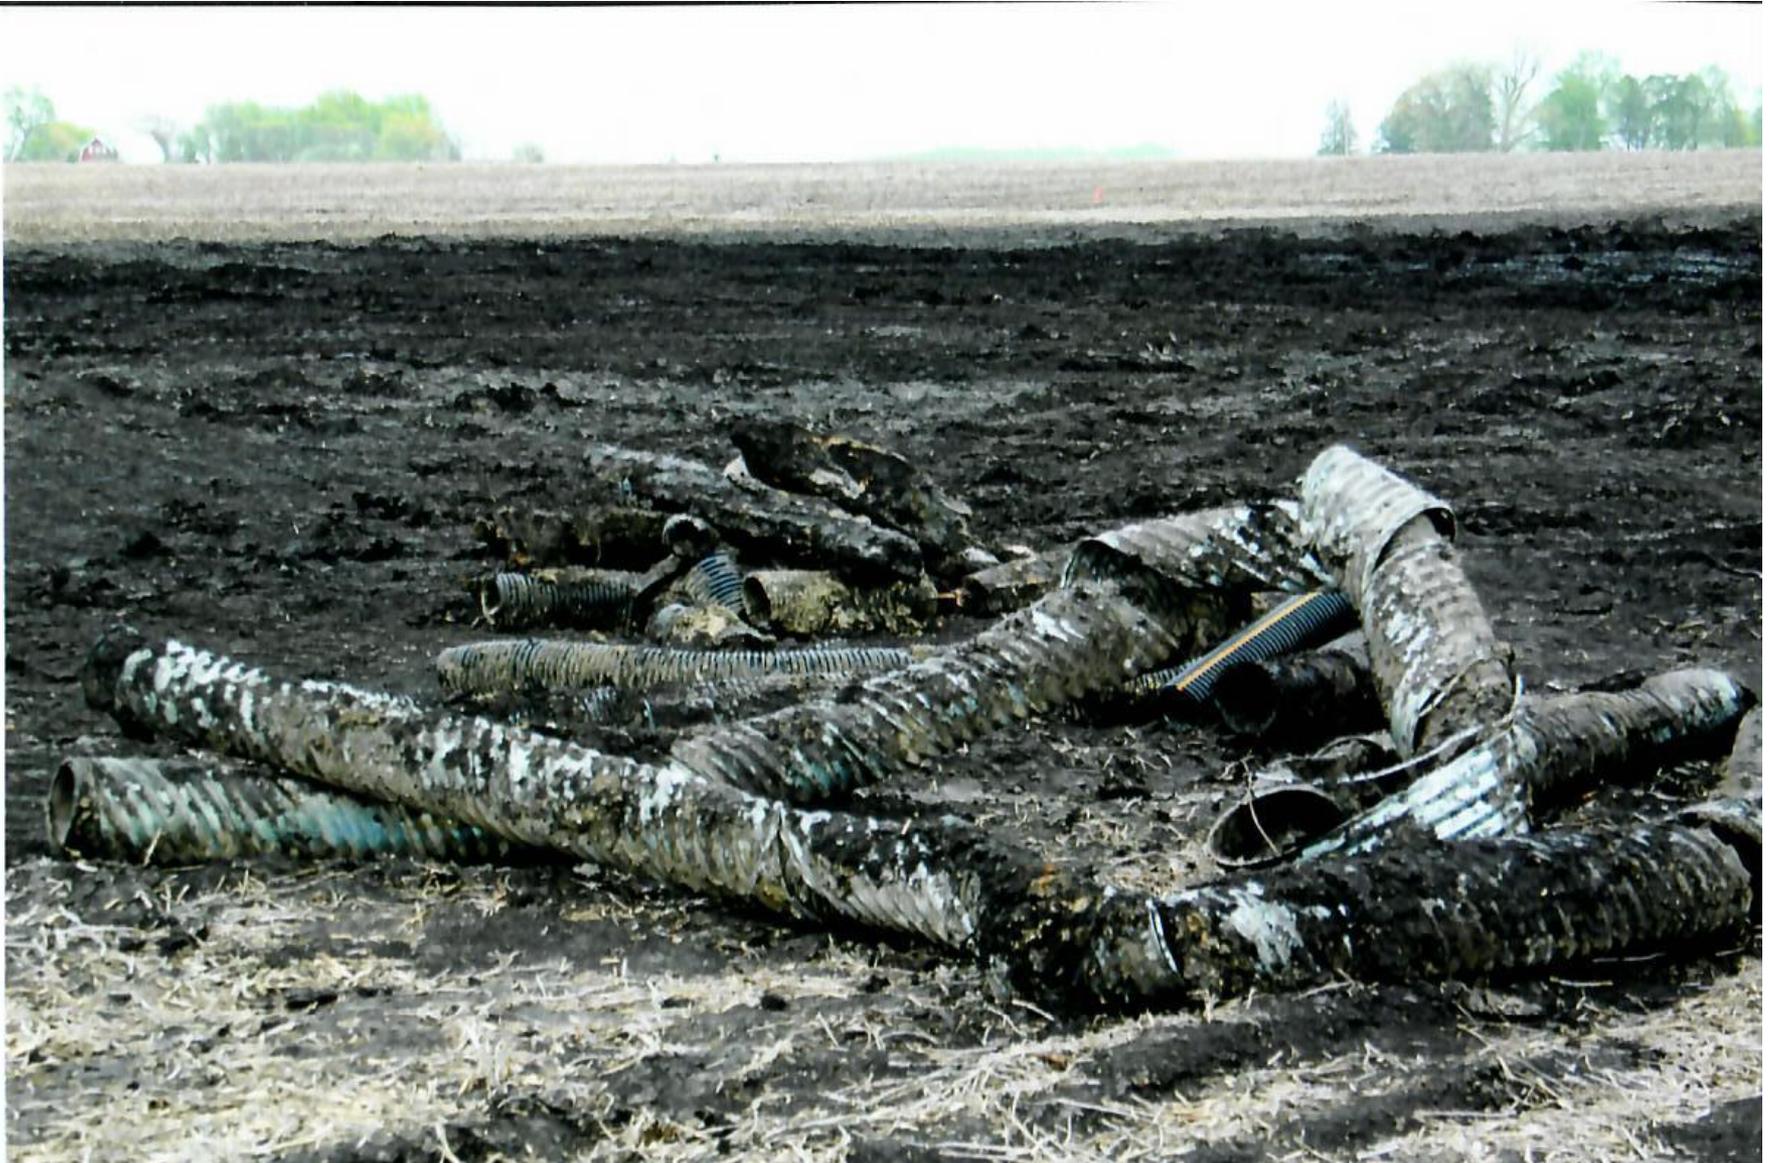
Stakes showing broken tile they are going to fix in wet conditions

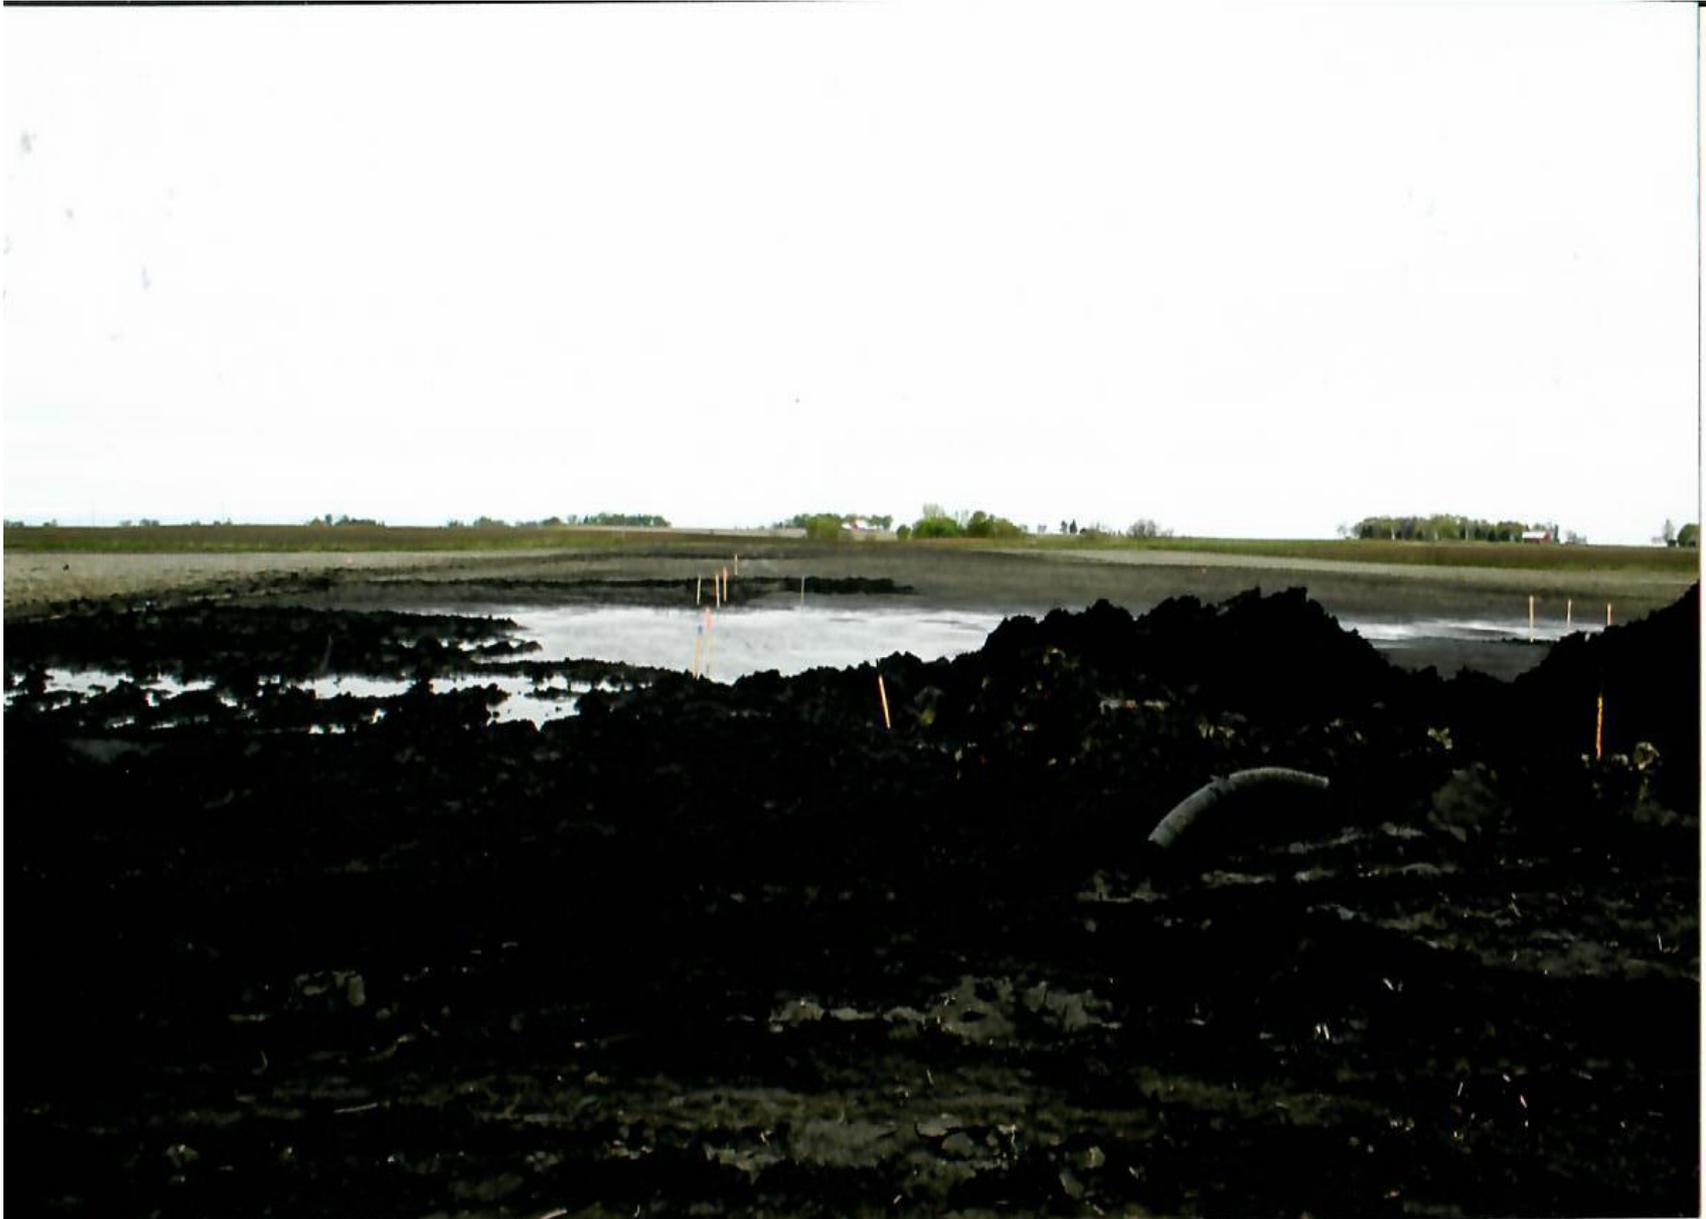
Stake next to broken tile, repair in wet conditions causing compaction
