Johnson  
BO-028.000  
Pic #1  
8/30/16

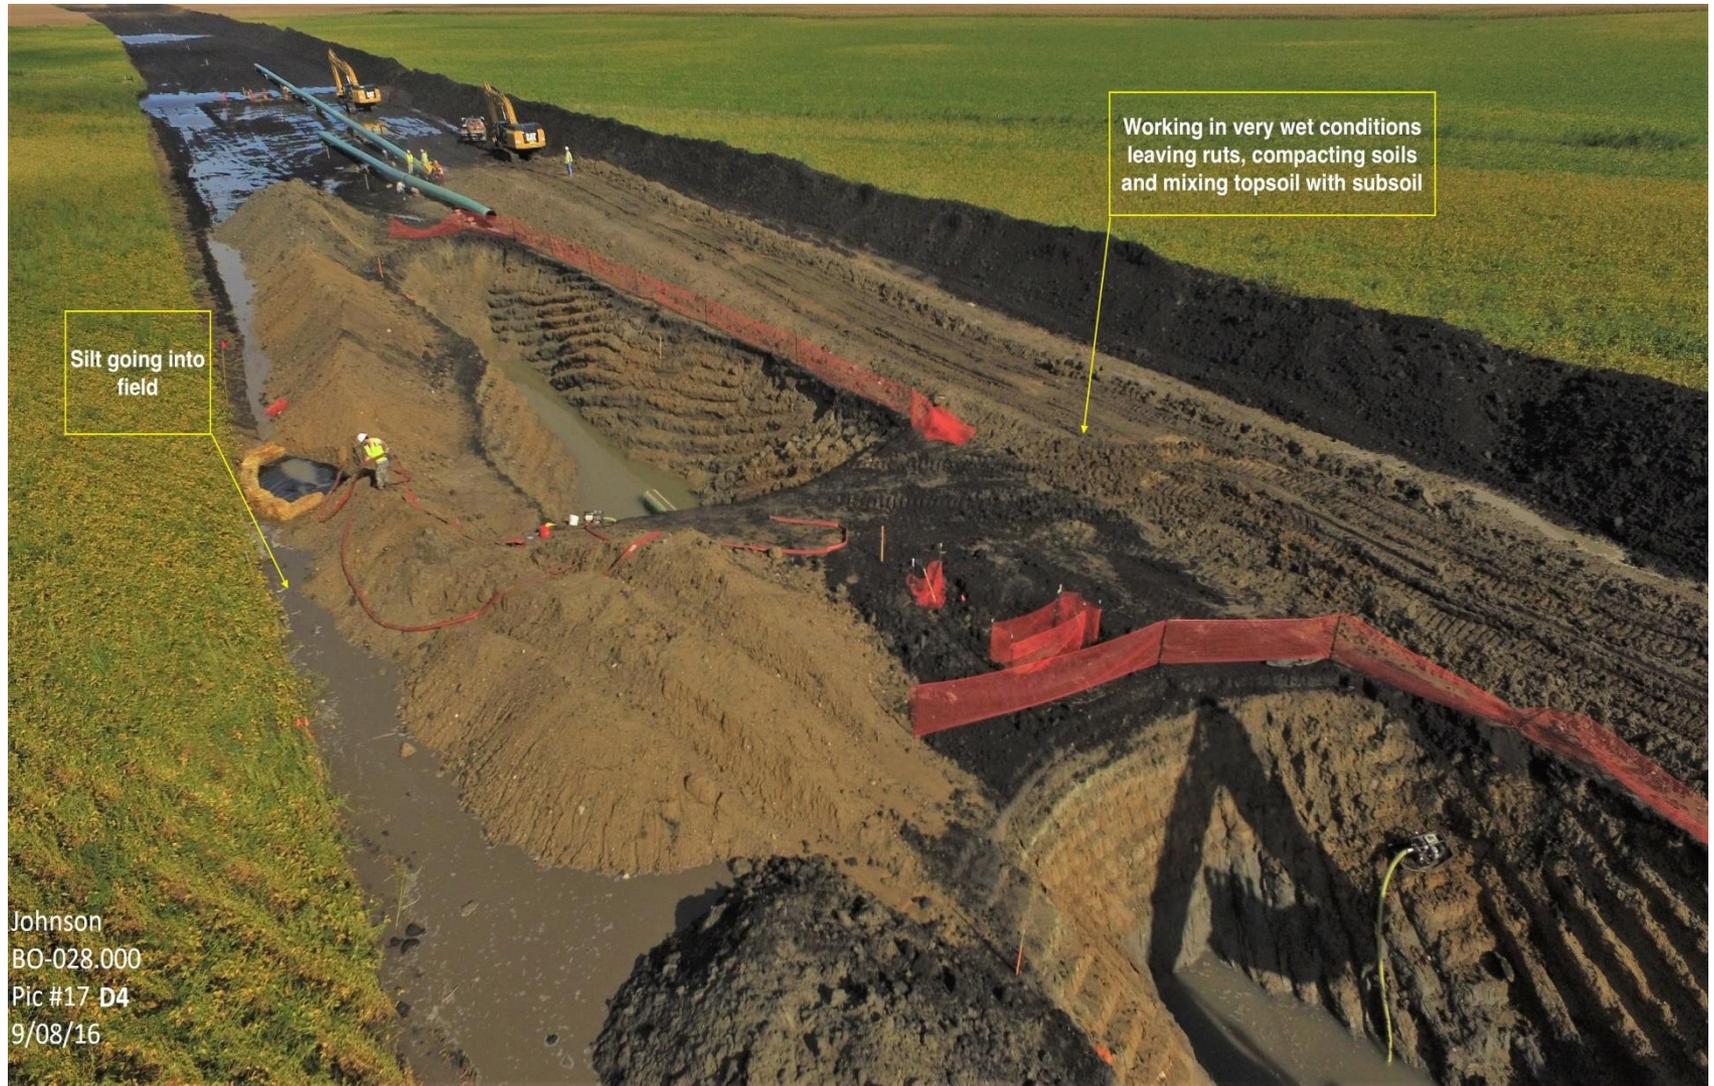
Johnson  
BO-028.000  
Pic #17 D4  
9/08/16

Silt going into field

Working in very wet conditions leaving ruts, compacting soils and mixing topsoil with subsoil

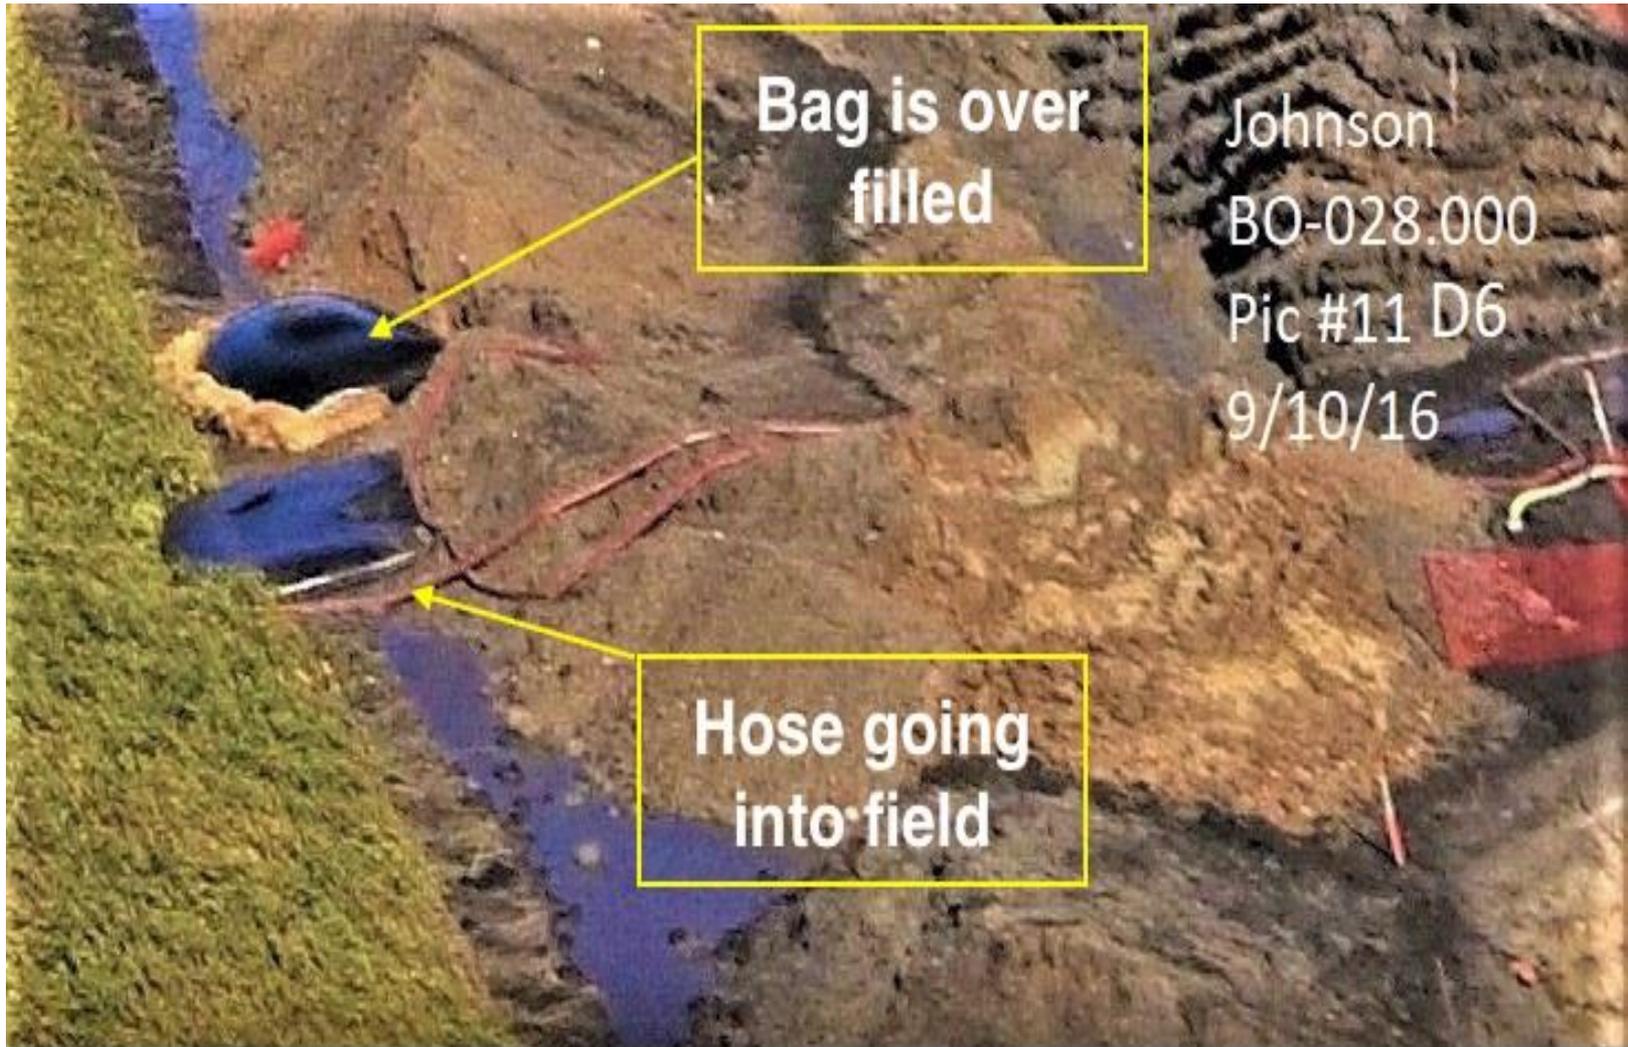
Johnson  
BO-028.000  
Pic #11 D6  
9/10/16

Bag is over  
filled

Hose going  
into field

Pumping water from trenches, dewatering, into agriculture land is not allowed due to negative impact on the fertile soil.

Filter bag and hay bales did not work to keep silt out of field.

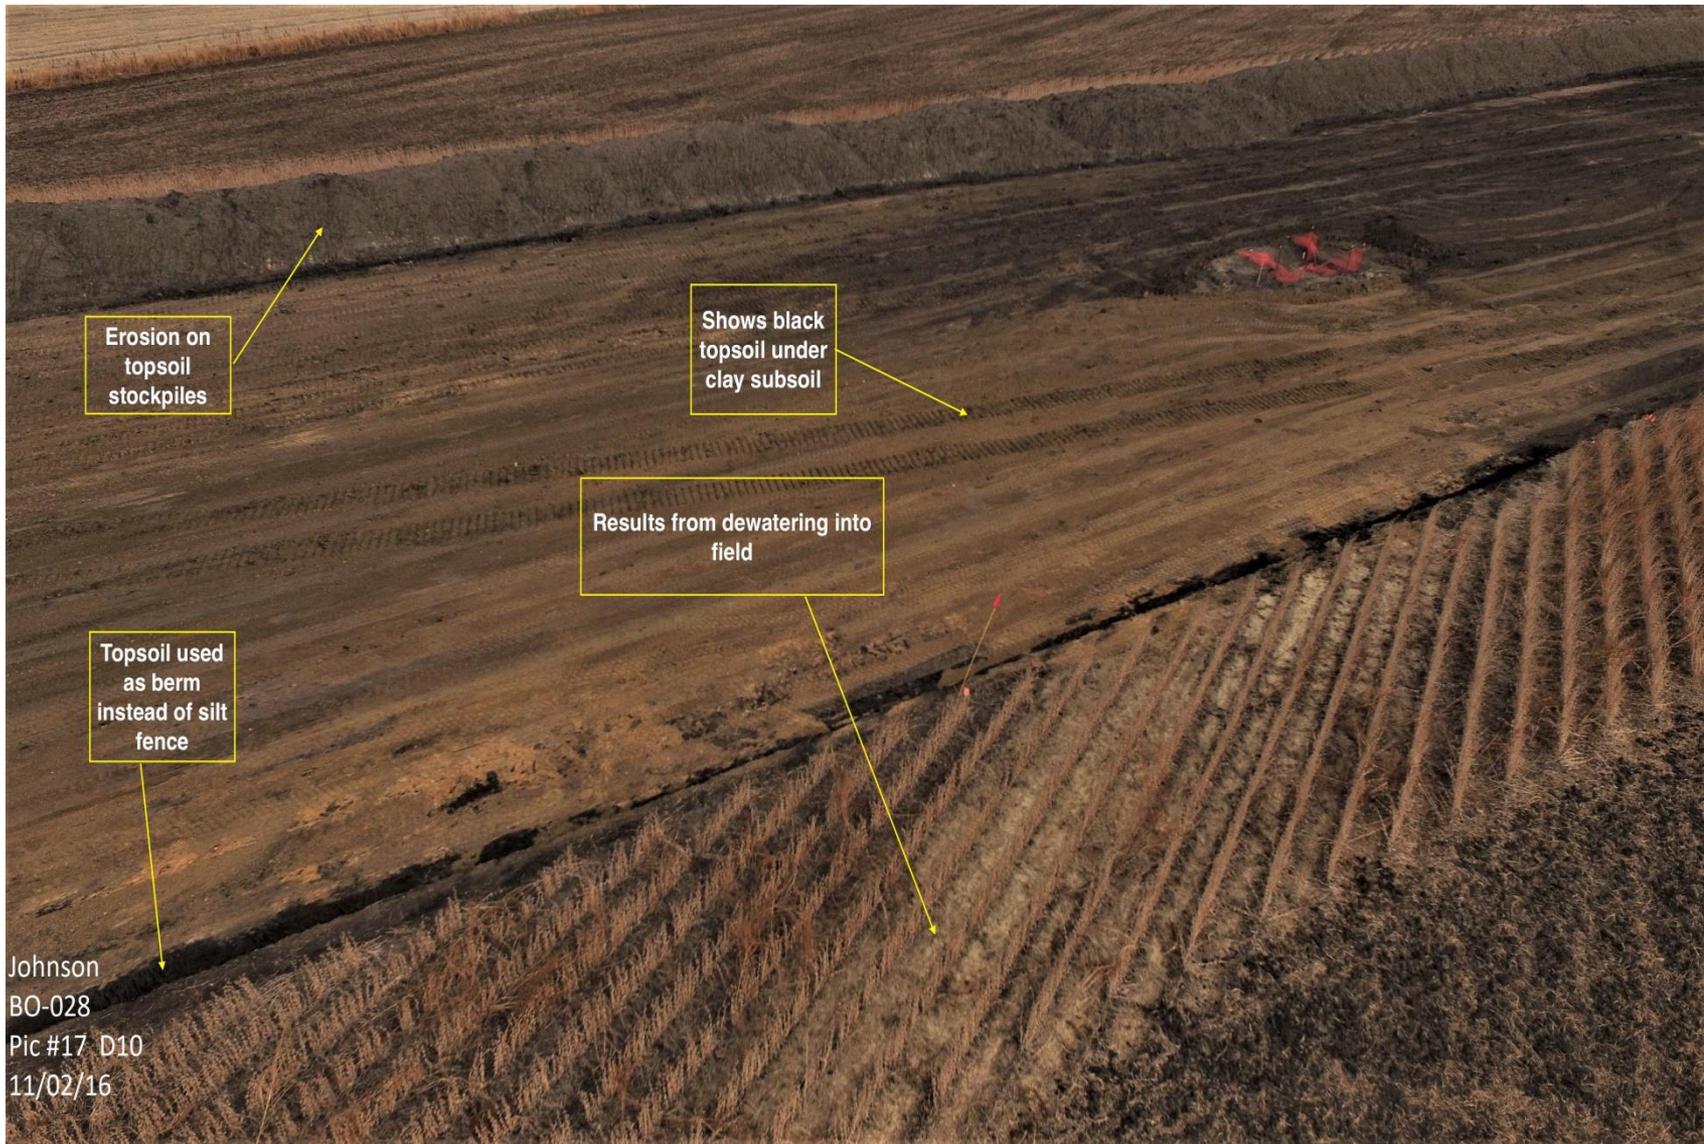
Johnson  
BO-028  
Pic #17 D10  
11/02/16

Erosion on topsoil stockpiles

Shows black topsoil under clay subsoil

Results from dewatering into field

Topsoil used as berm instead of silt fence

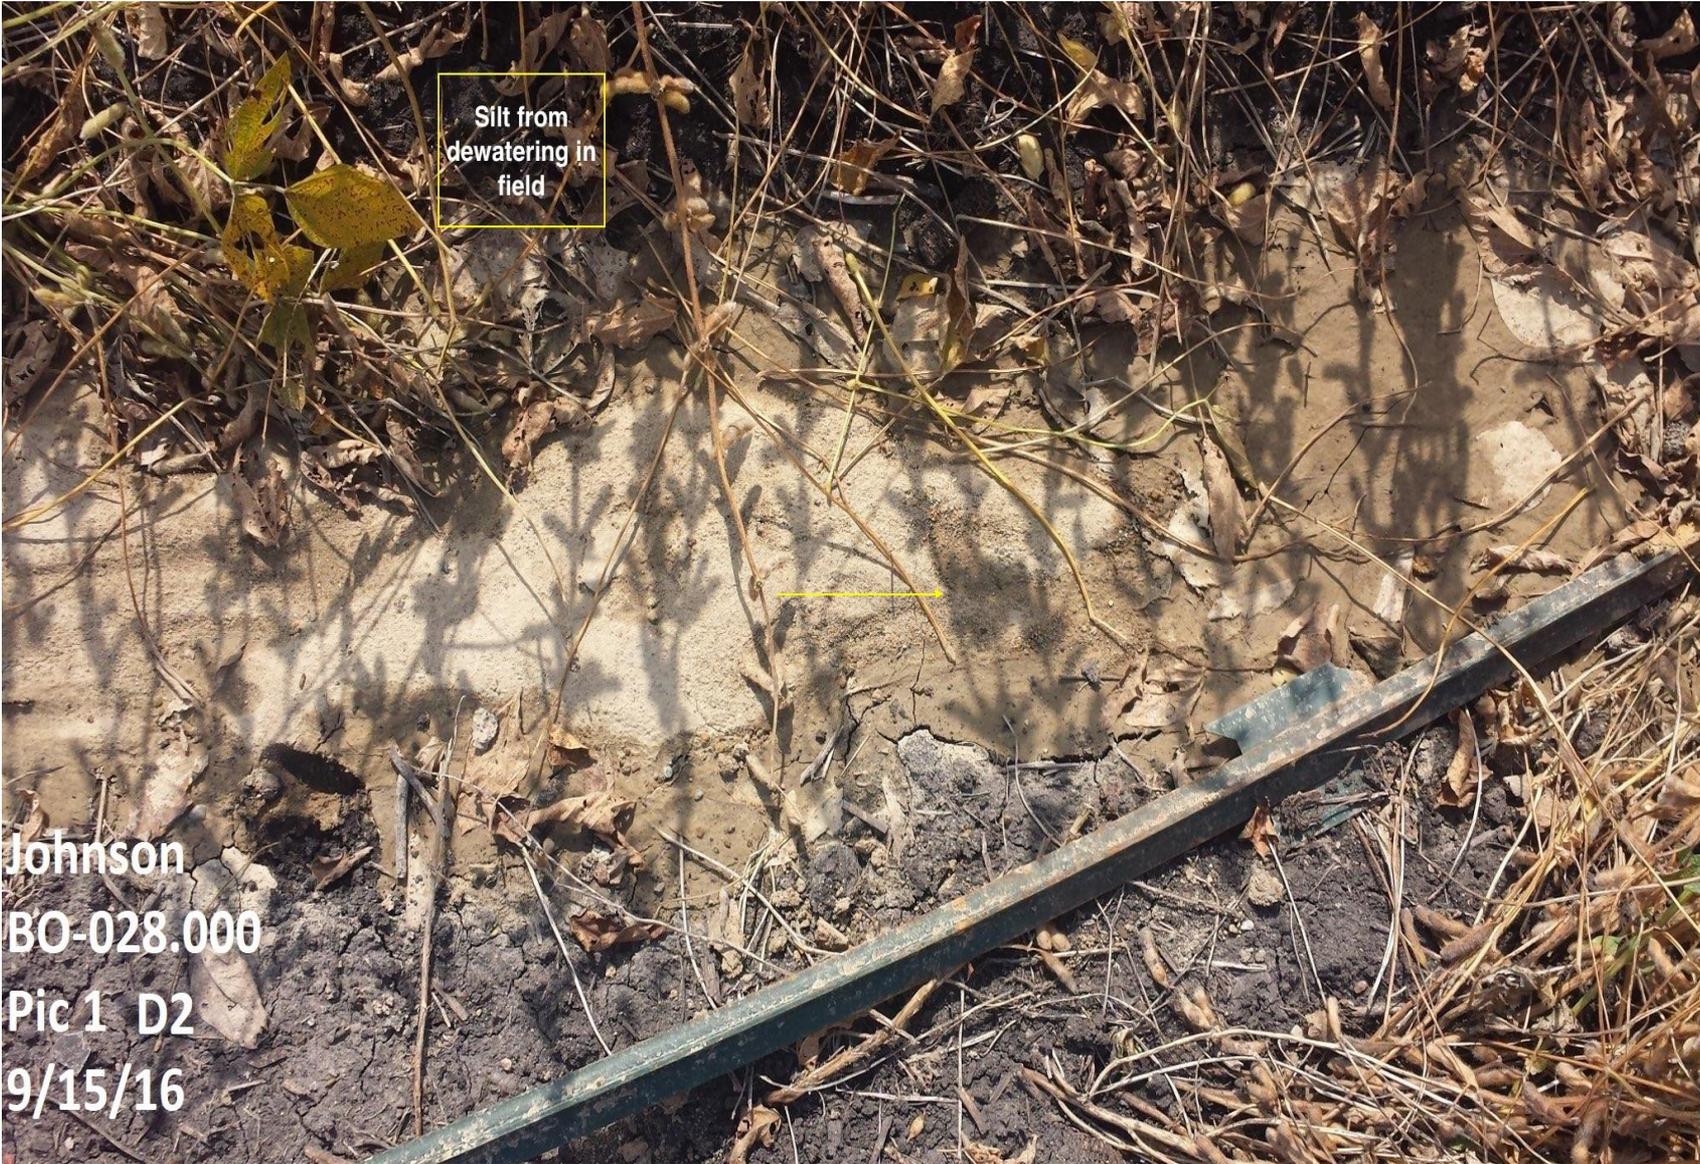
Johnson  
BO-028.000  
Pic 1 D2  
9/15/16

Silt from  
dewatering in  
field

Dewatering in field even though there is a no dewater agreement. Broken silt bag and berm not holding water in.

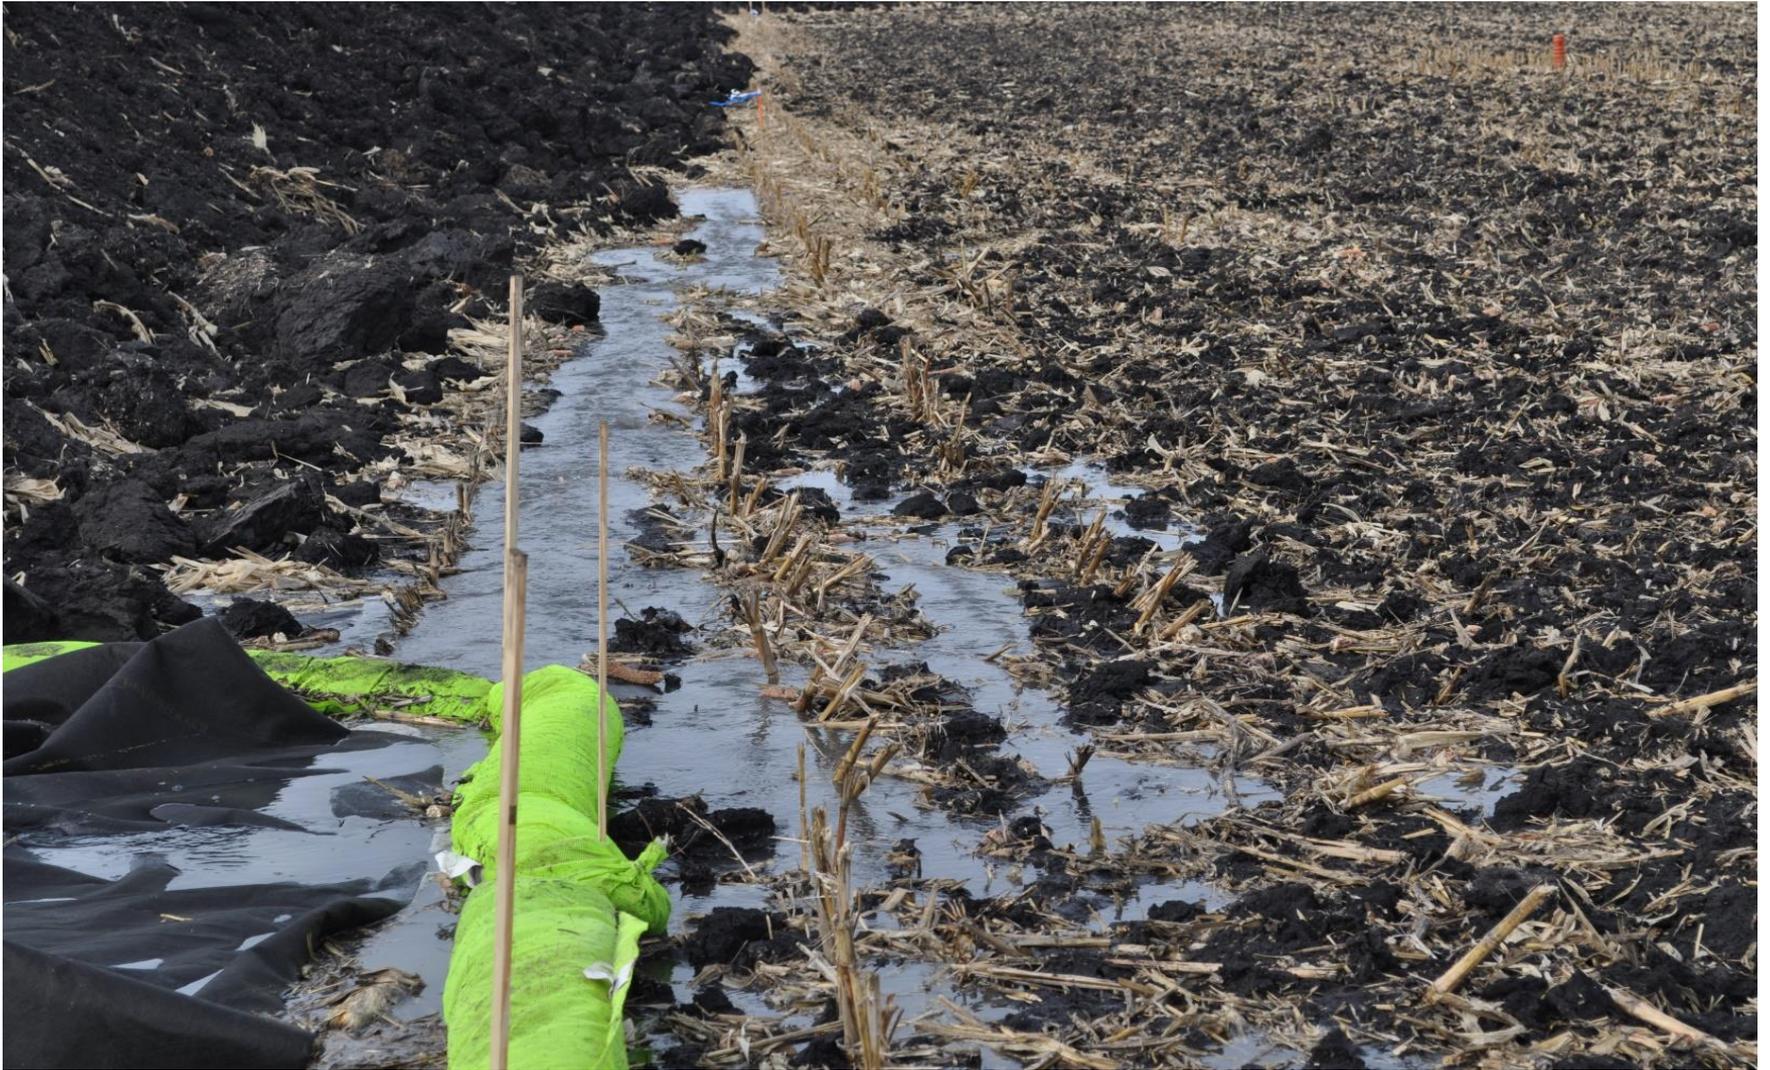
Silt water allowed to drain into field

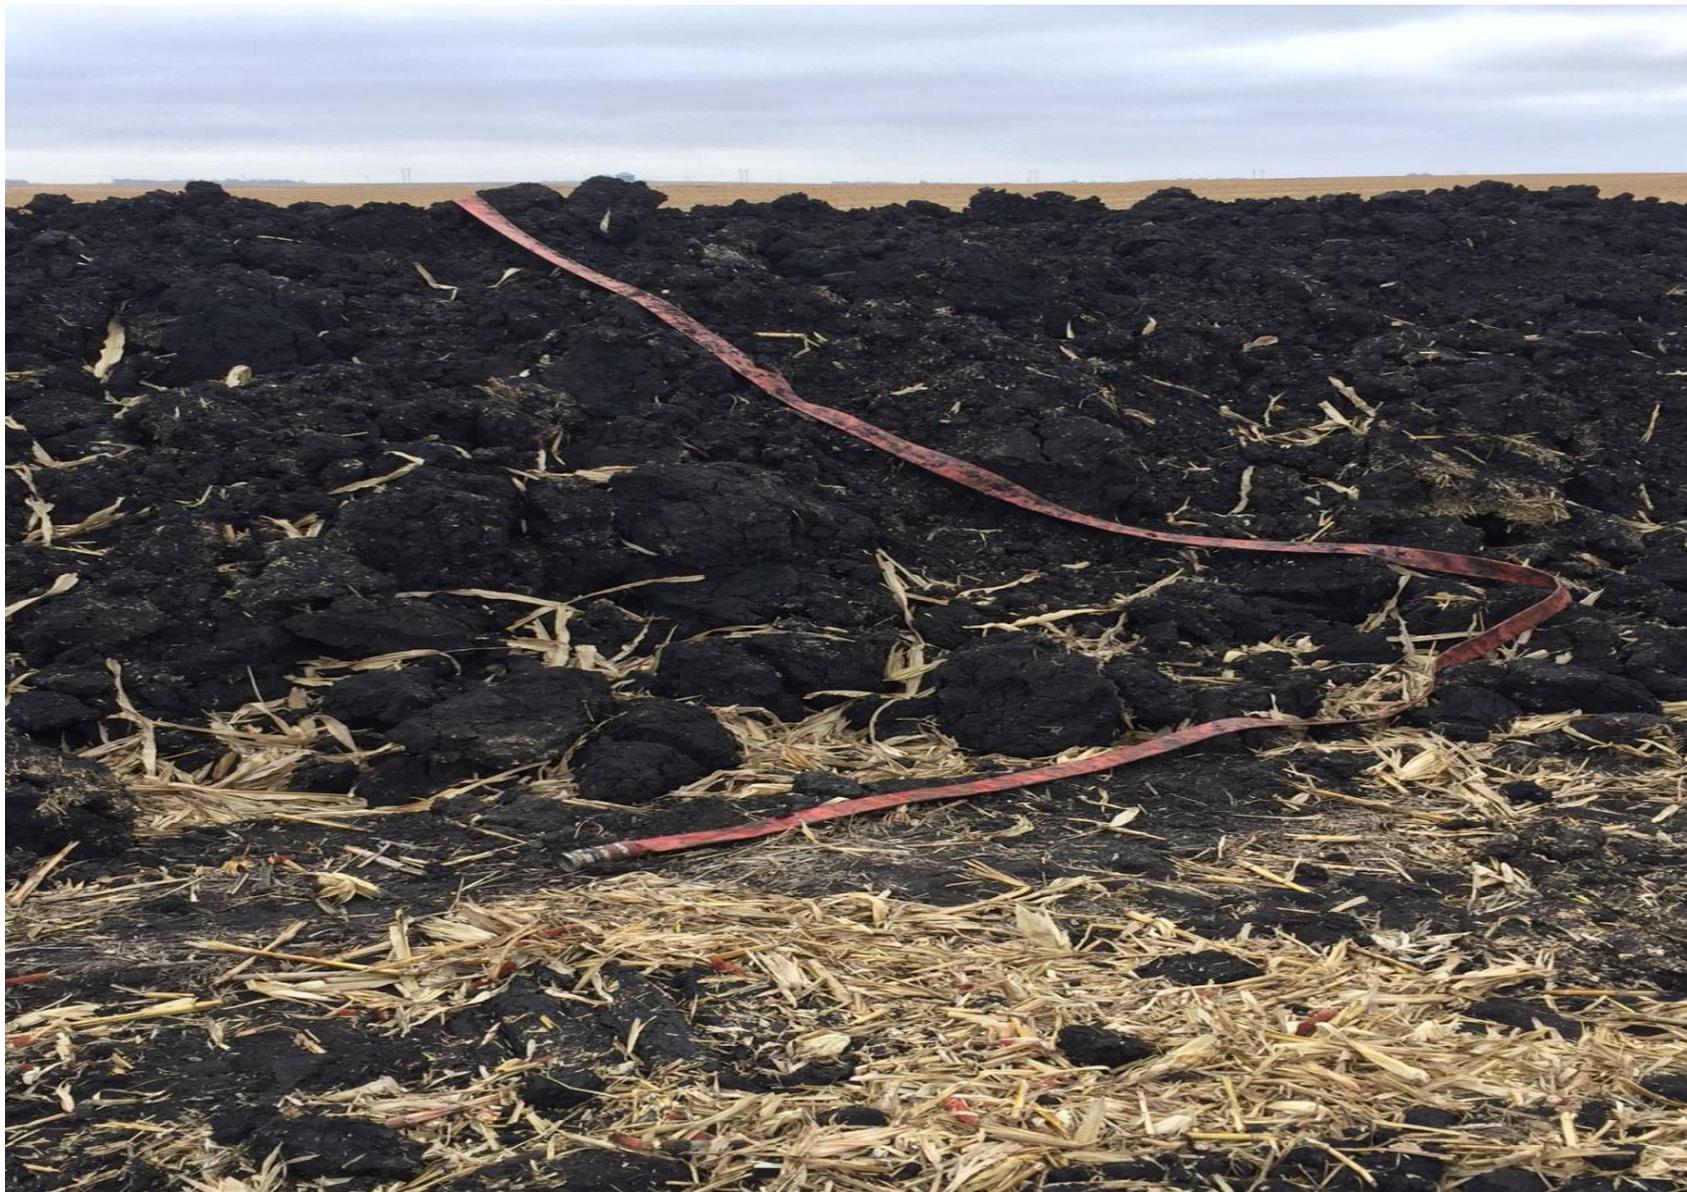
## Dewatering into field

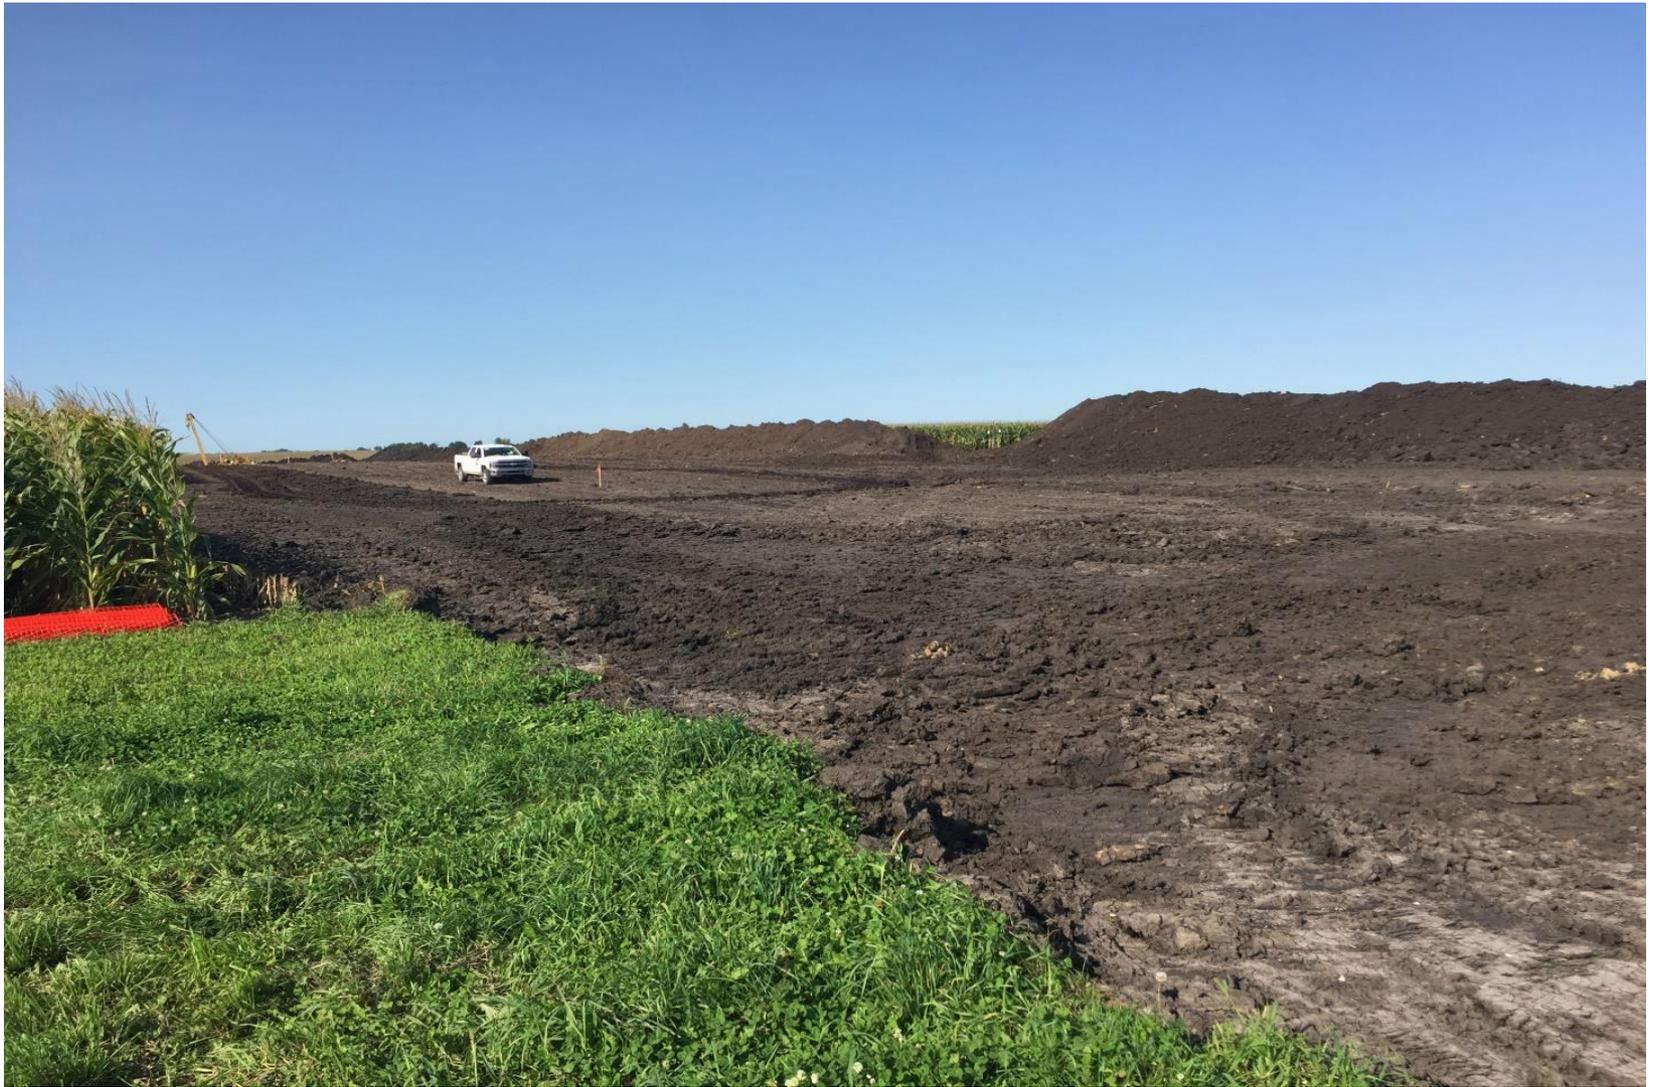
Compaction were equipment was parked every night working in wet conditions. Light were there as they worked at night to avoid inspectors.

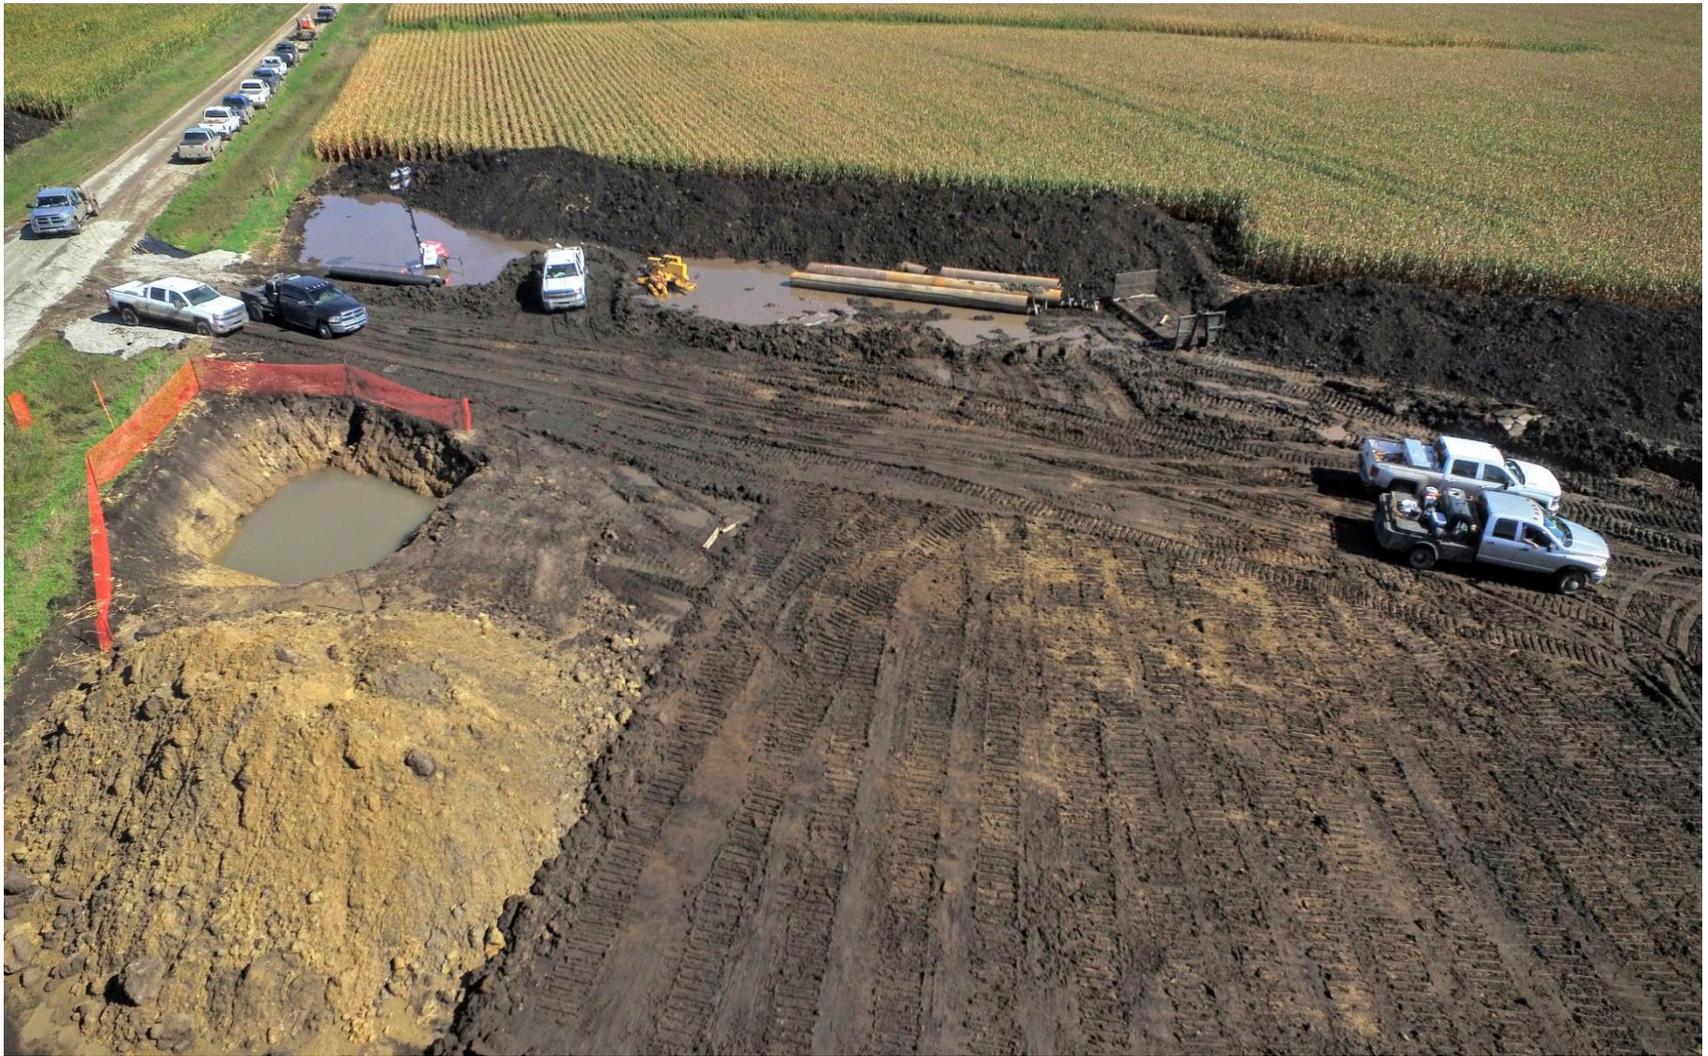
## Broken tile and compaction

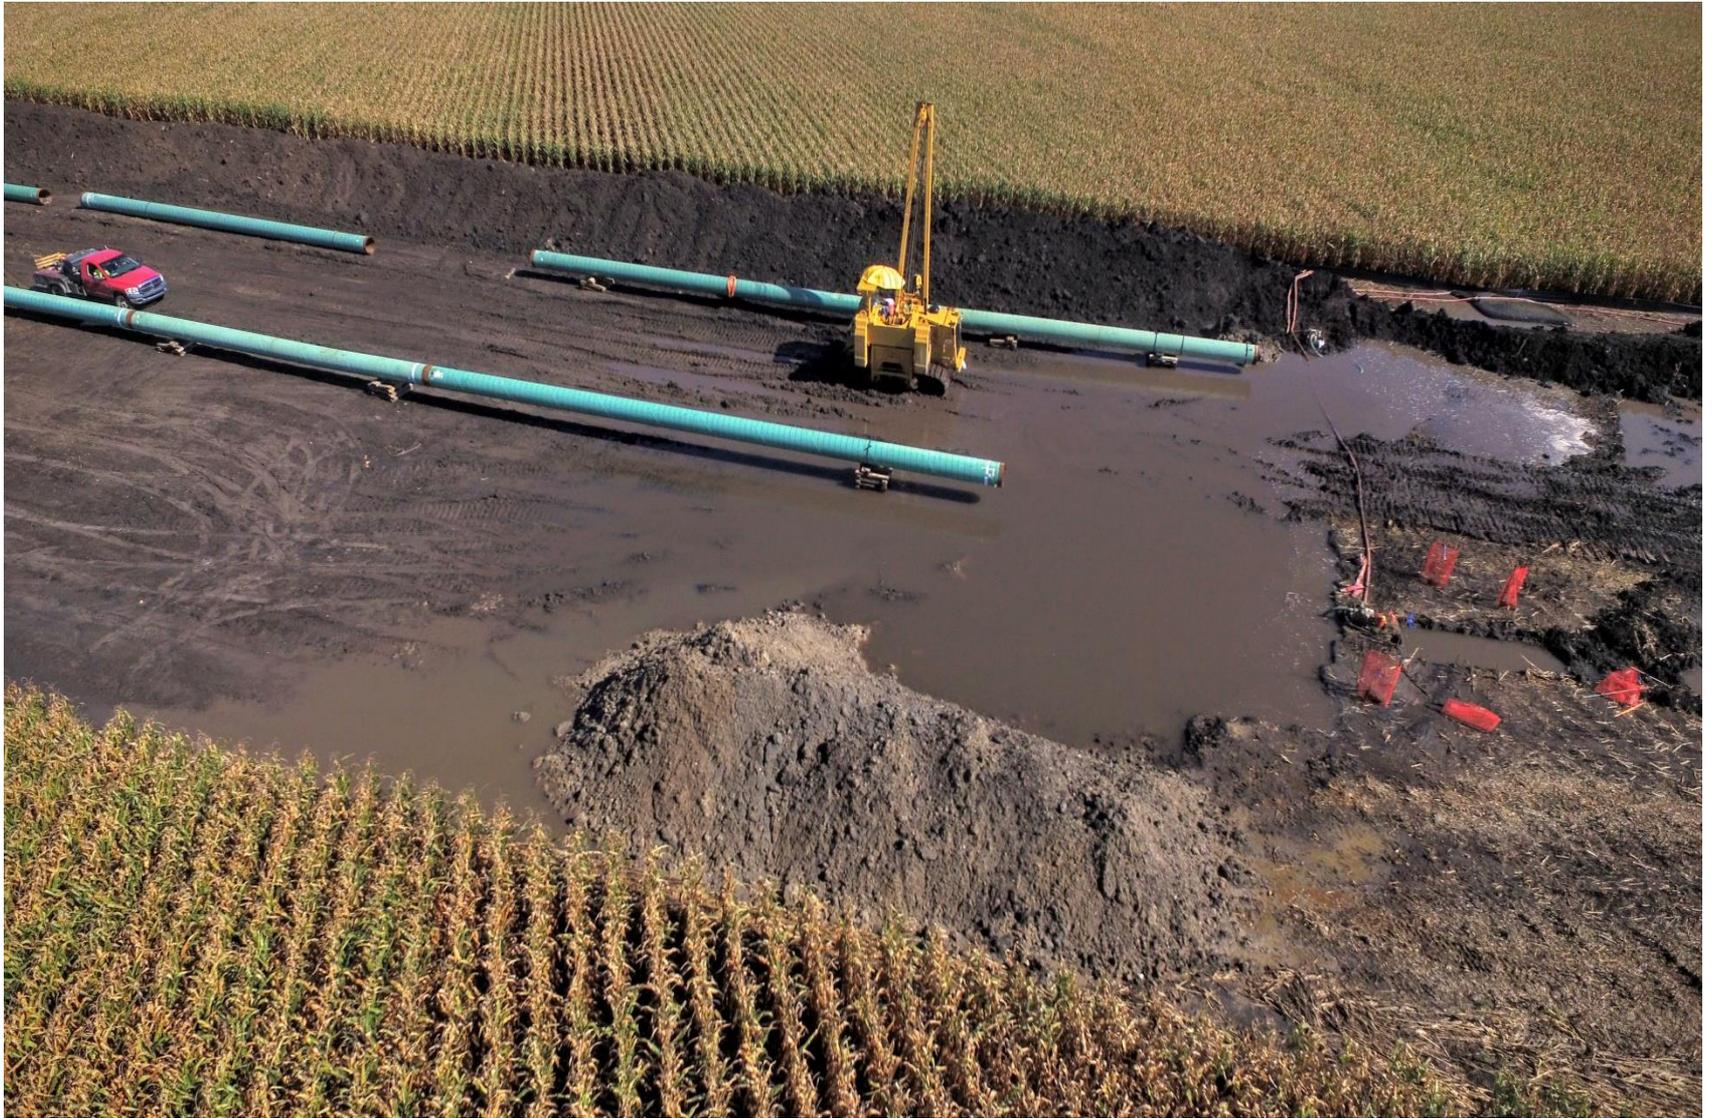
Too wet should not be working on top soil

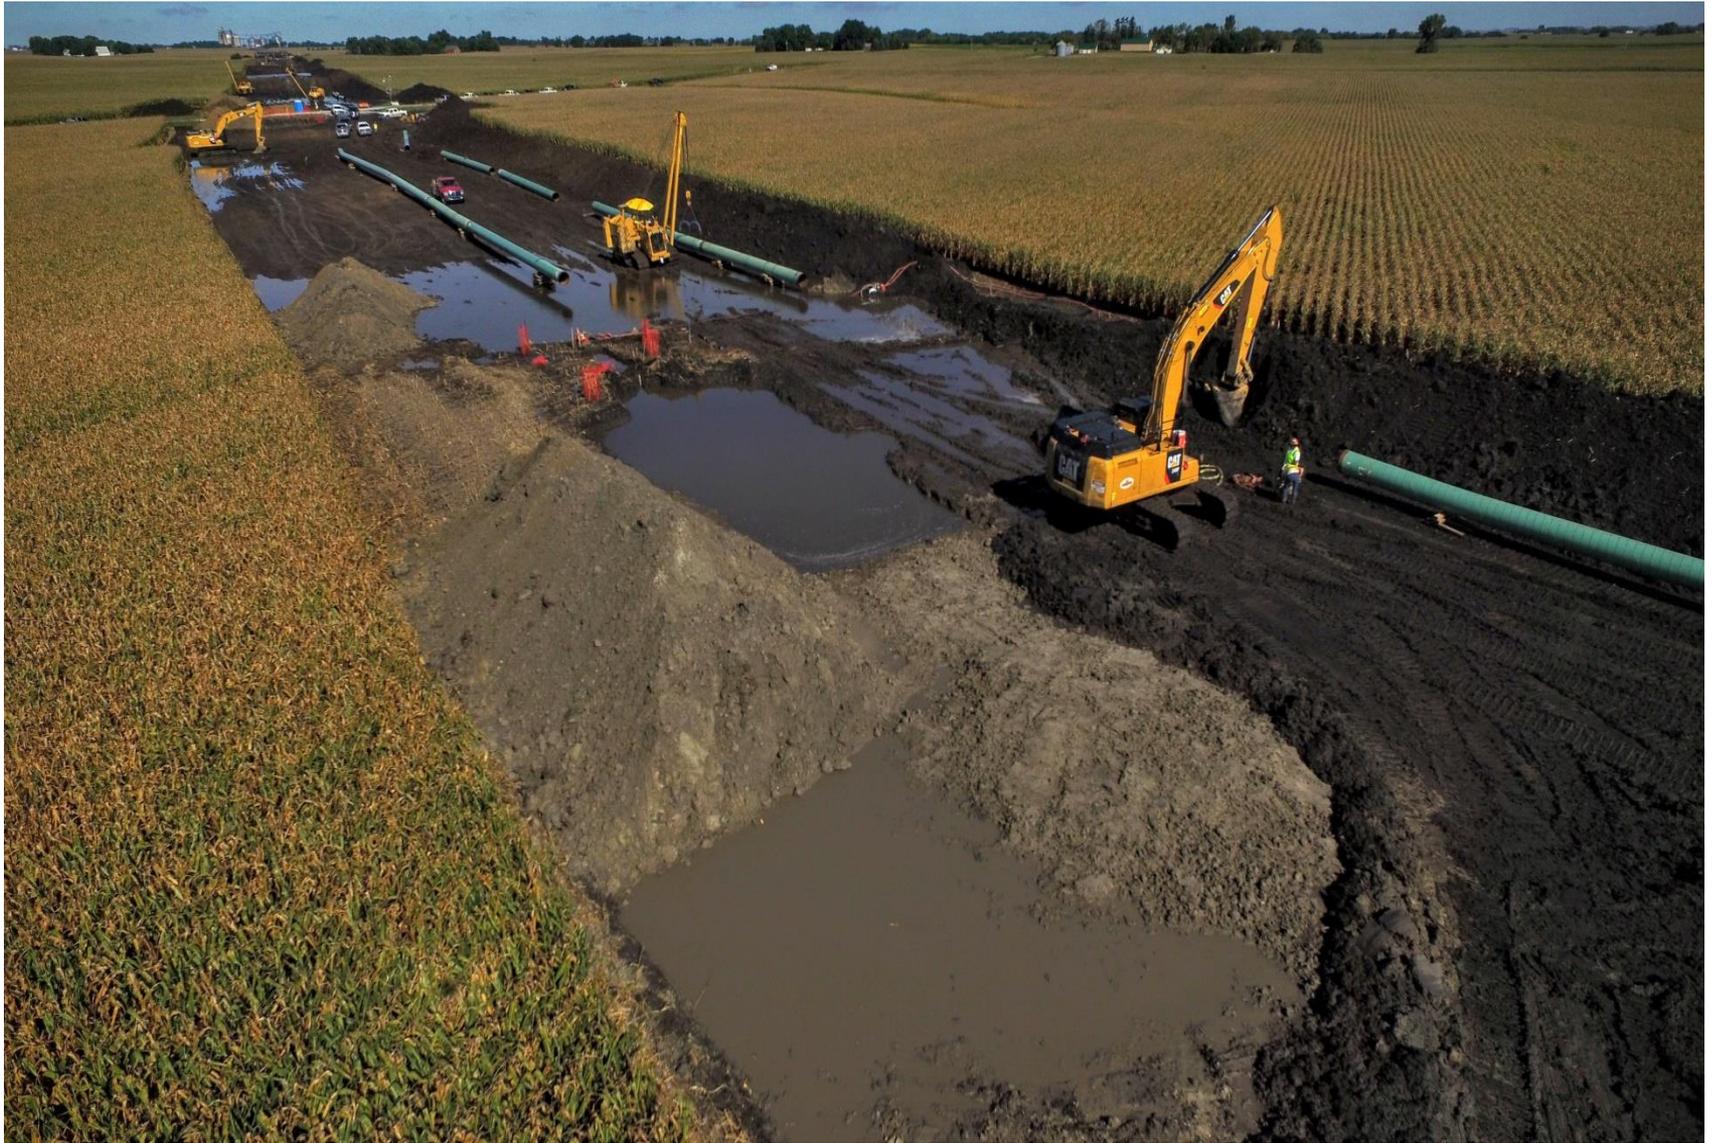
Wet working conditions, pumping water into ditches

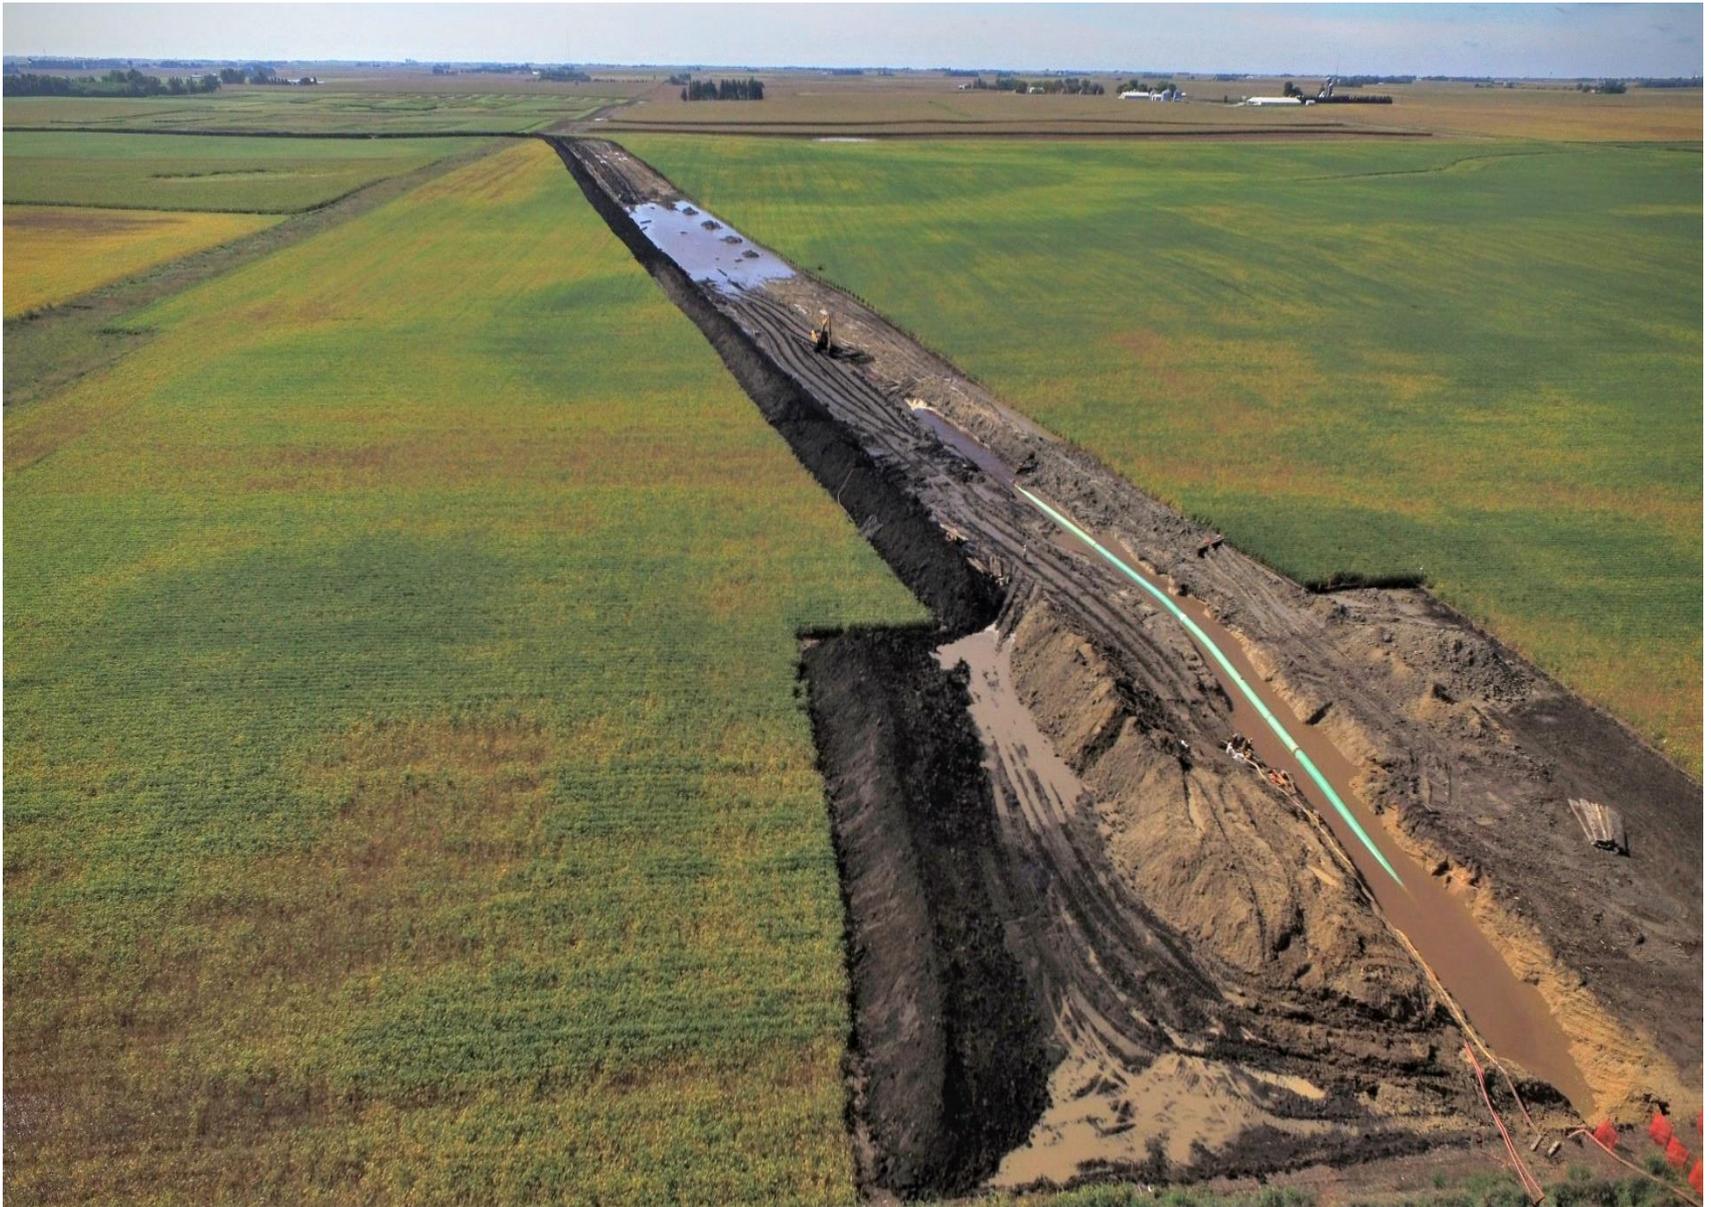
## Dewatering into field, ruts and compaction

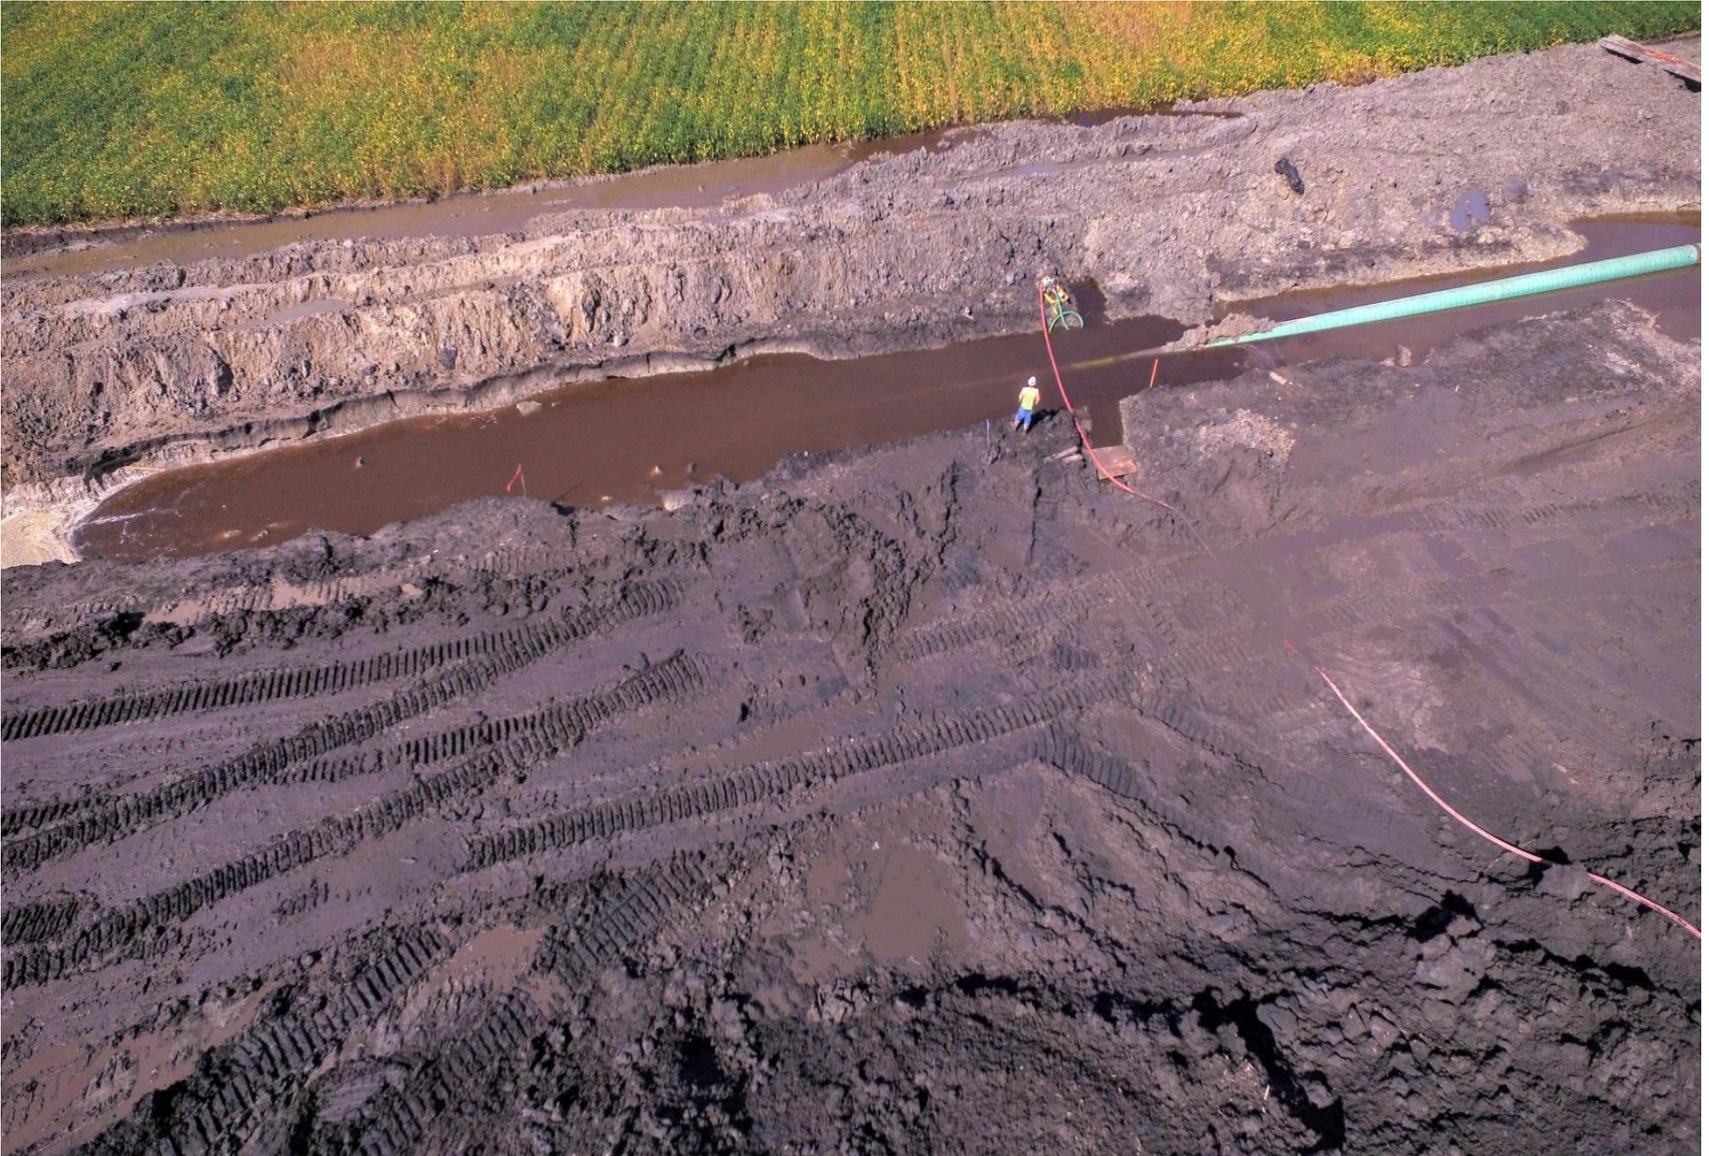
Dewatering , mixing, compaction. Topsoil has been moved to get hose to field and is now mixed into ROW
