Johnson  
BO-028.000  
Pic #1  
8/30/16

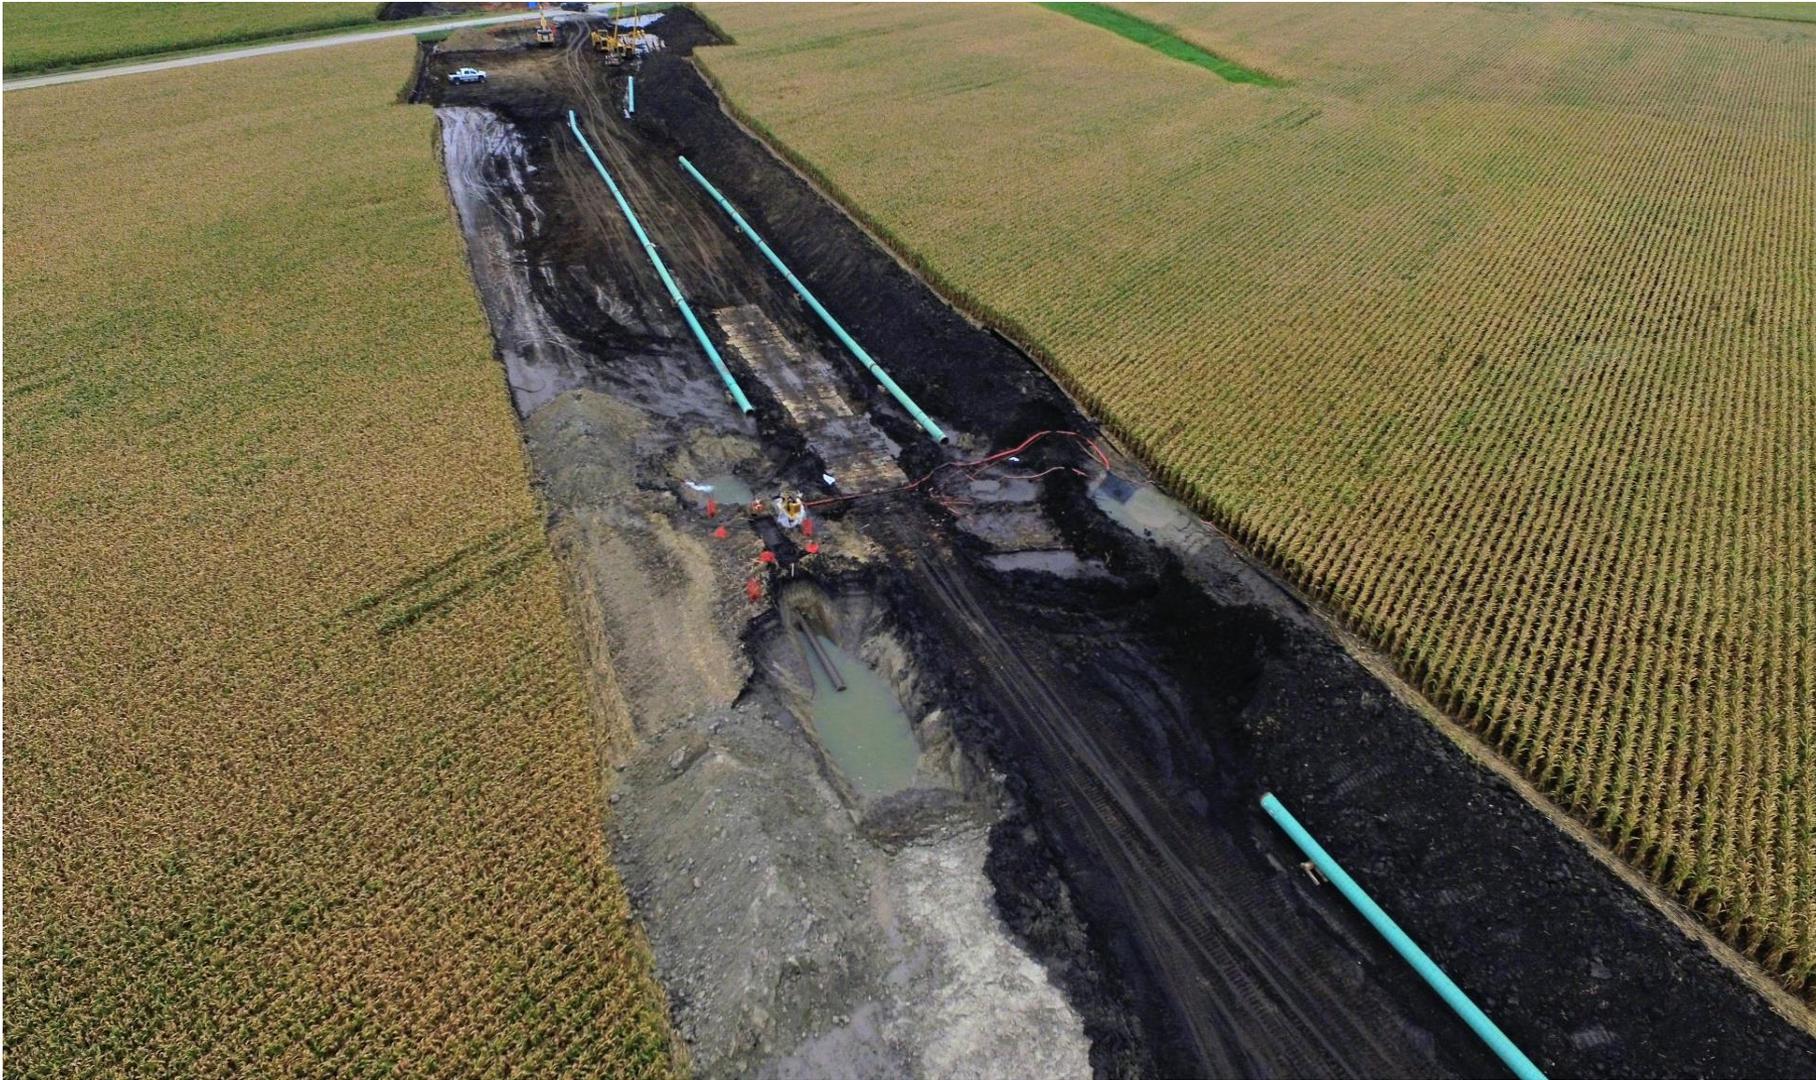
# Close up of dewatering and topsoil

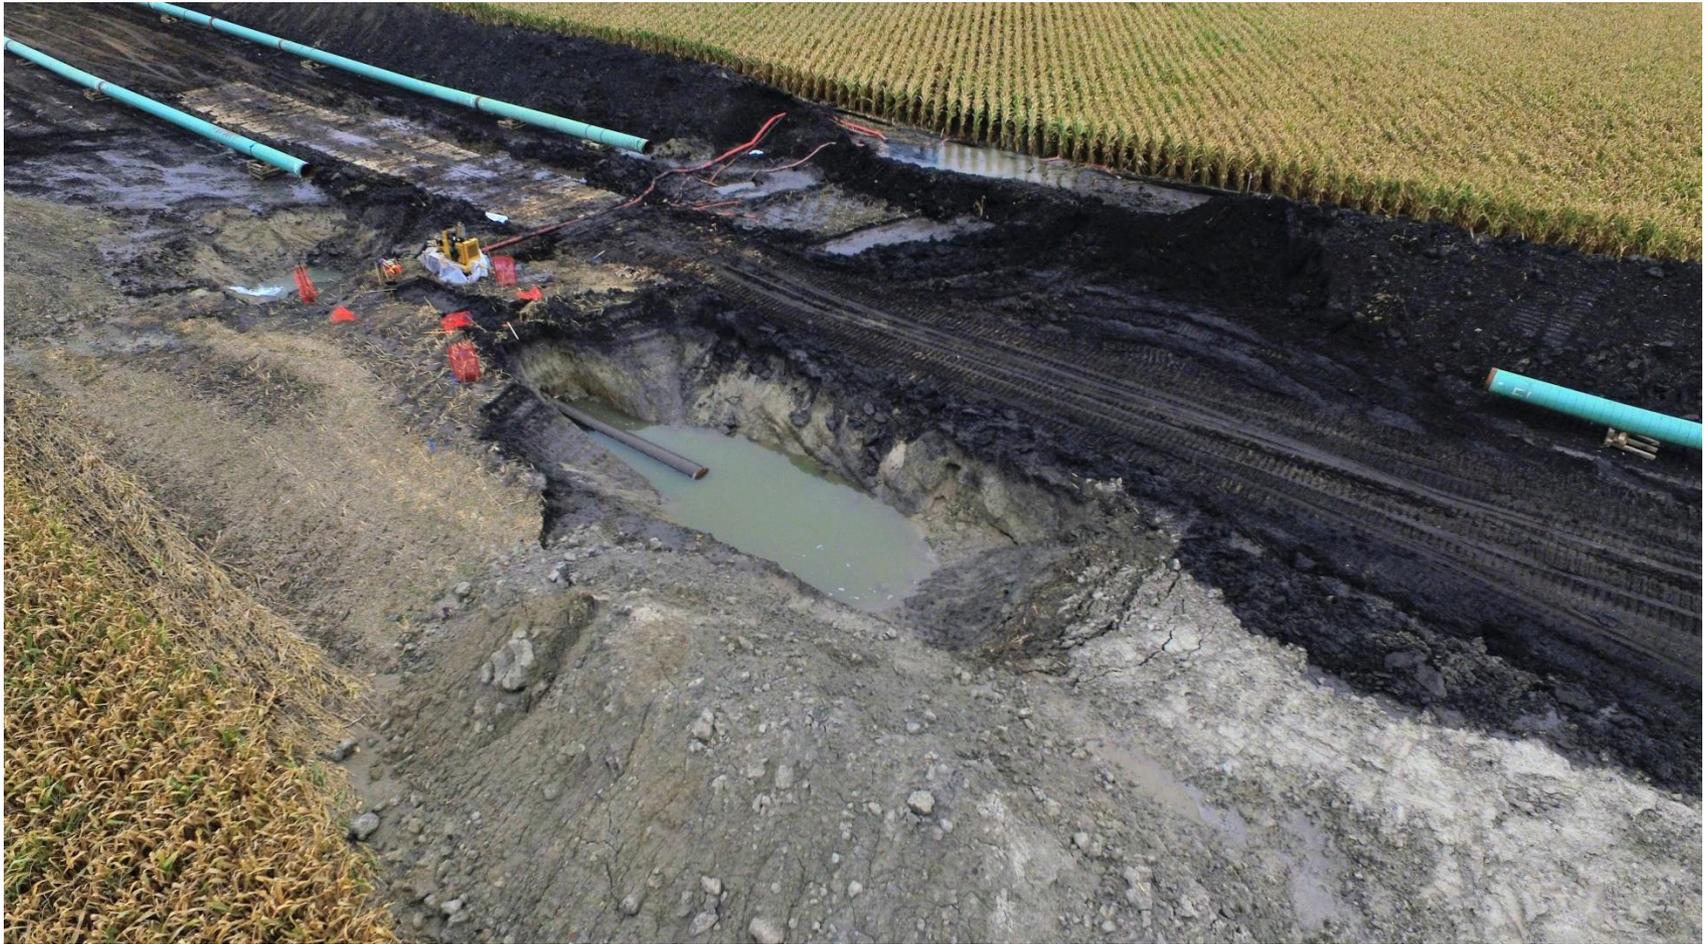
Working in wet conditions causing more compaction

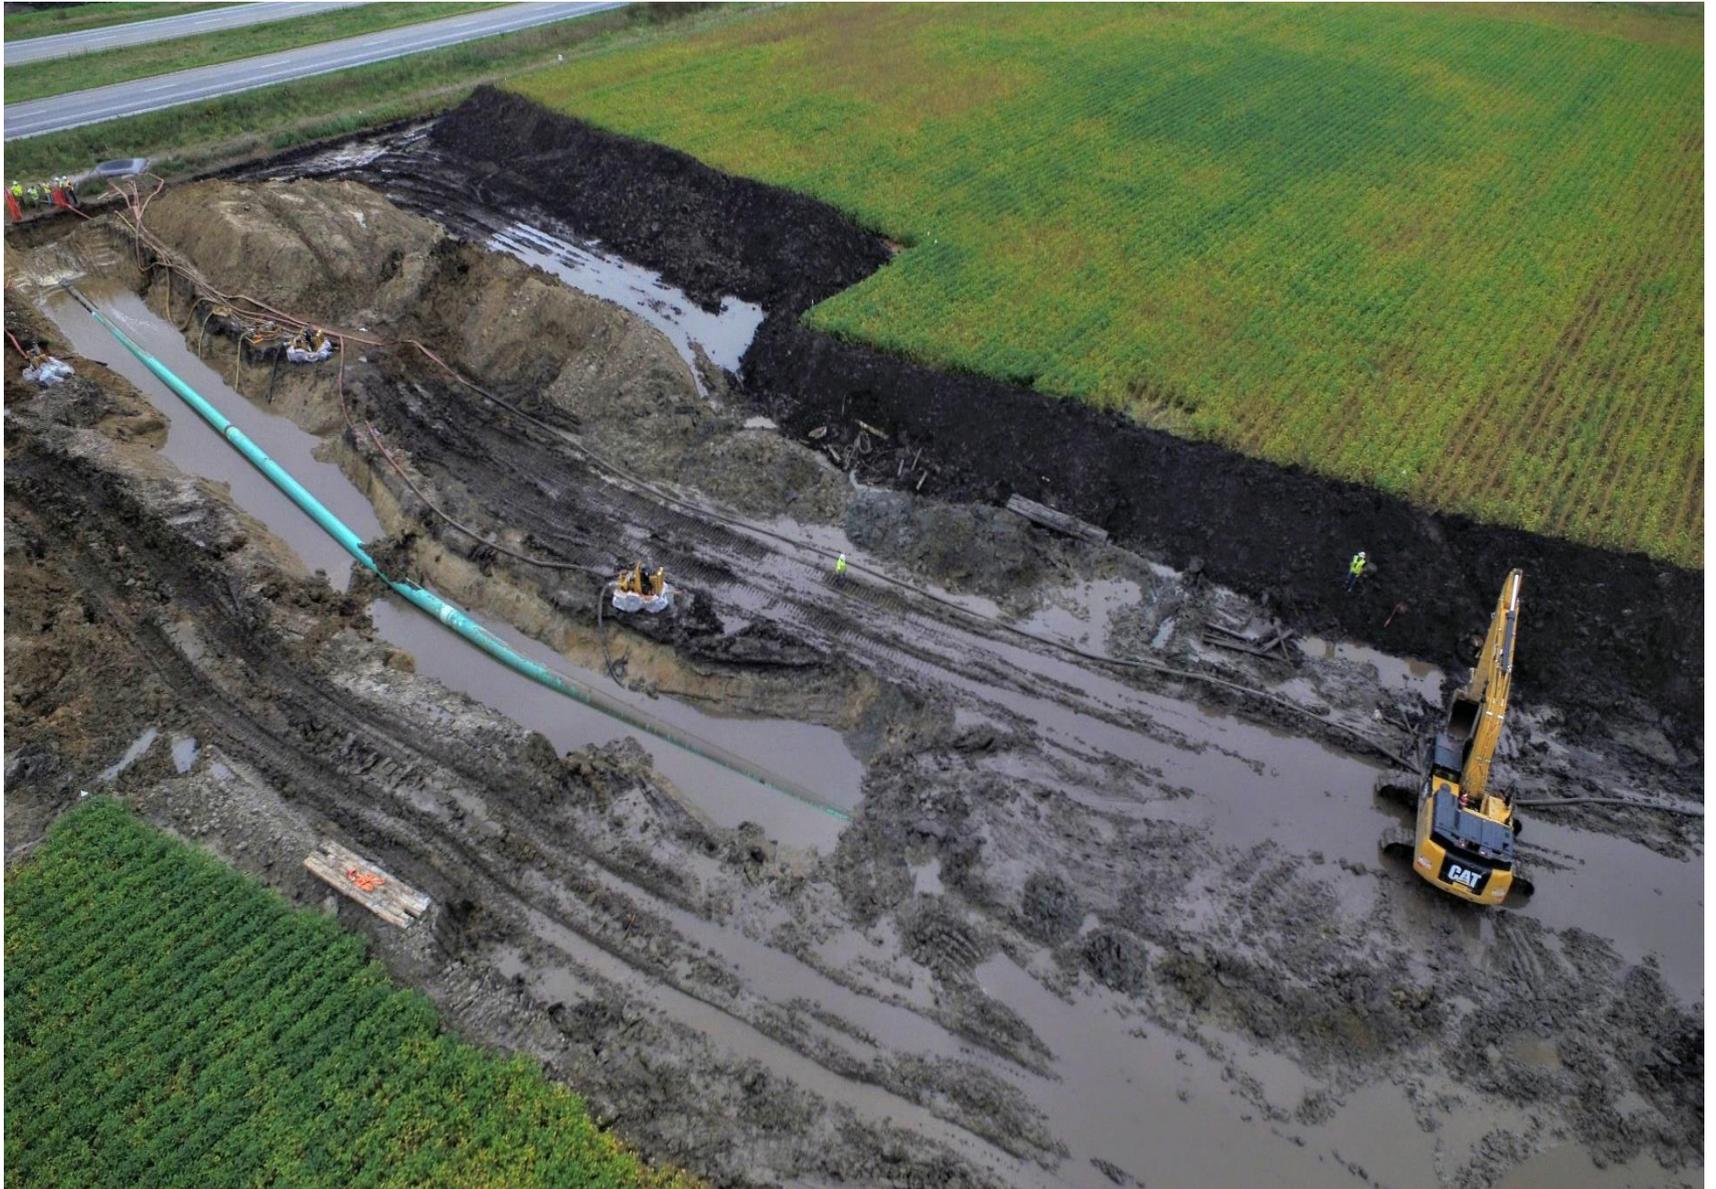
# Ariel view of extent of damage

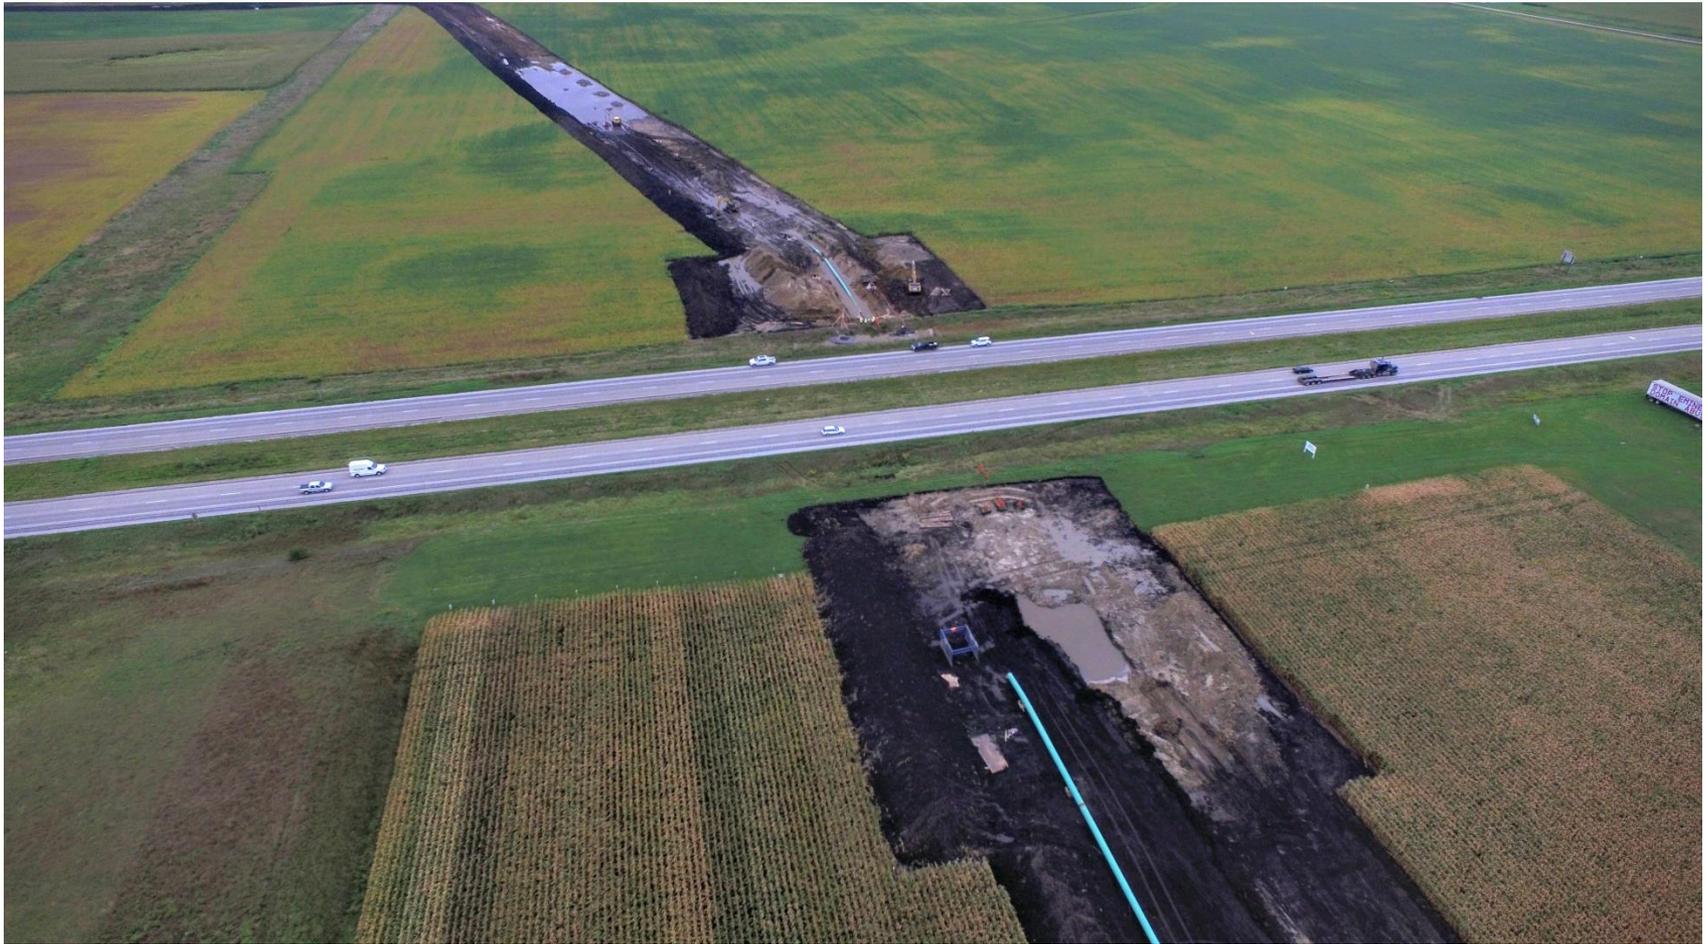
Matting has now been placed, berm has been placed but not working and too late

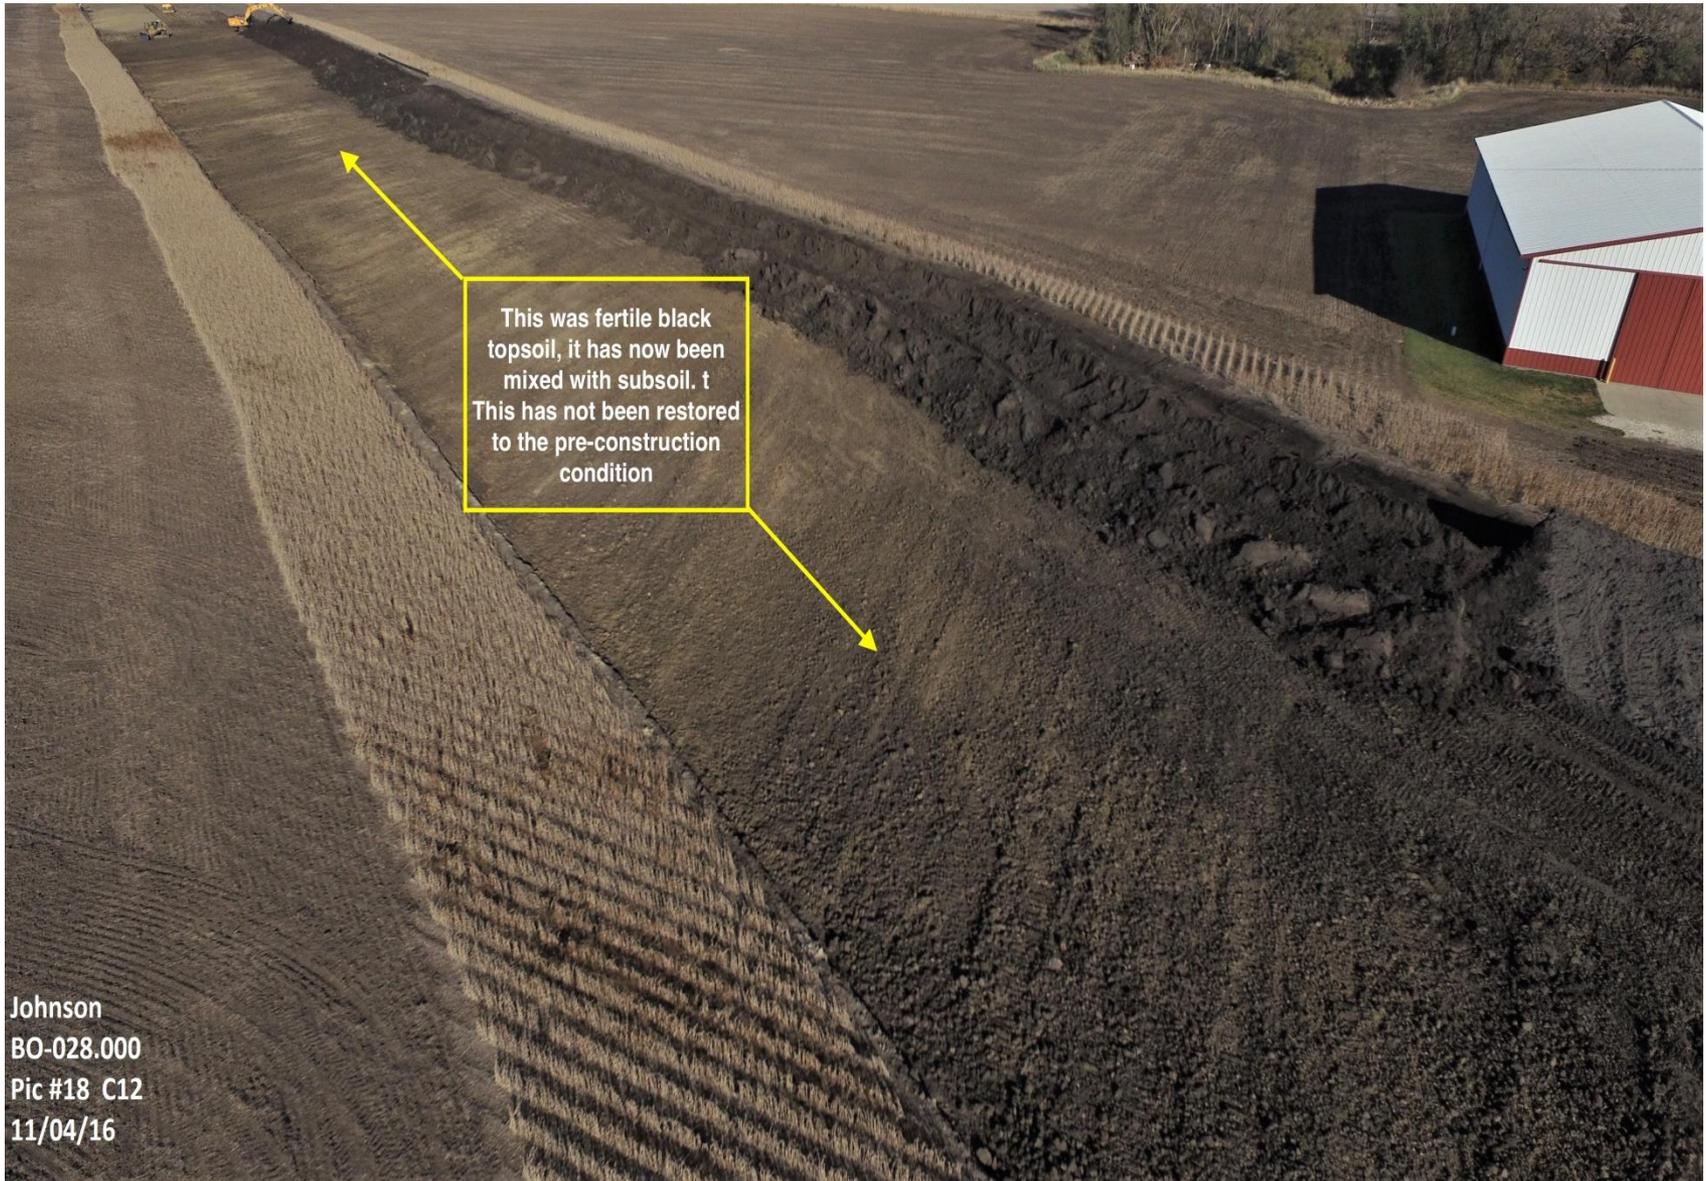
Johnson  
BO-028.000  
Pic #18 C12  
11/04/16

This was fertile black topsoil, it has now been mixed with subsoil. t This has not been restored to the pre-construction condition

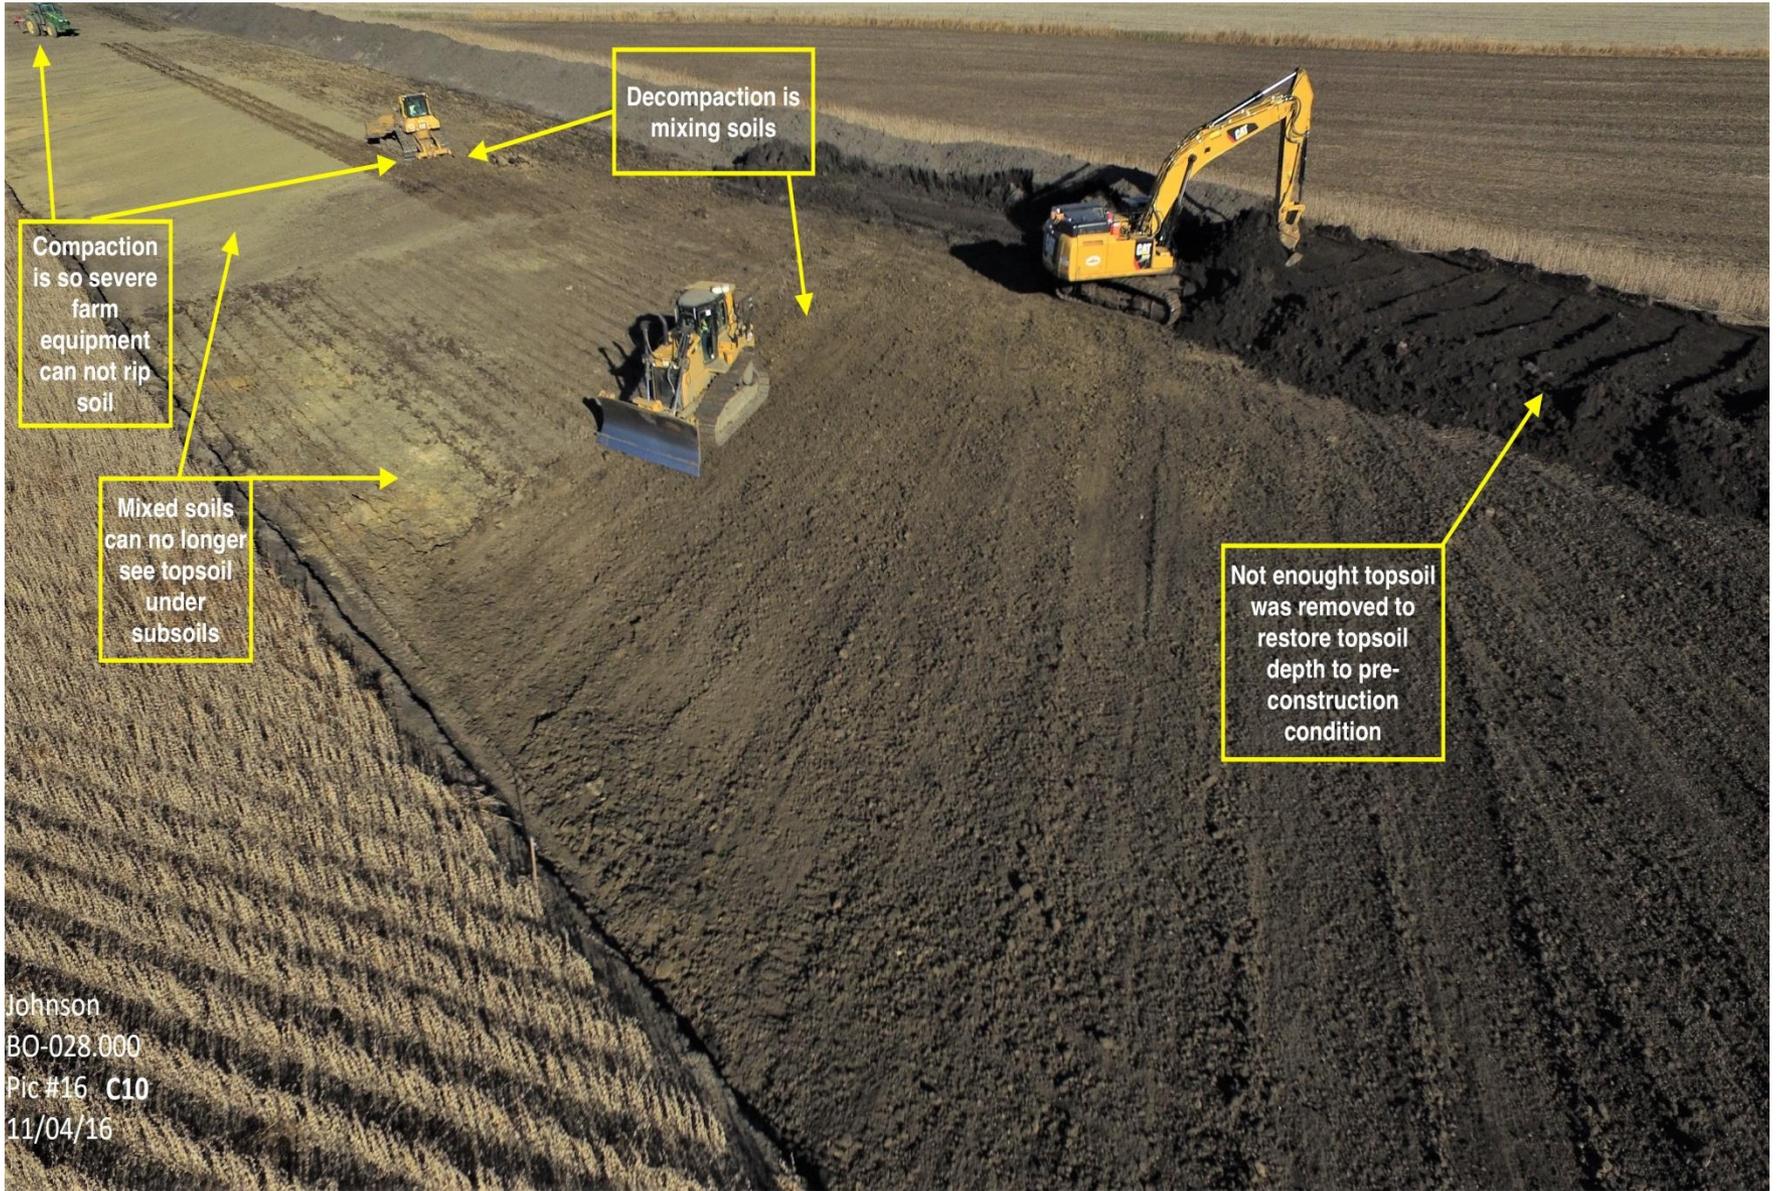
Johnson  
BO-028.000  
Pic #16 C10  
11/04/16

Decompaction is mixing soils

Compaction is so severe farm equipment can not rip soil

Mixed soils can no longer see topsoil under subsoils

Not enough topsoil was removed to restore topsoil depth to pre-construction condition

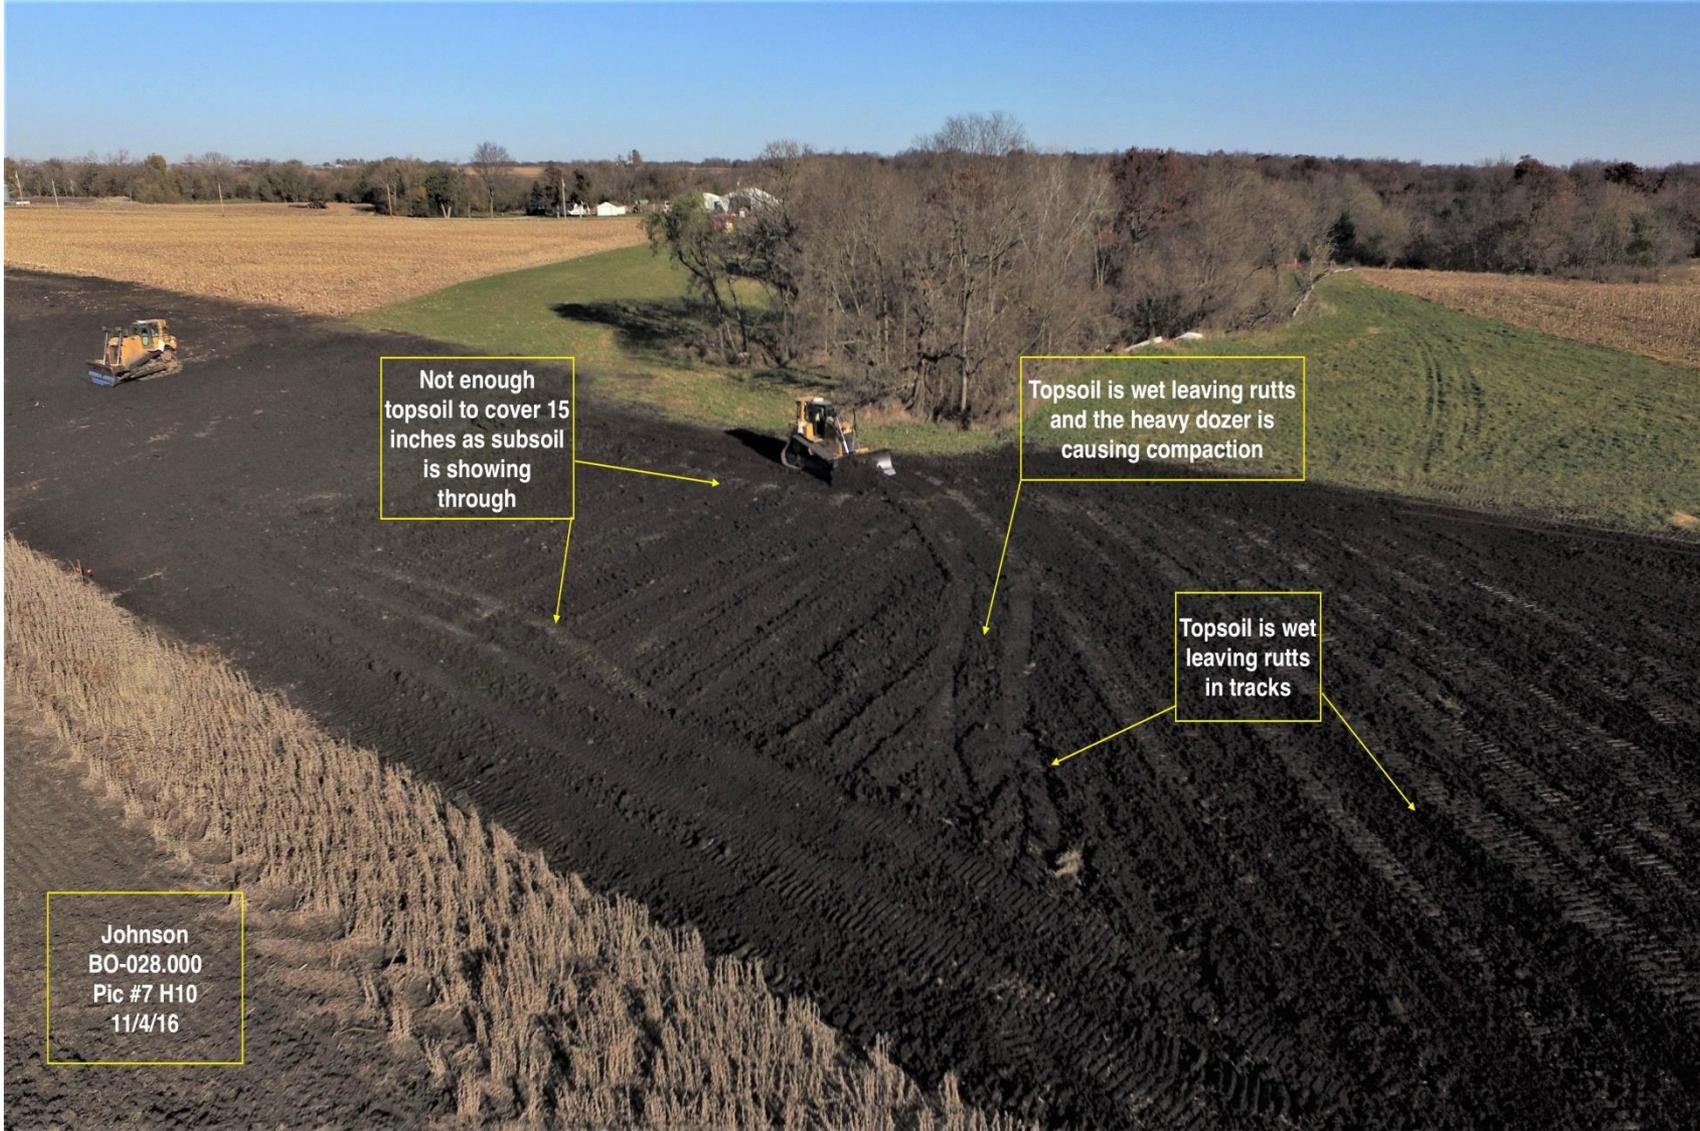
Johnson  
BO-028.000  
Pic #7 H10  
11/4/16

Not enough topsoil to cover 15 inches as subsoil is showing through

Topsoil is wet leaving ruts and the heavy dozer is causing compaction

Topsoil is wet leaving ruts in tracks

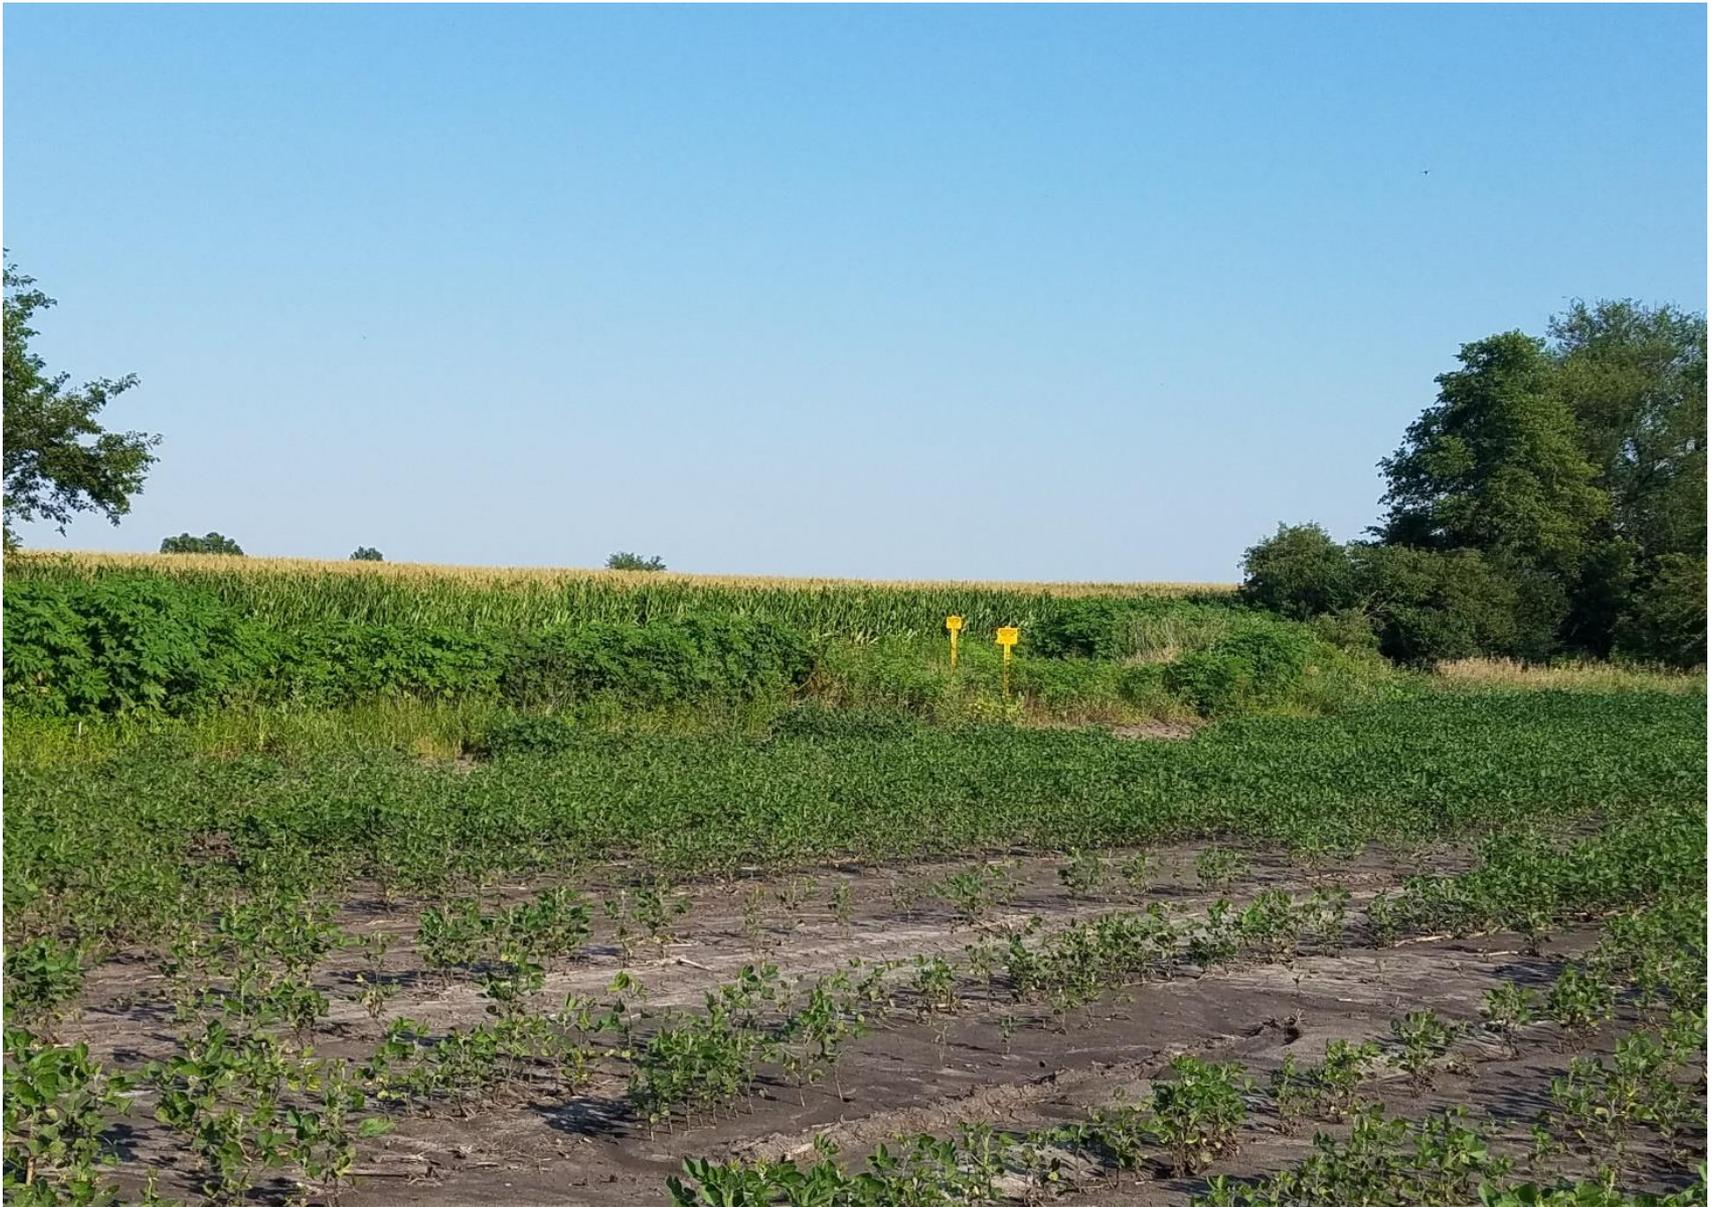
## Erosion, mixed soil and crop loss

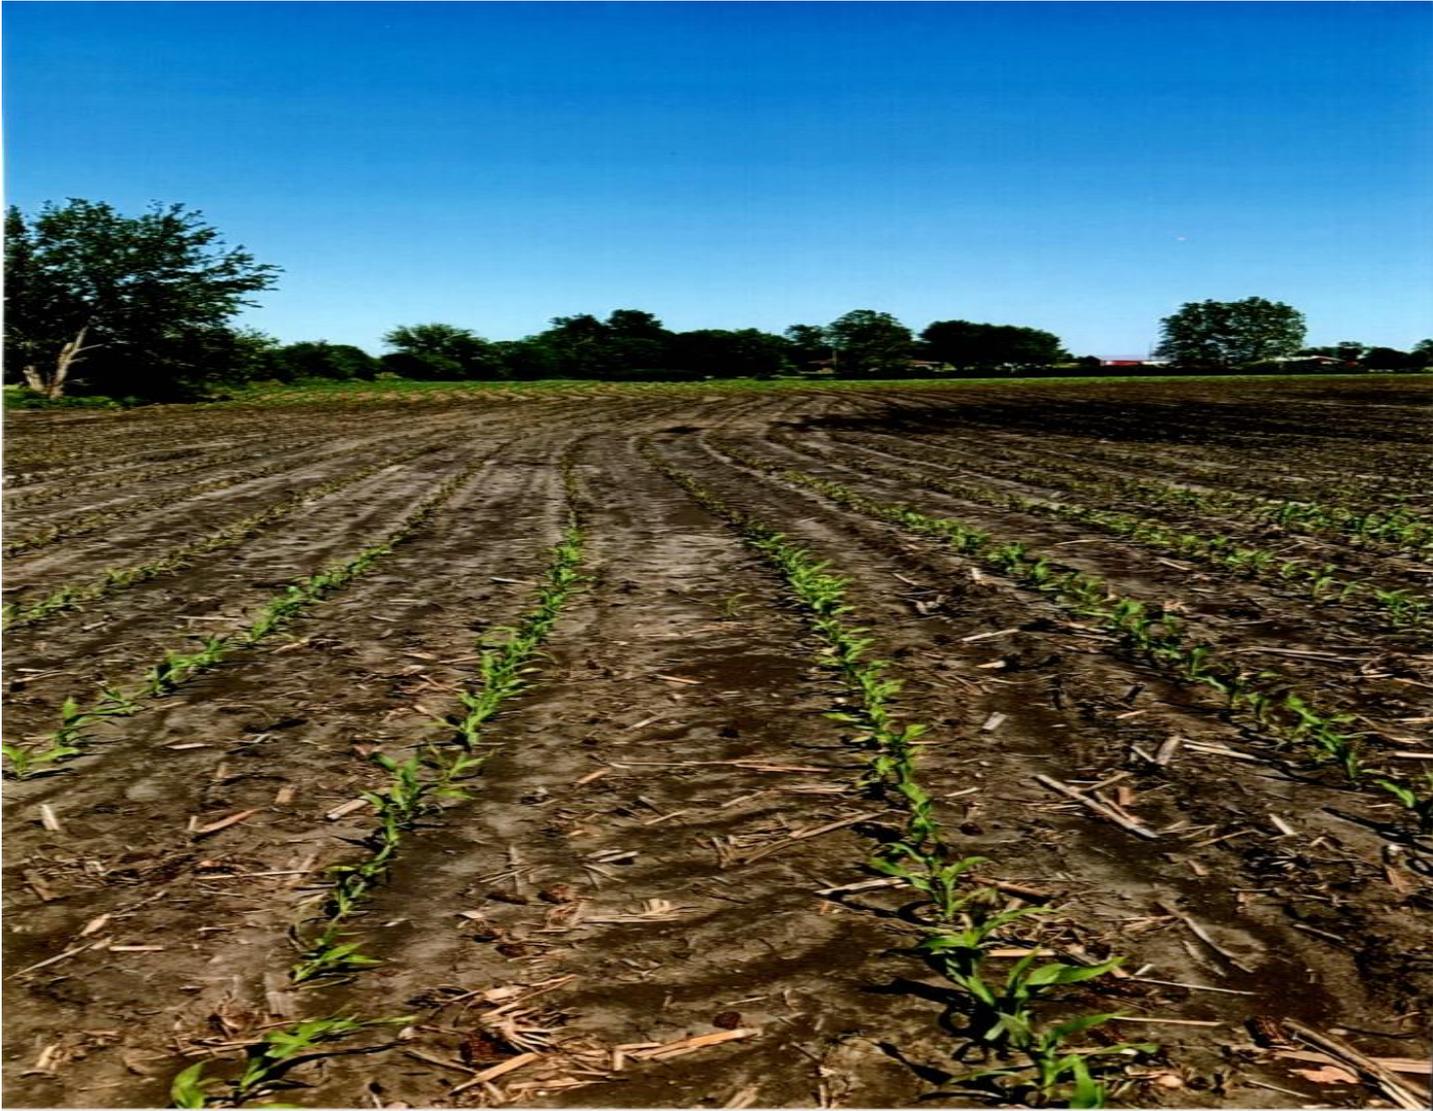
## Flooding due to broken tile and compaction in ROW

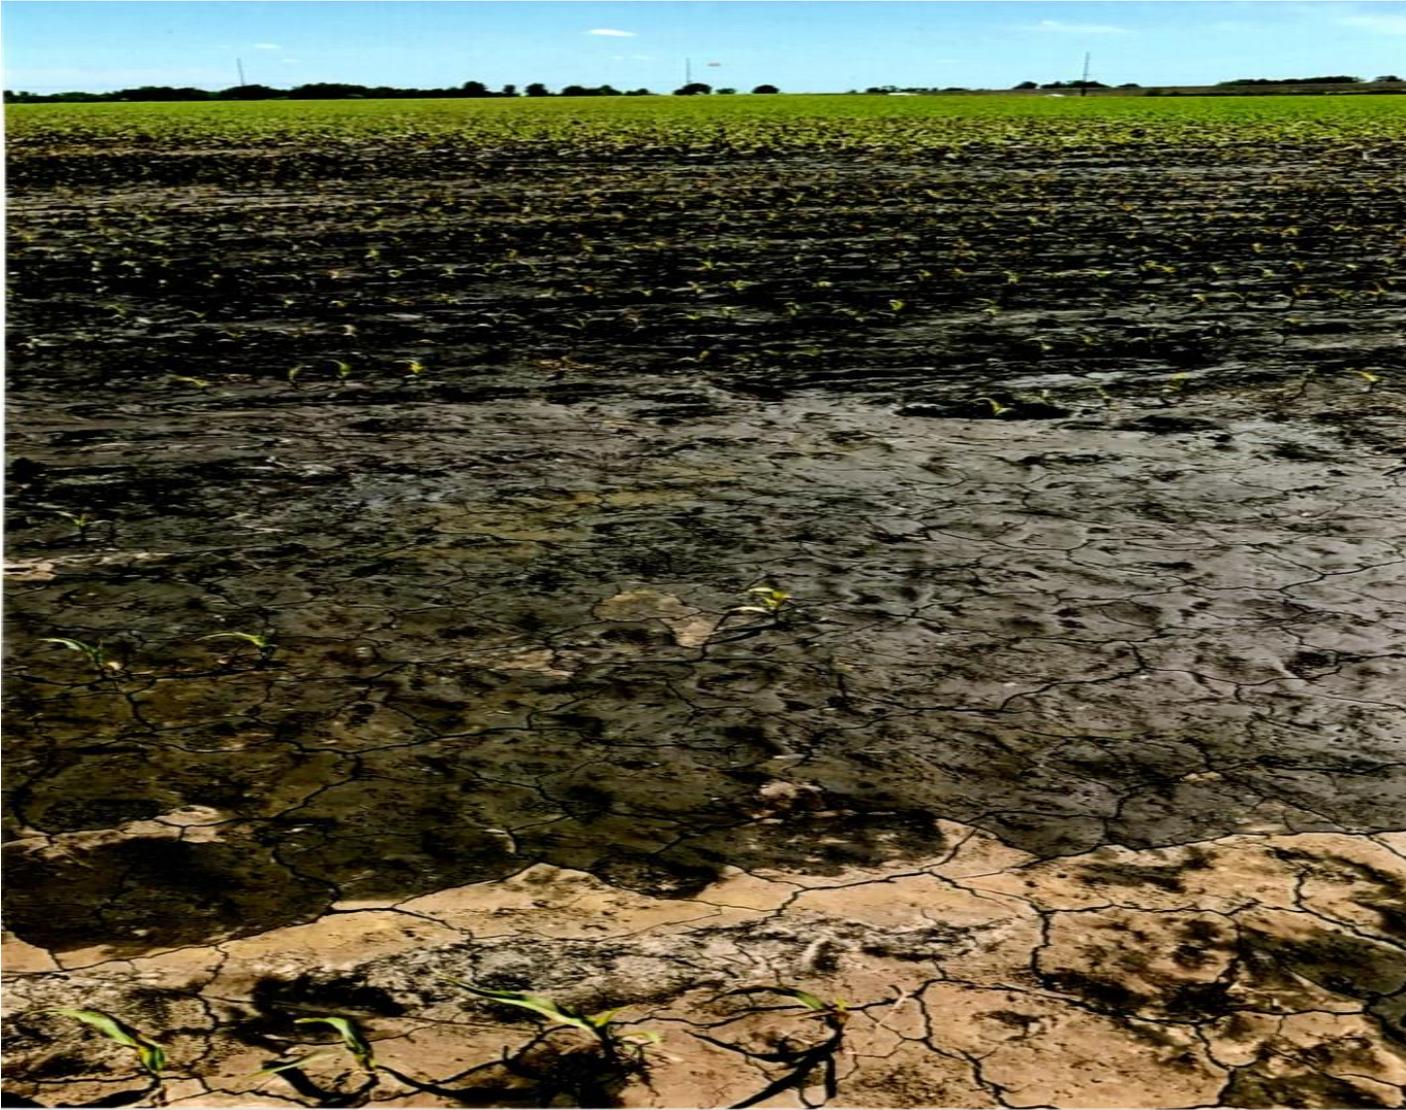
Crops on ROW vs off ROW. Red color is due to mixed soil and crops died

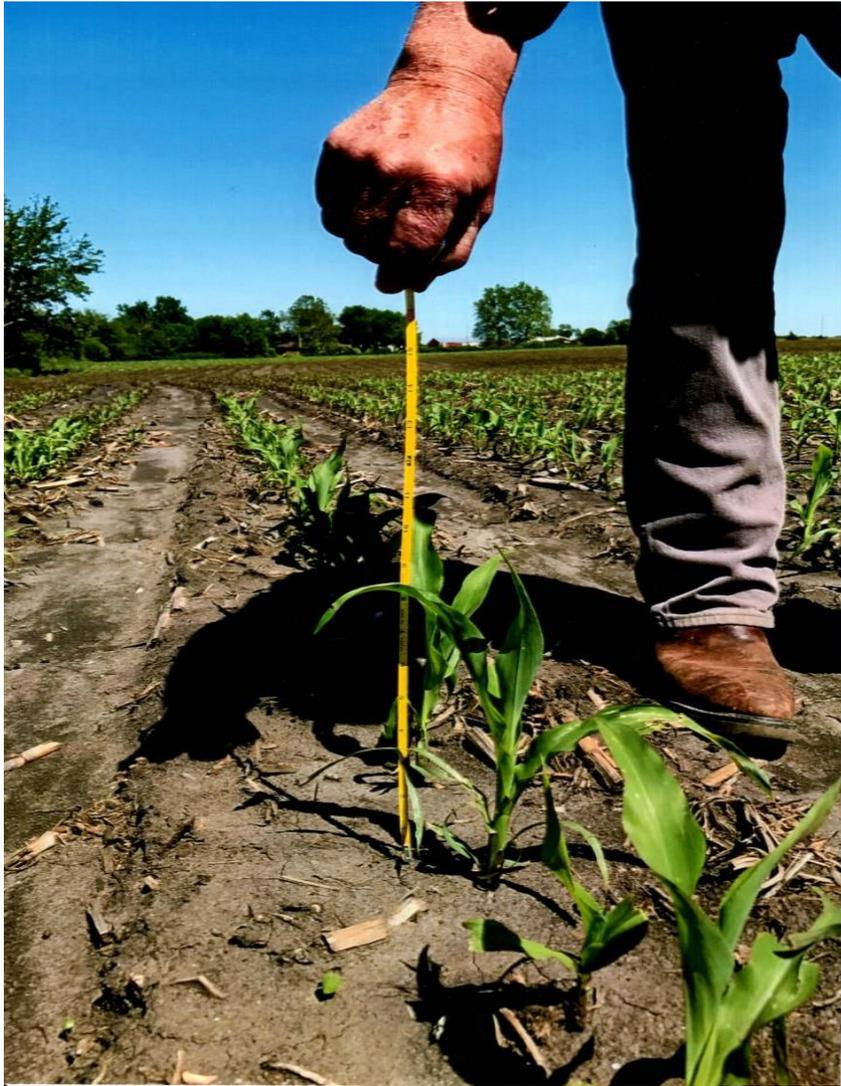
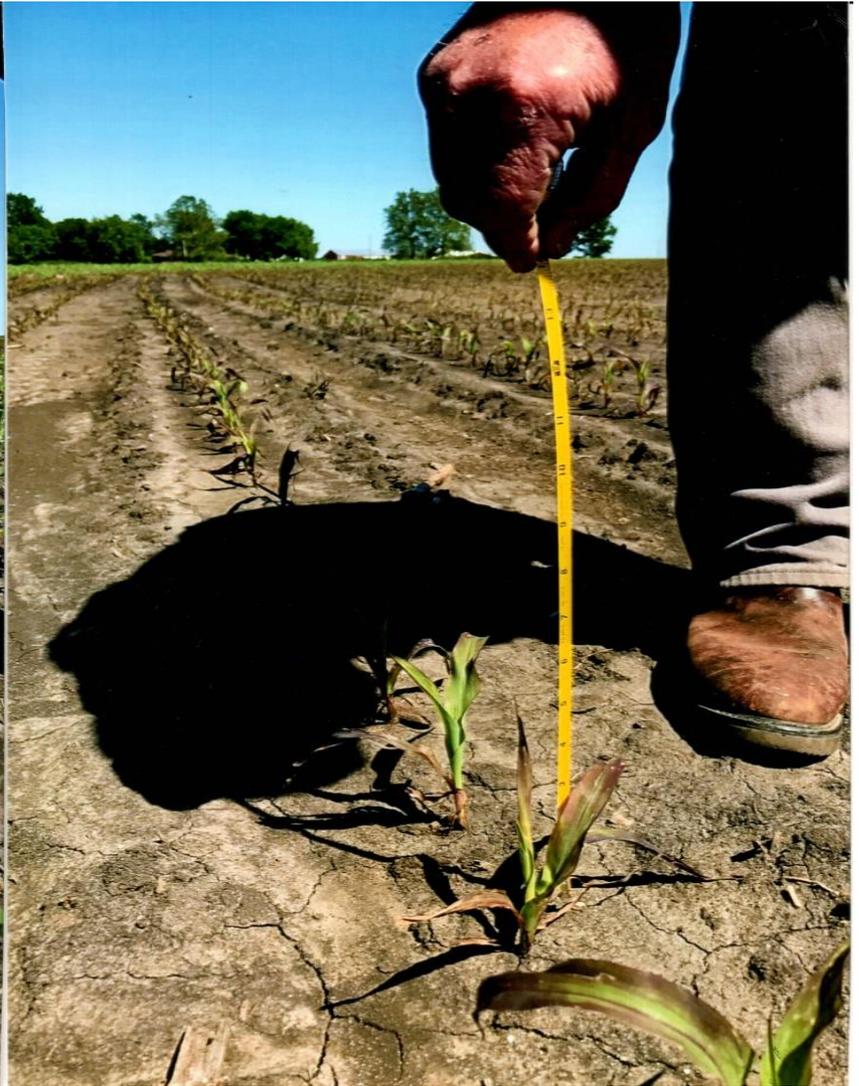
Erosion due to broken tile and contour not being restored

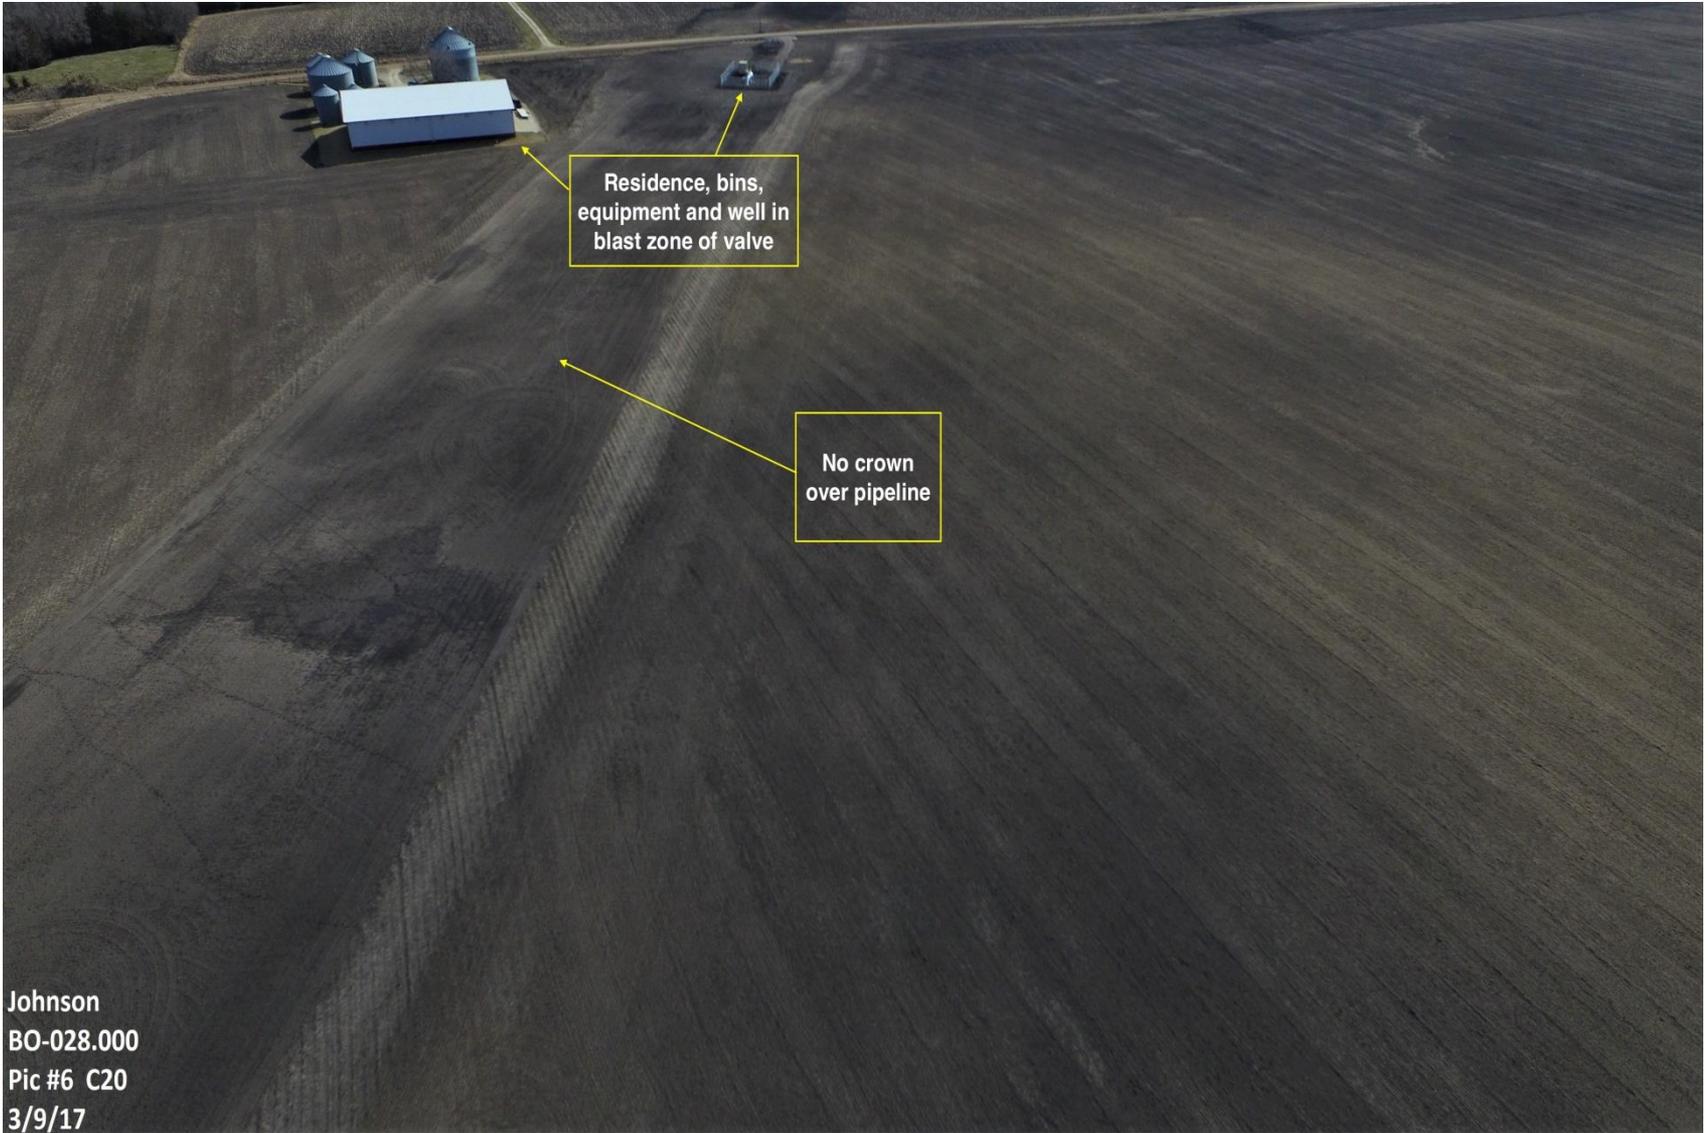
Johnson  
BO-028.000  
Pic #6 C20  
3/9/17

Residence, bins,  
equipment and well in  
blast zone of valve

No crown  
over pipeline
