Johnson  
BO-028.000  
Pic #1  
8/30/16

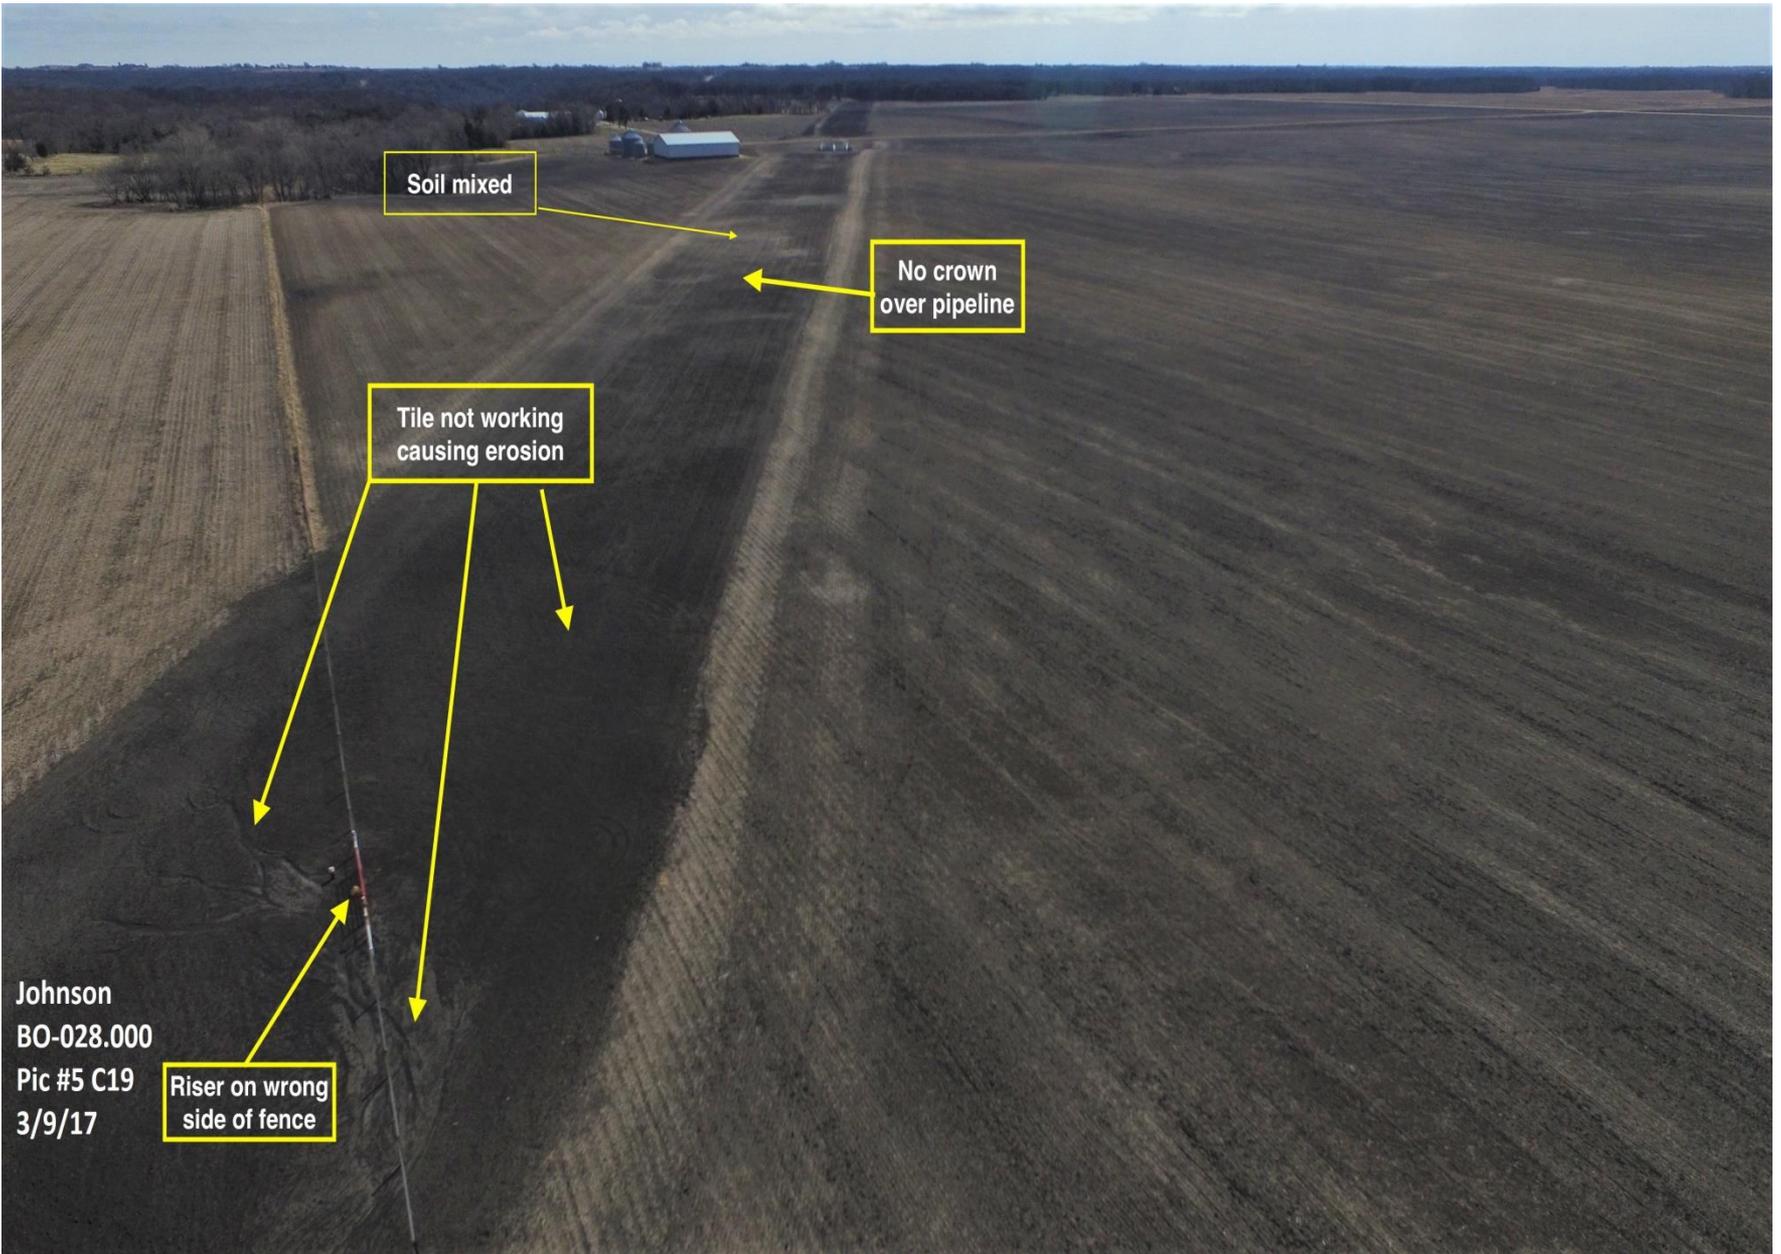
Johnson  
BO-028.000  
Pic #5 C19  
3/9/17

Soil mixed

No crown over pipeline

Tile not working causing erosion

Riser on wrong side of fence

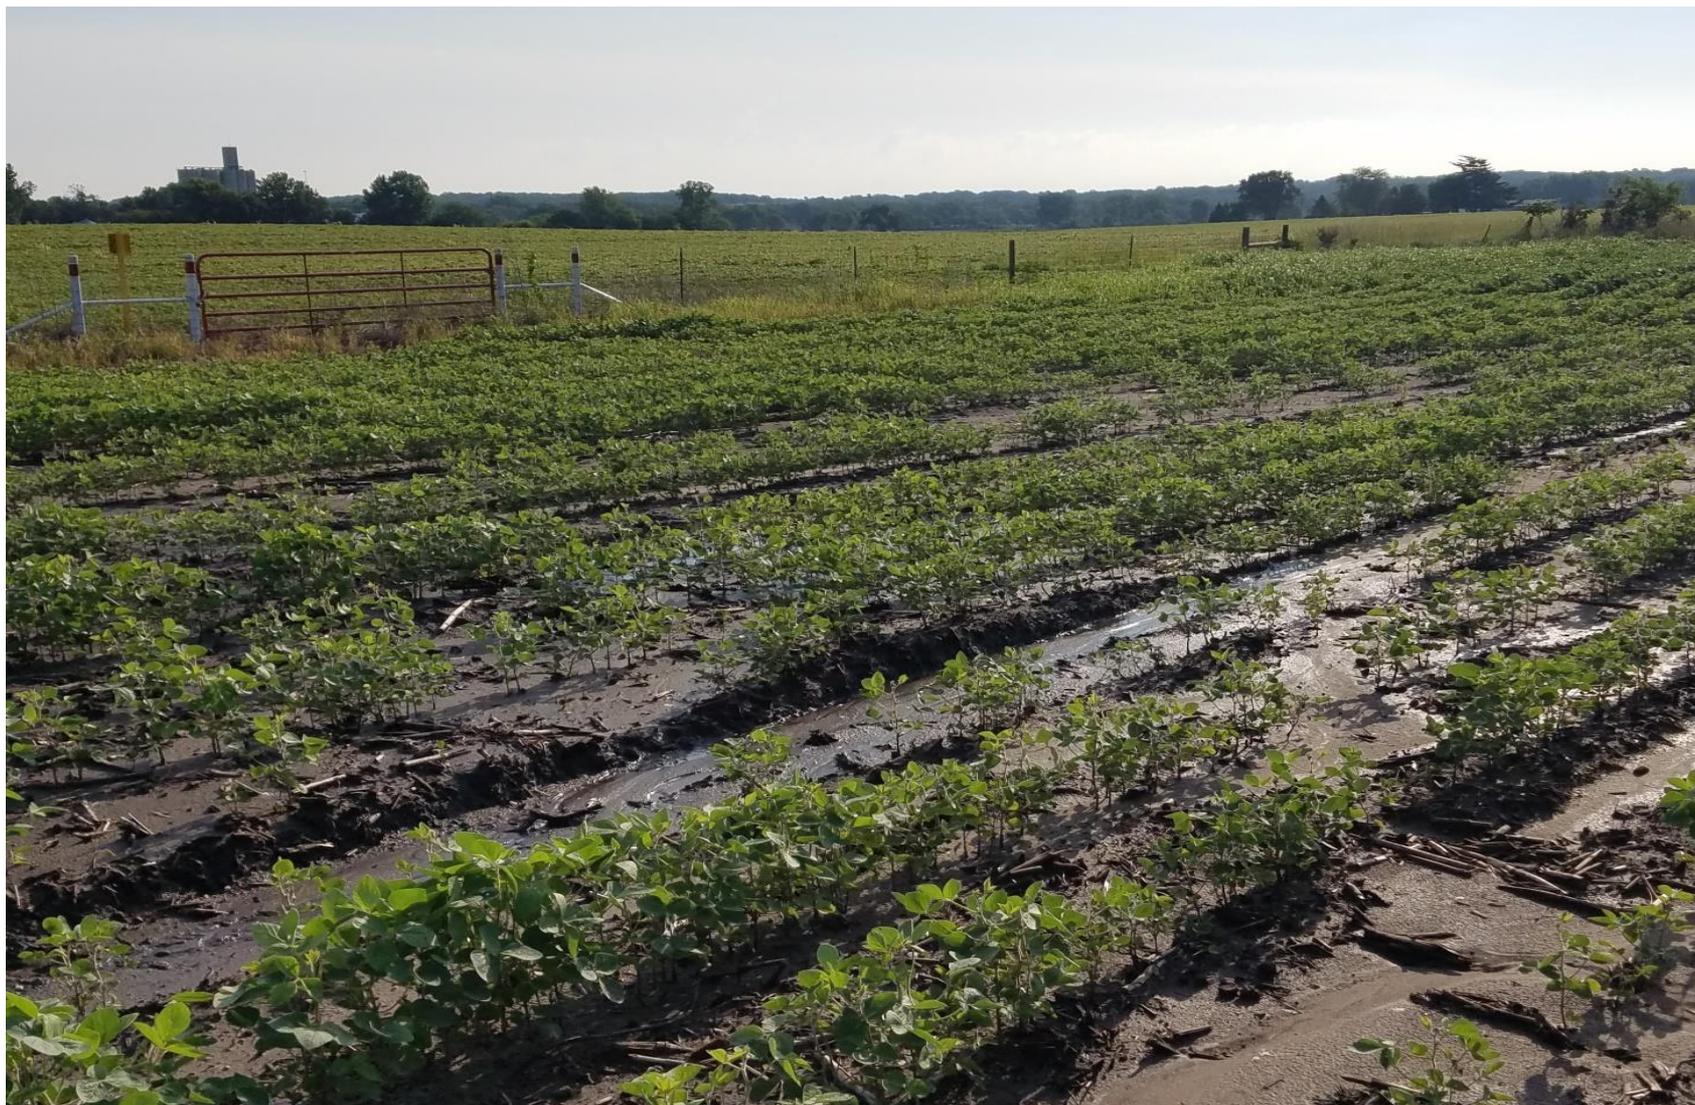
Berm showing dis vs. undis

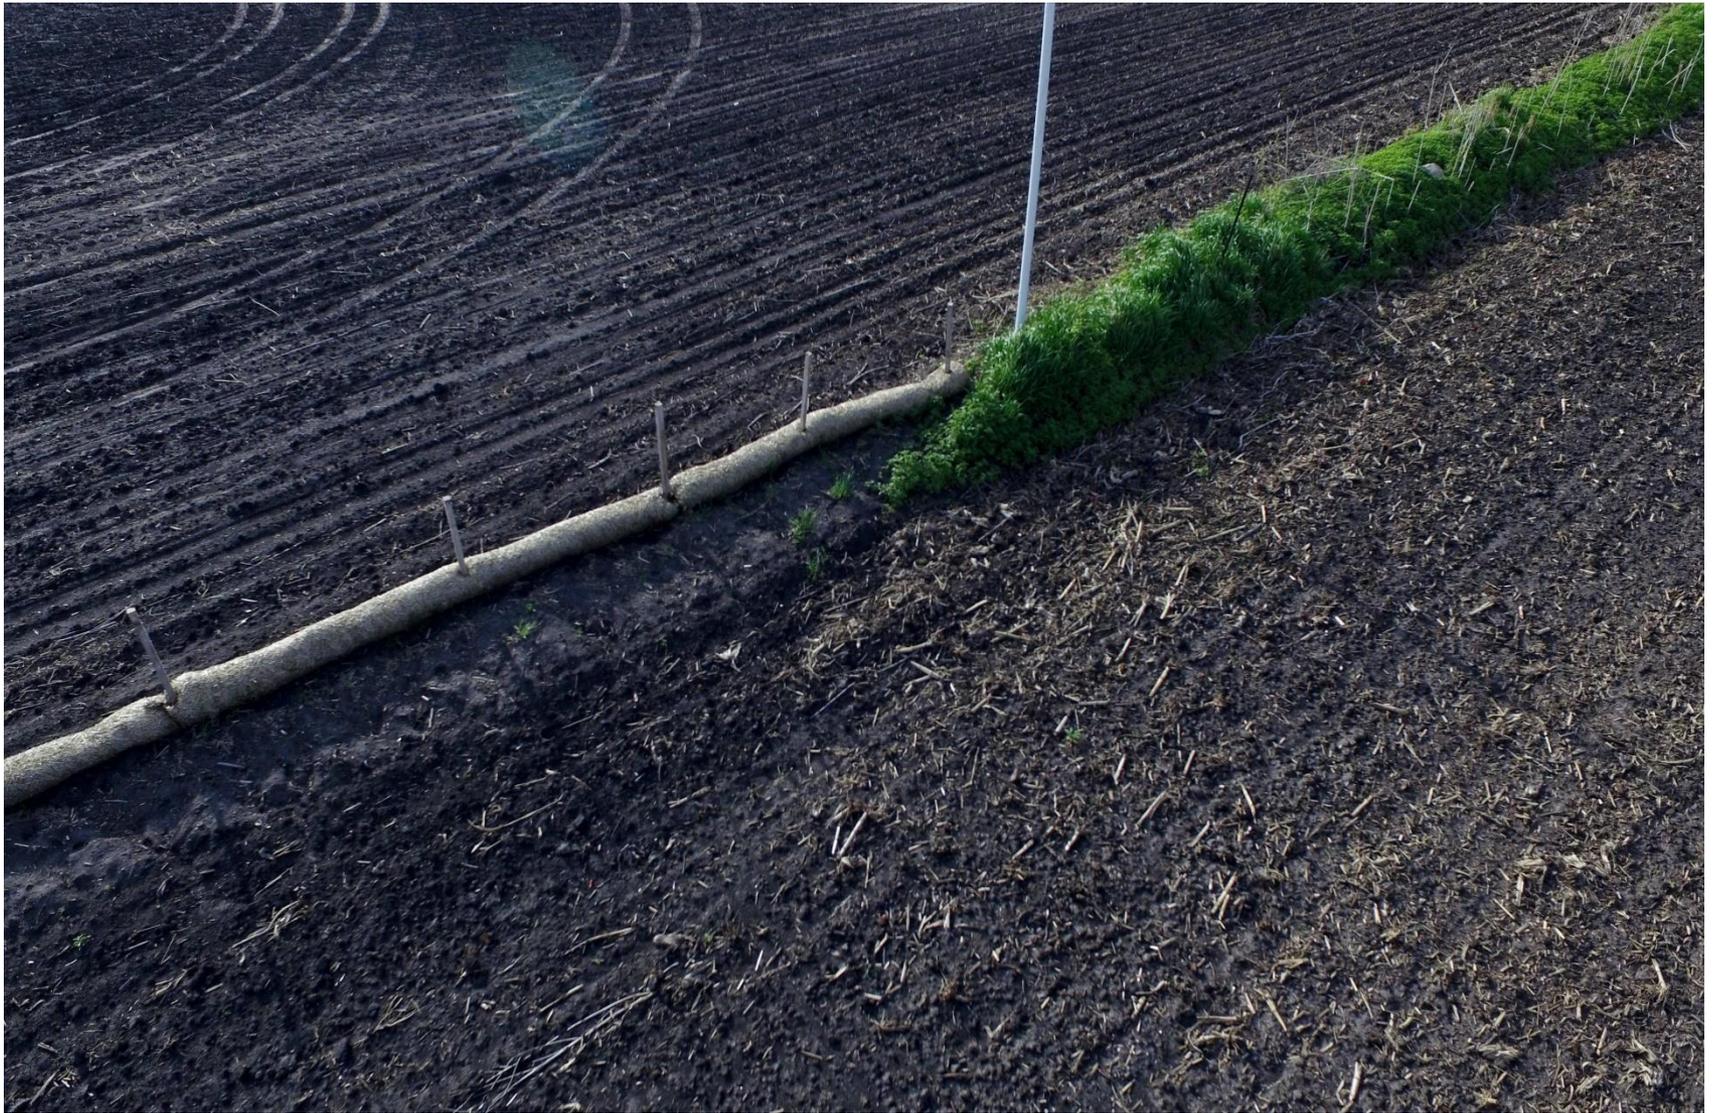
Erosion as berm was not reinstalled

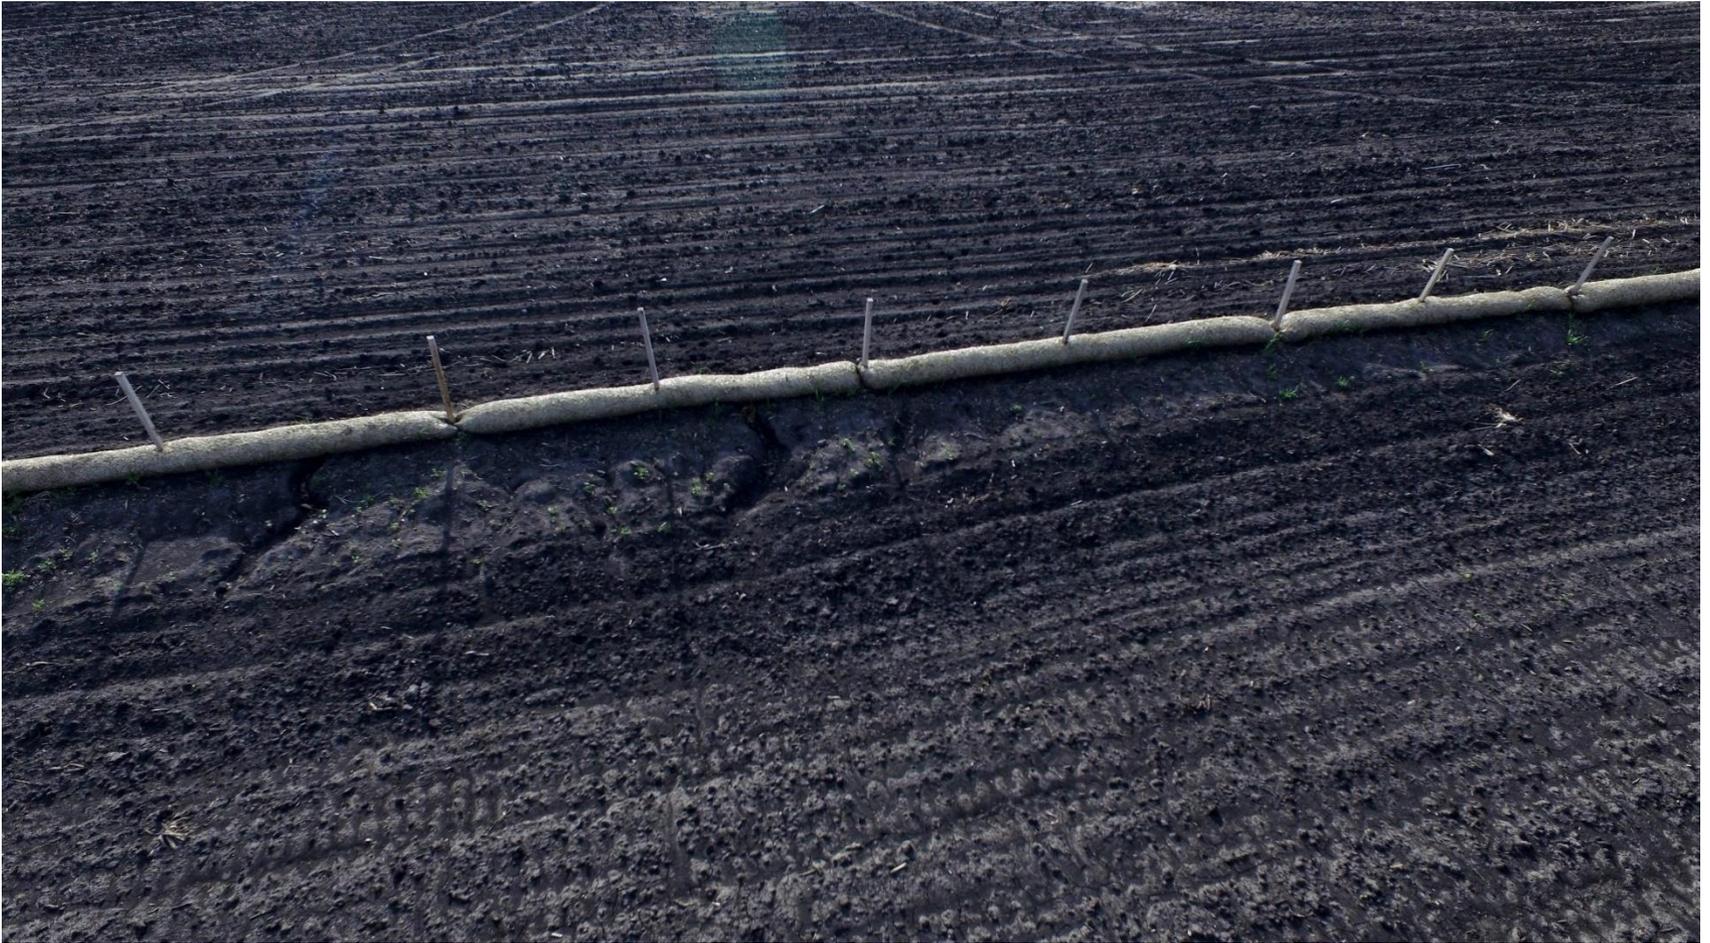
## Broken berm showing erosion

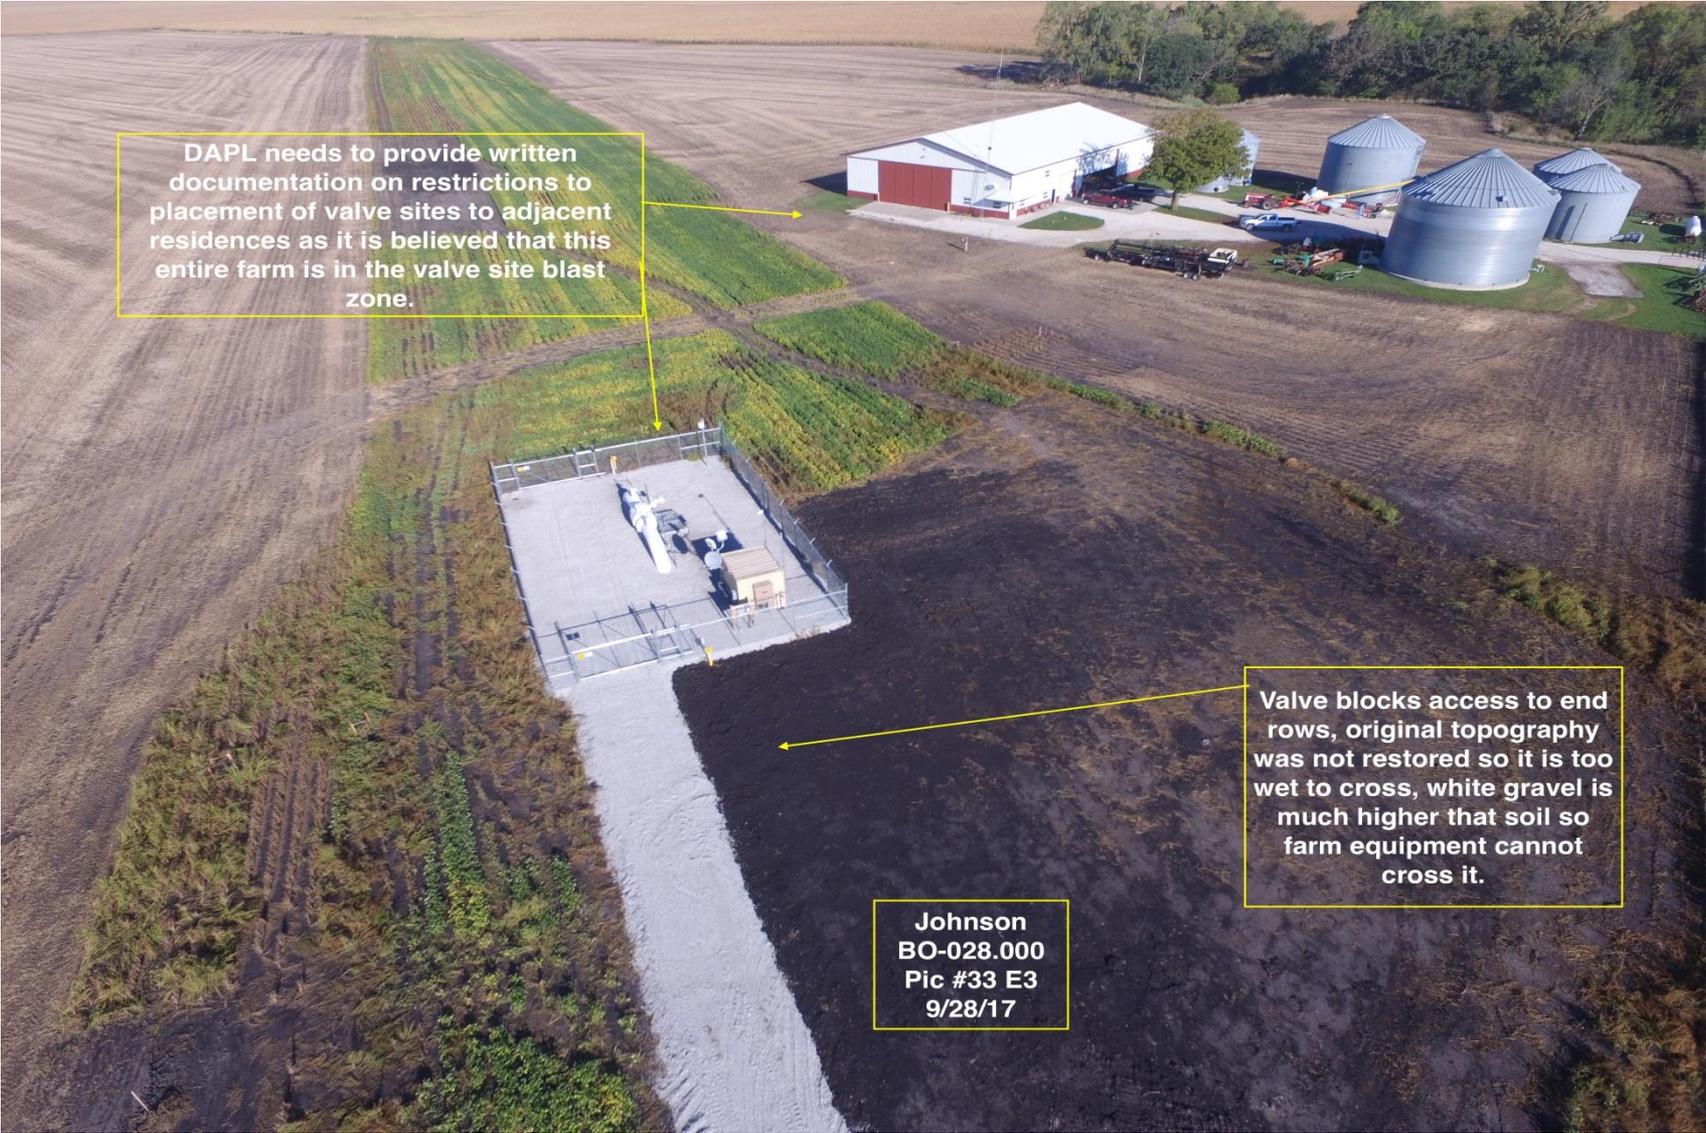
Johnson  
BO-028.000  
Pic #33 E3  
9/28/17

Valve blocks access to end rows, original topography was not restored so it is too wet to cross, white gravel is much higher that soil so farm equipment cannot cross it.

DAPL needs to provide written documentation on restrictions to placement of valve sites to adjacent residences as it is believed that this entire farm is in the valve site blast zone.
