Johnson  
BO-028.000  
Pic #1  
8/30/16

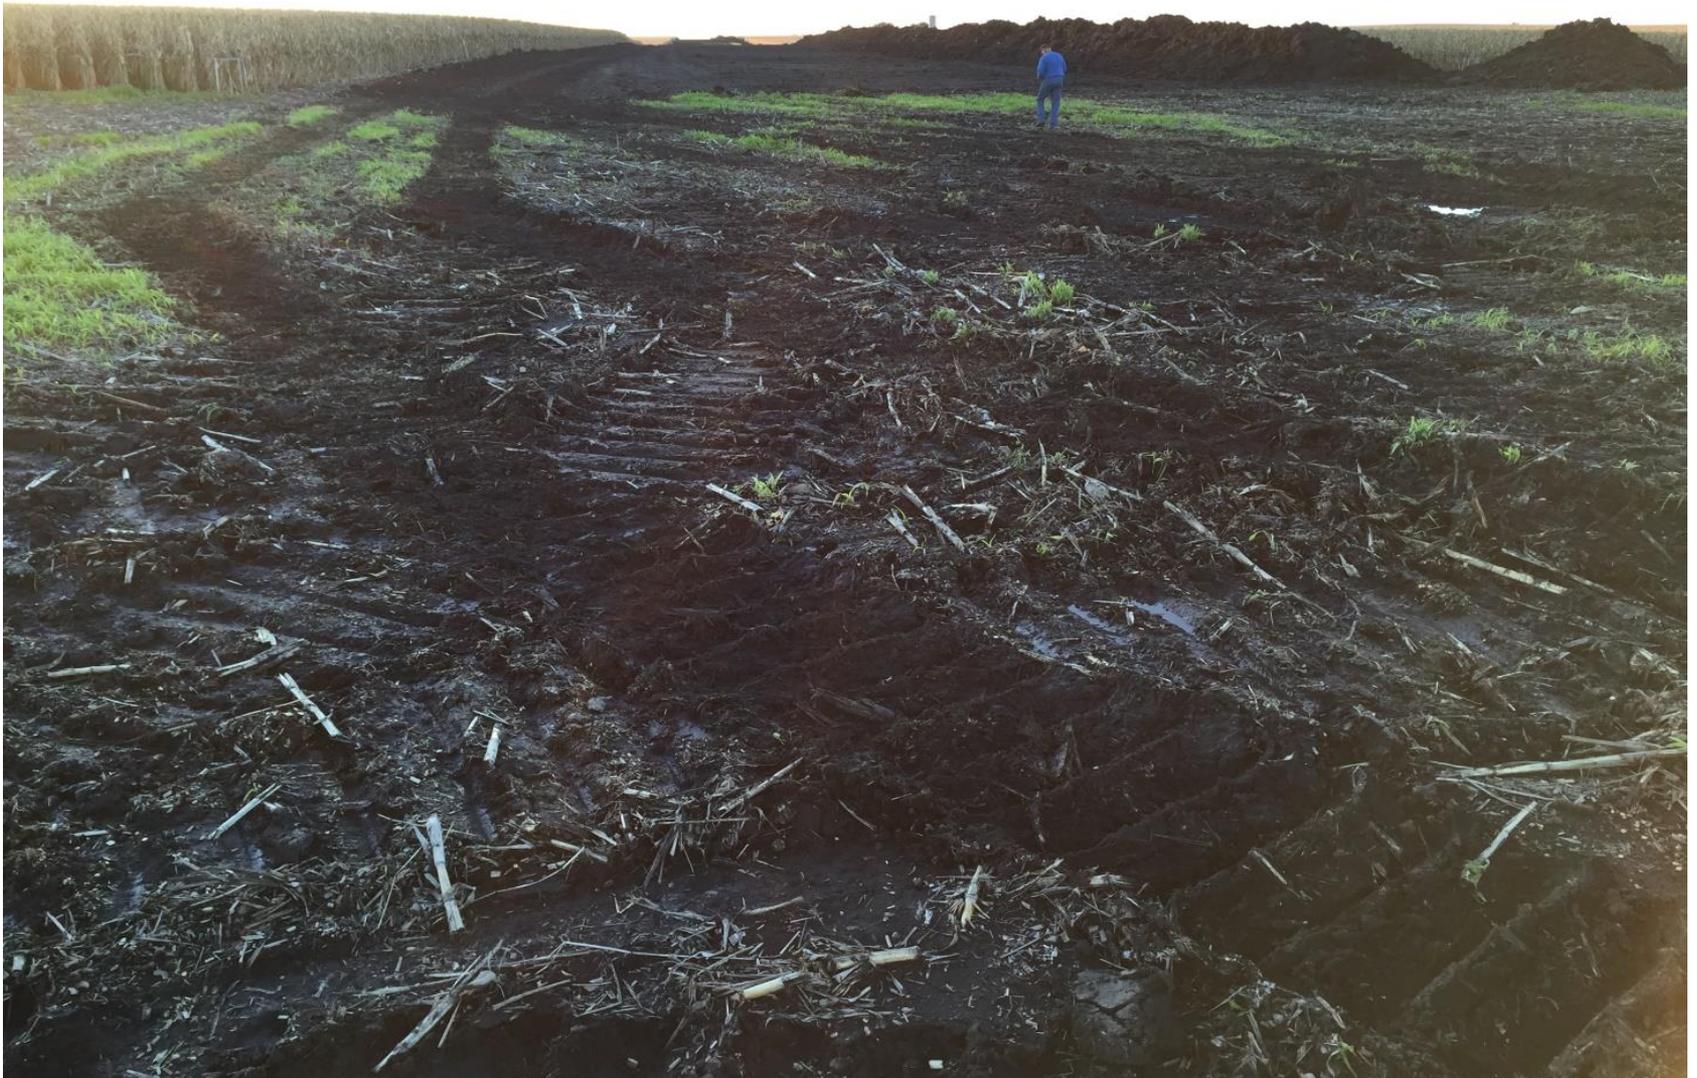
Driving off ROW compacting soil as ROW is too wet to drive on

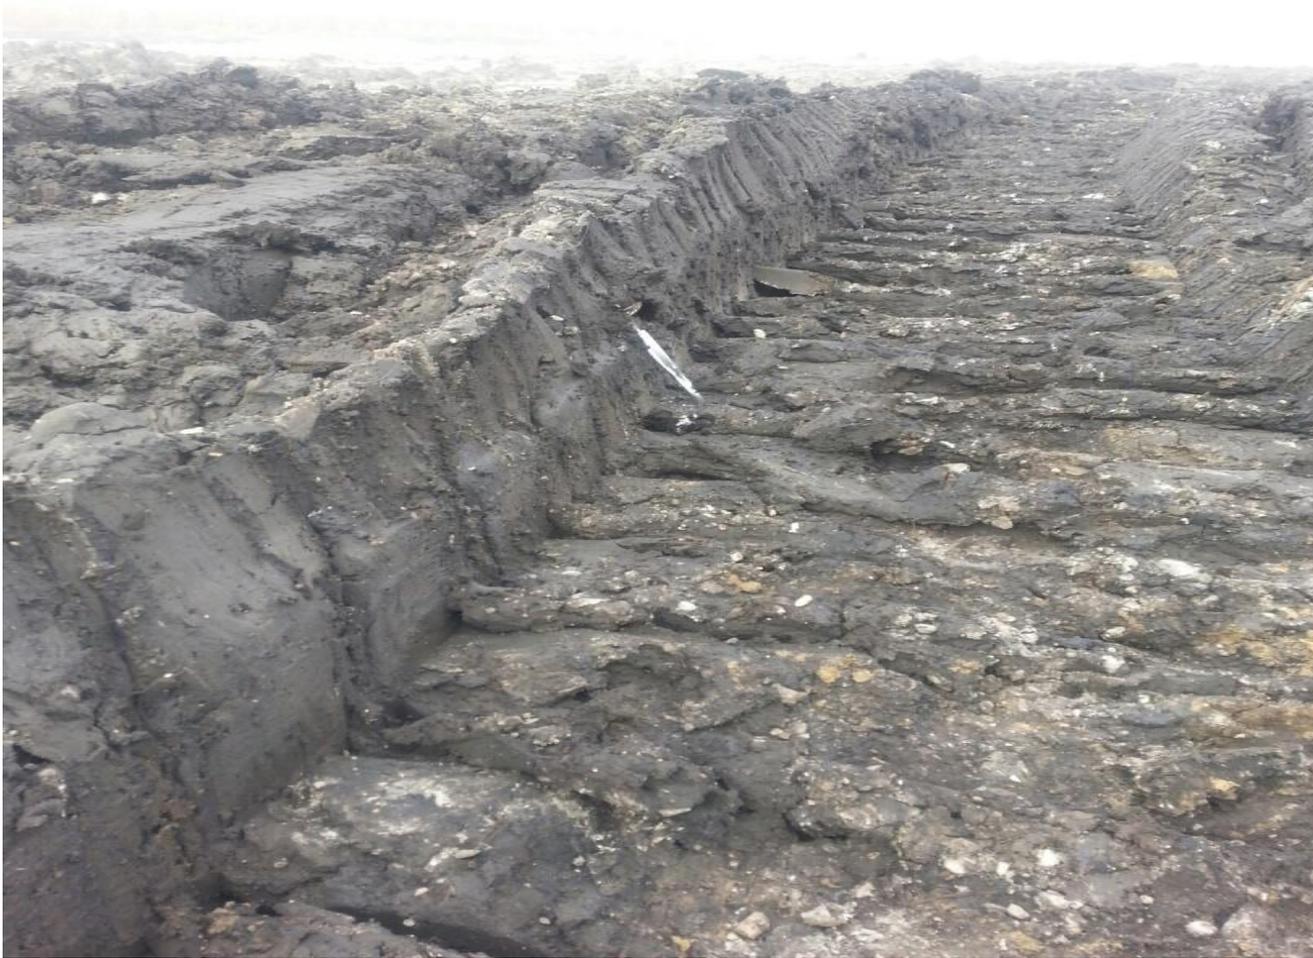
# Compaction on and off ROW

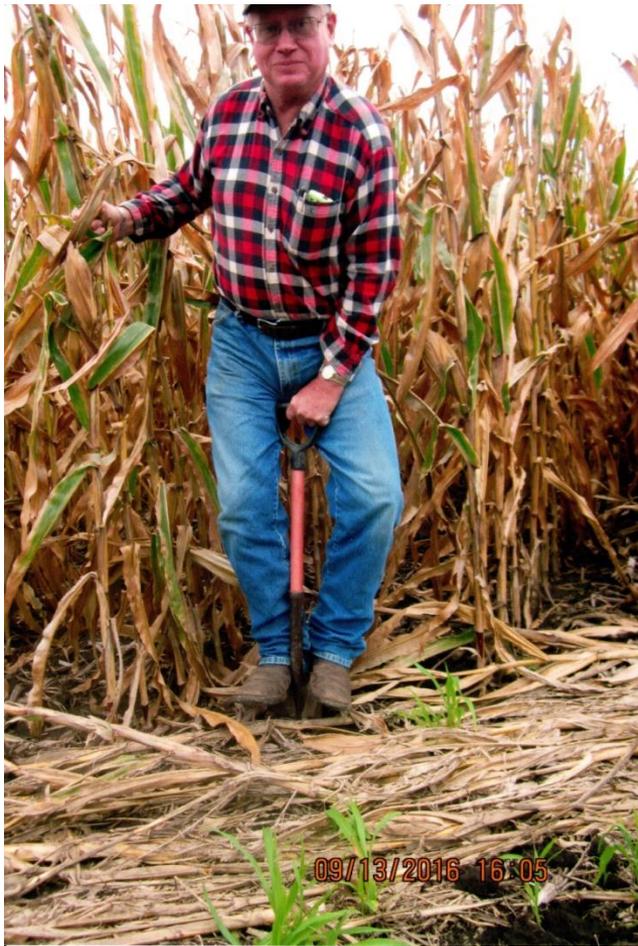
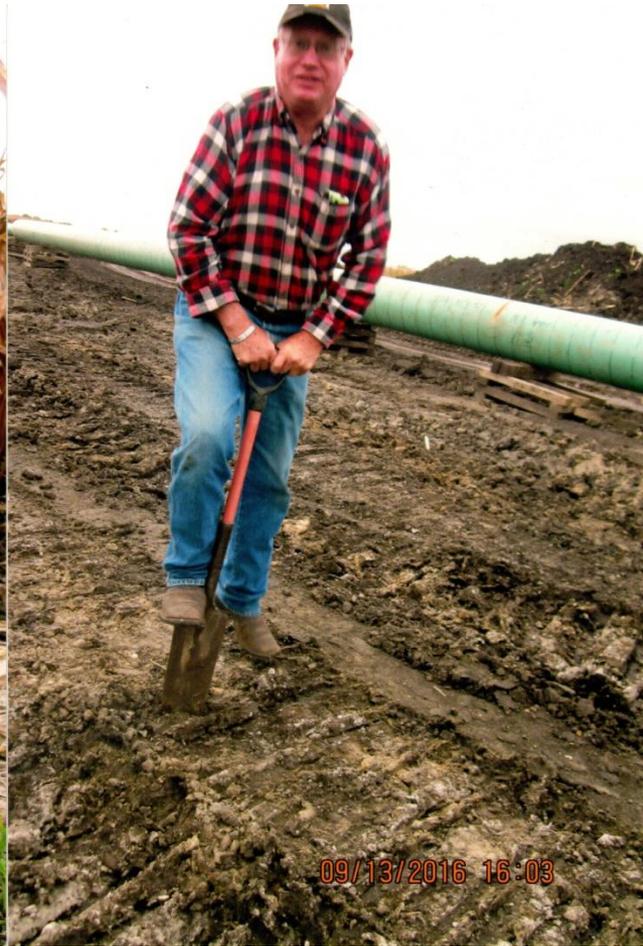
No haybales and silt going into

Rutting  
and co

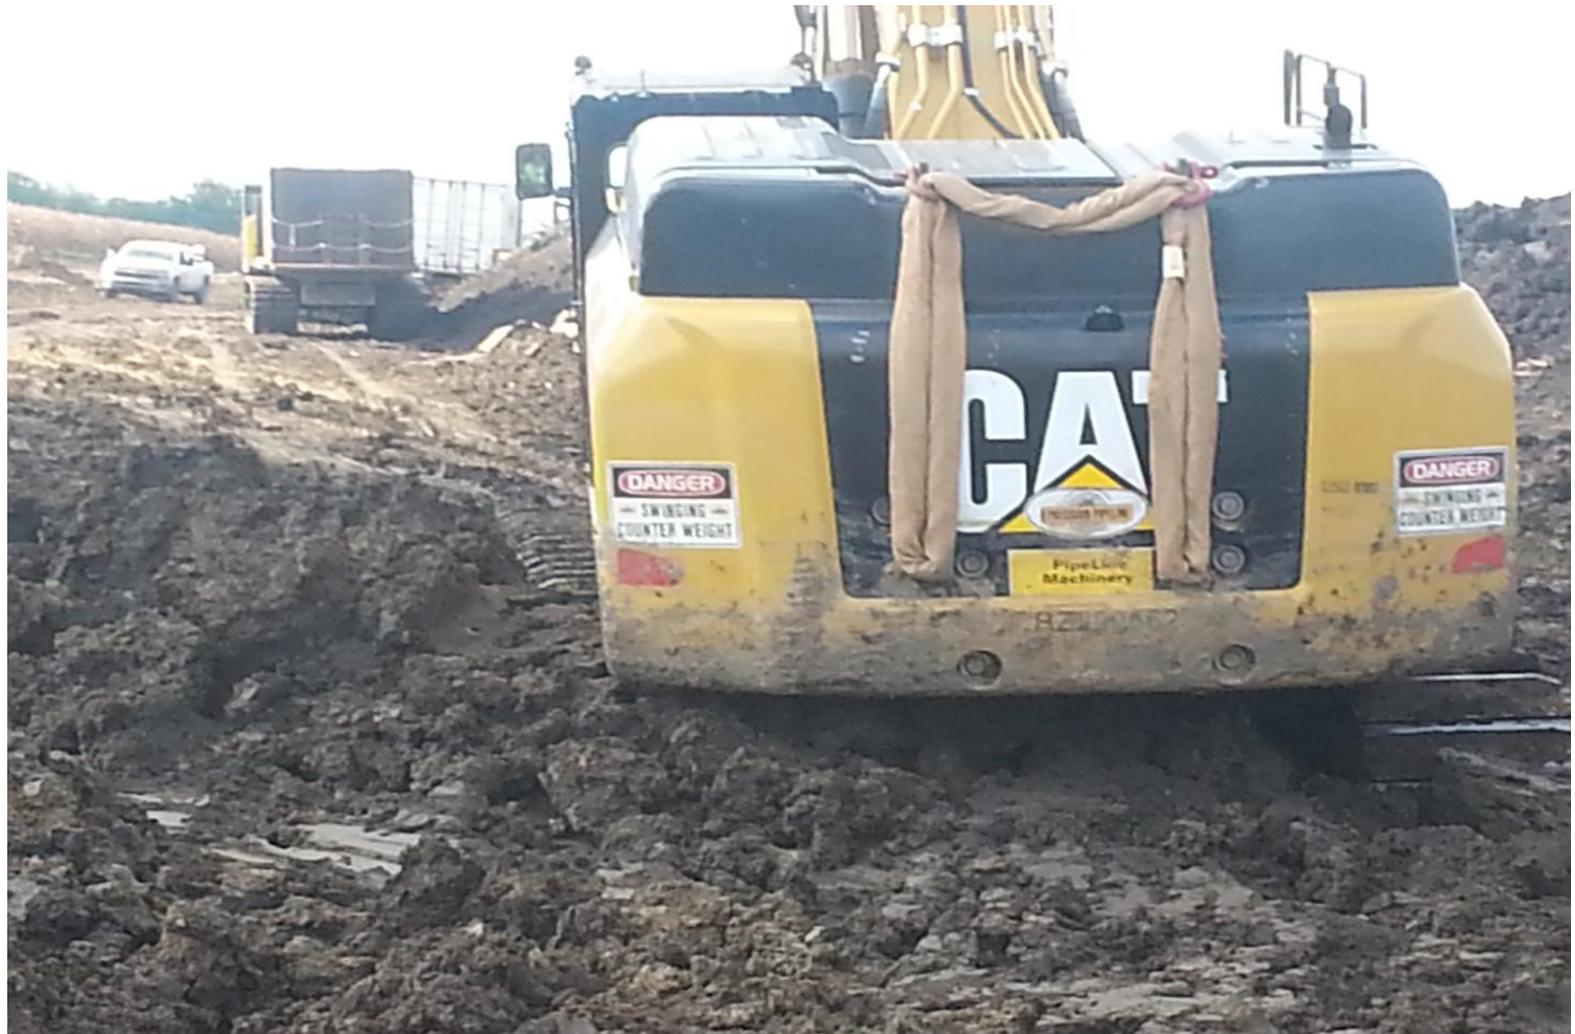
Mixing soil and causing ruts

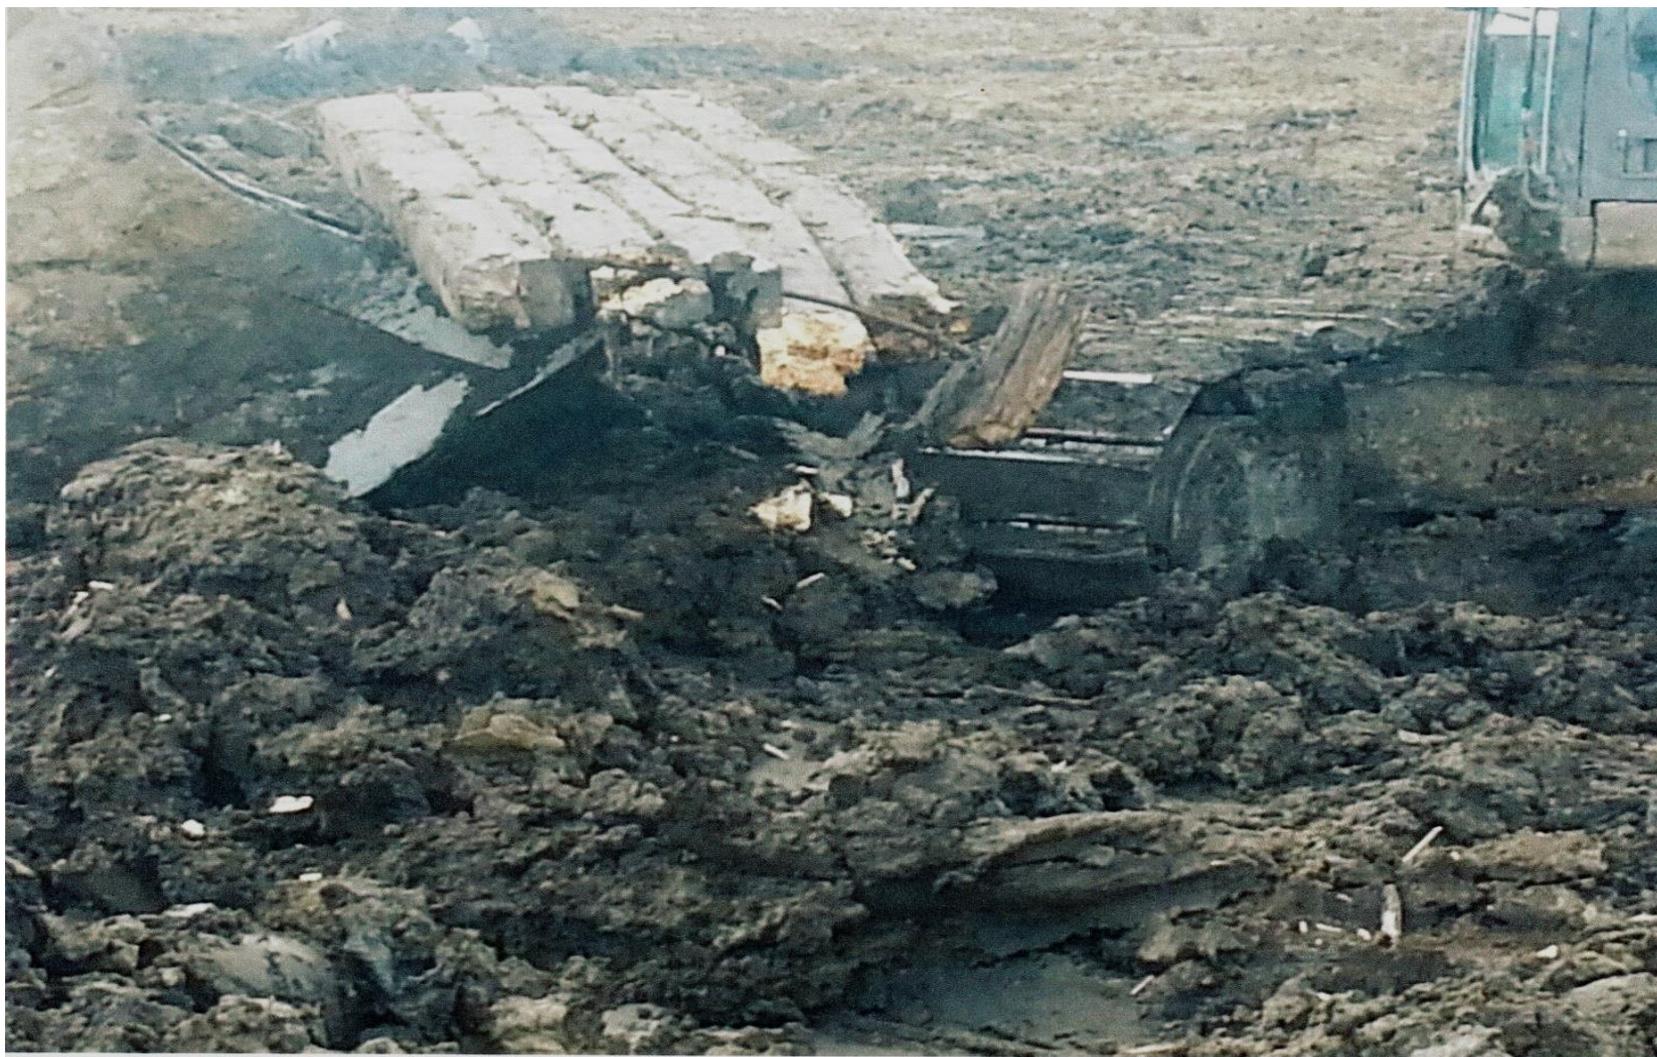
Johnson  
BO-028.000  
Pic #1 J1  
5/2018

Piece of  
cribbing  
brought up  
when ripping

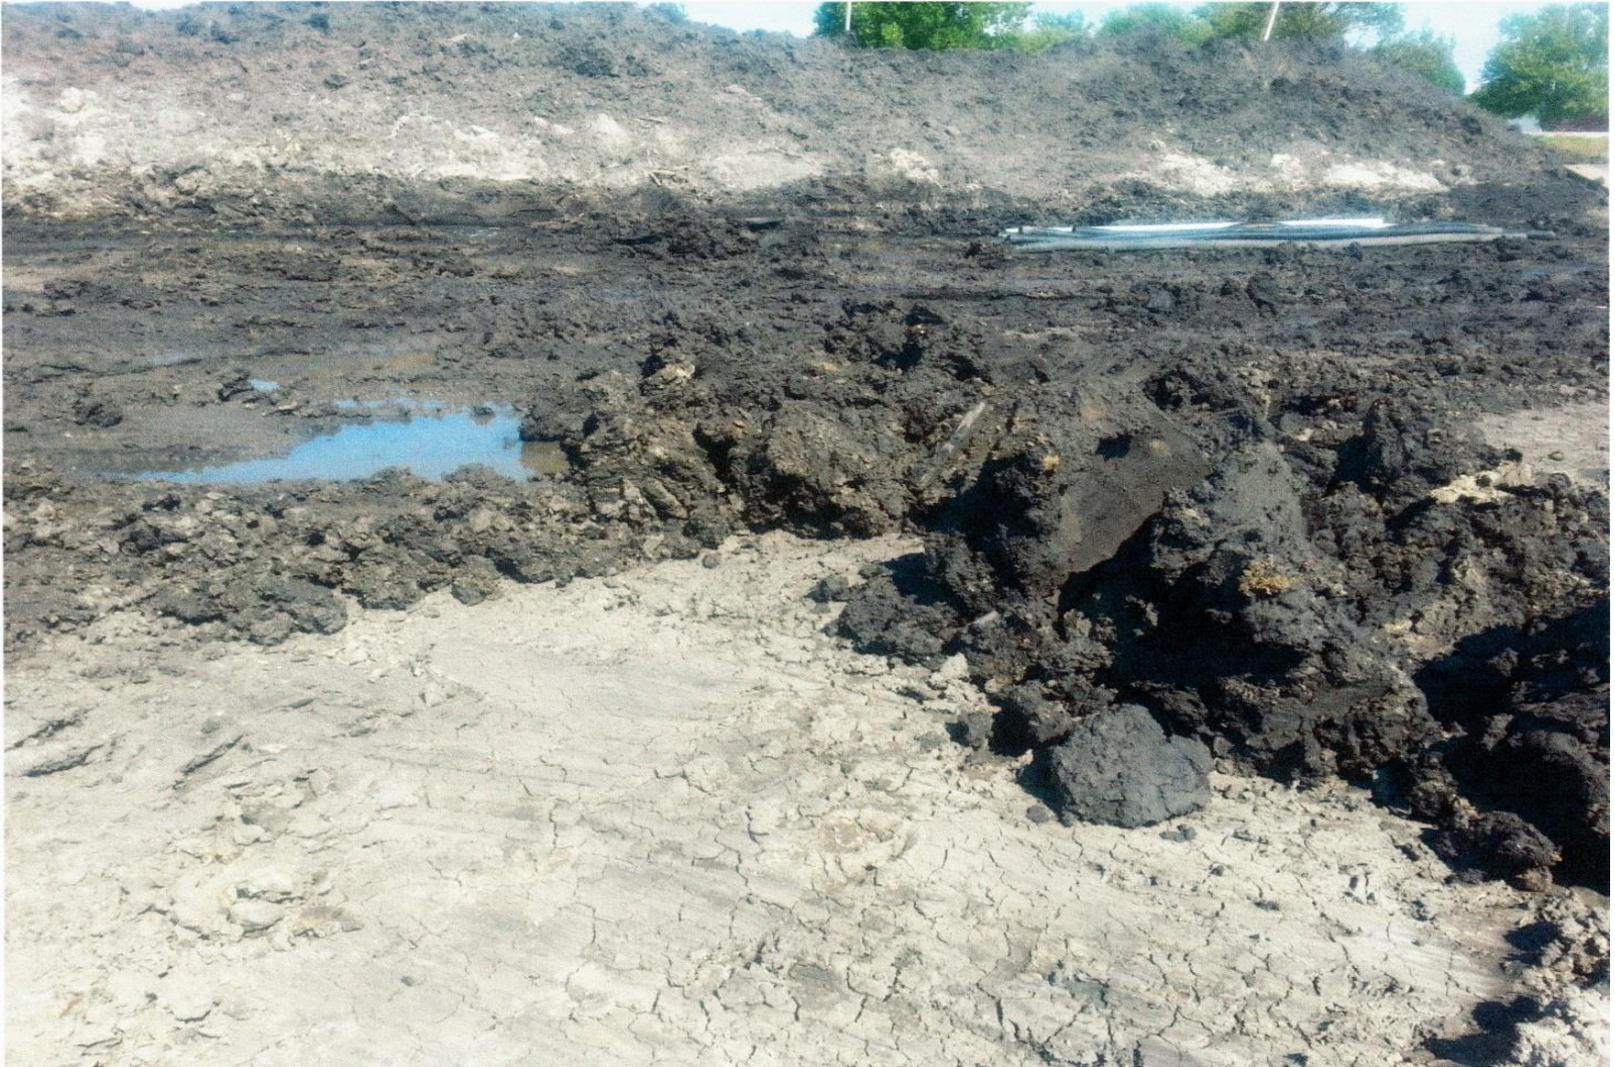
Showing size of dirt clots

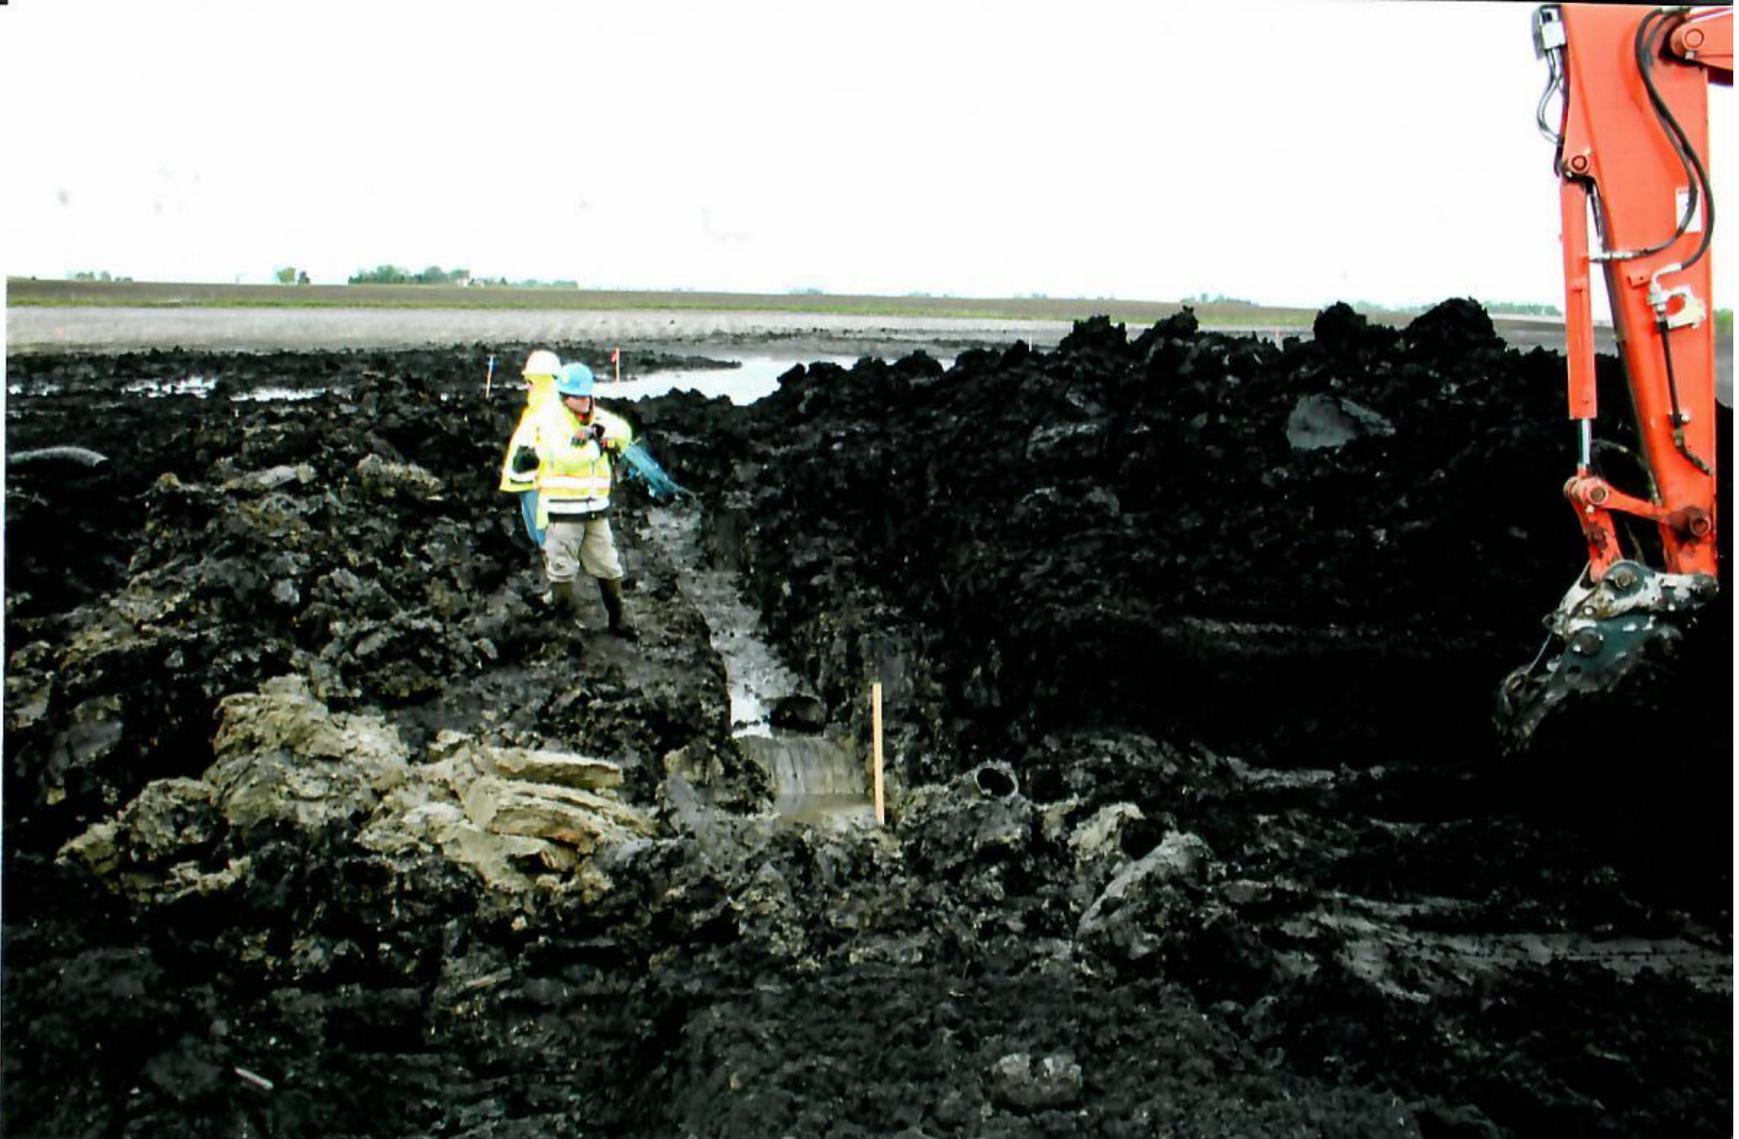
Stake next to broken tile, repair in wet conditions causing compaction

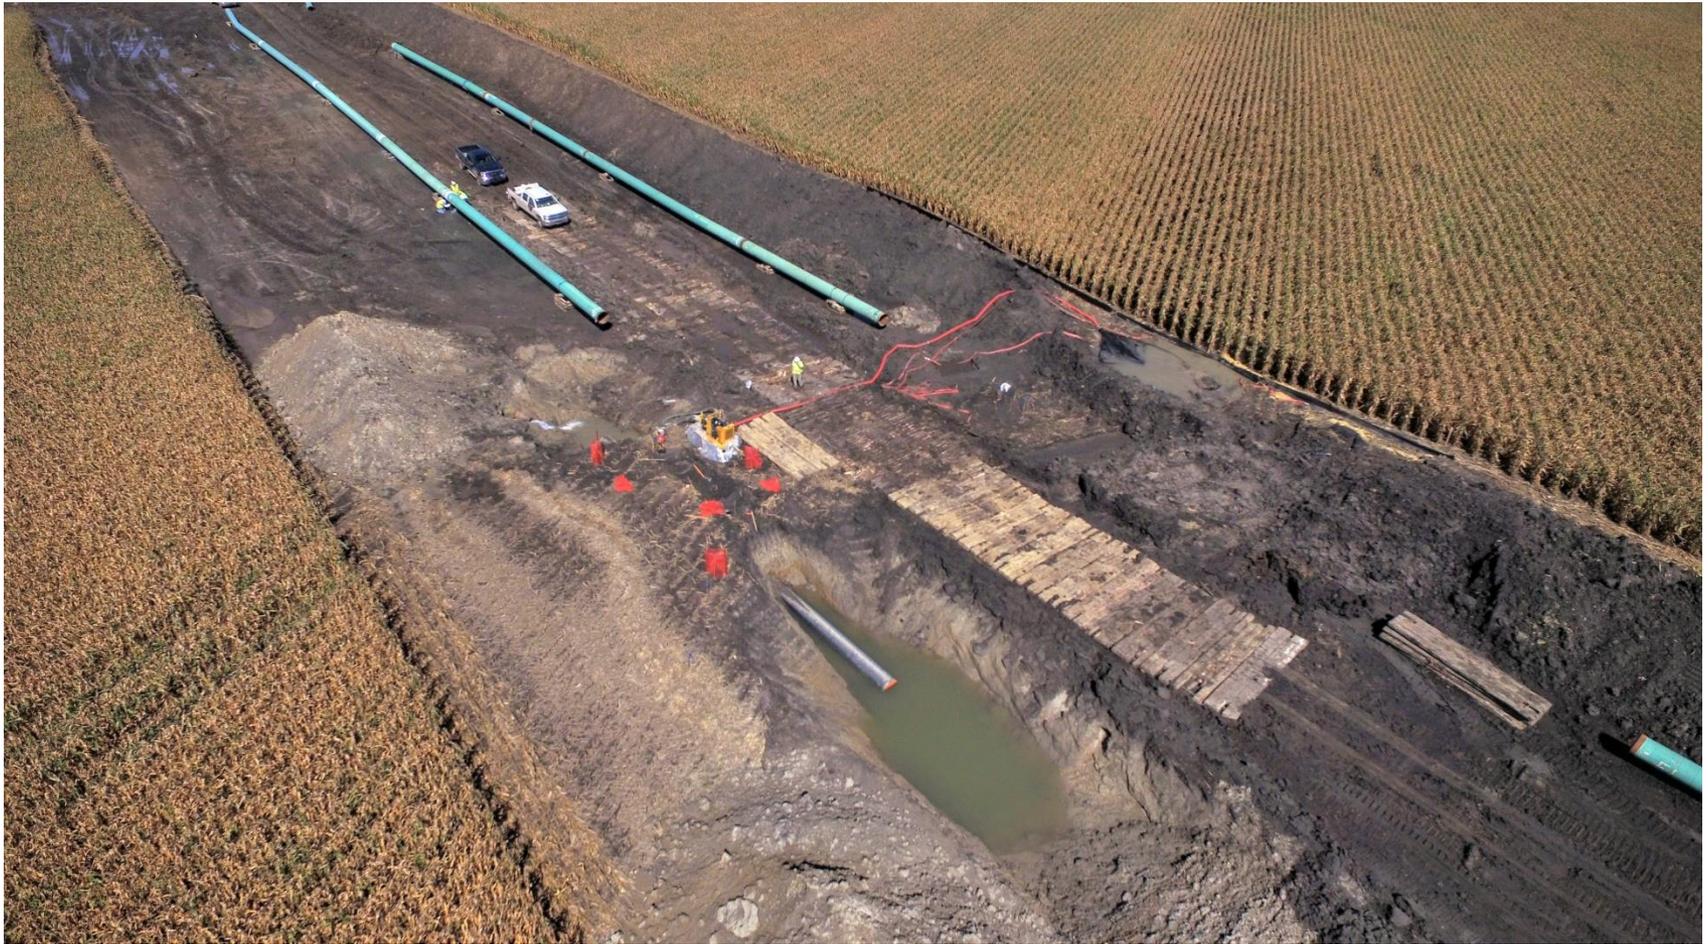
## Example of working su

Dozers working subsoil  
causing deep ruts and  
compaction

Wood matt shards left behind from broken matts and mixed soils next to the topsoil storage piles.

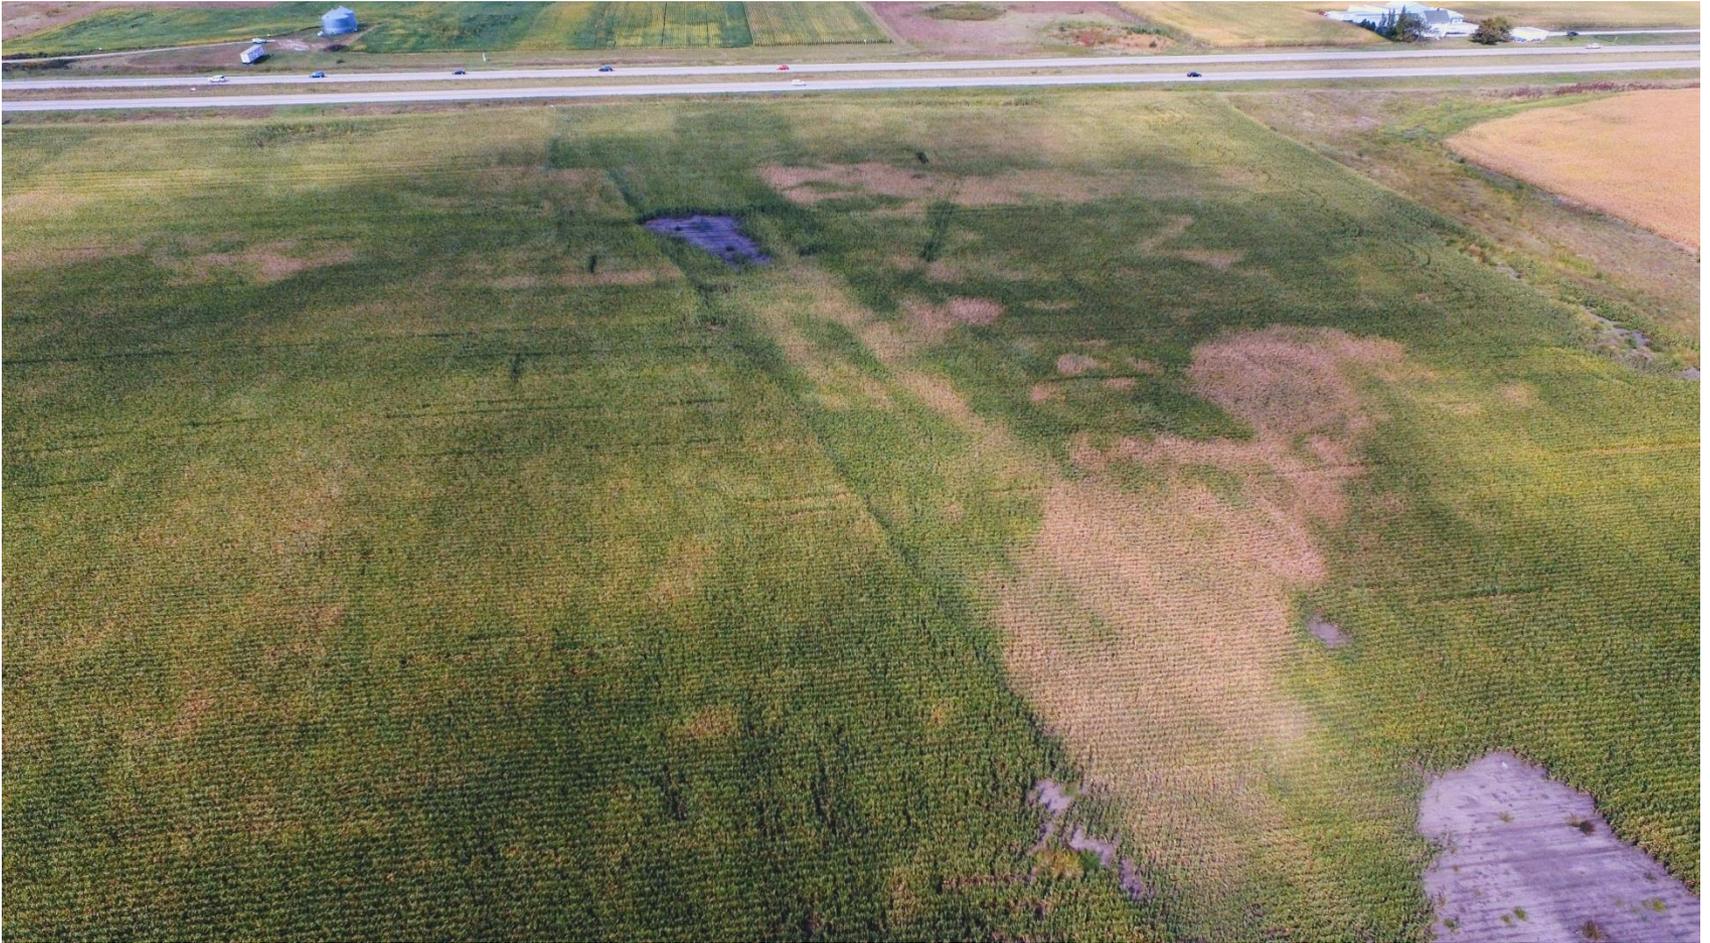
# Mixing, compaction

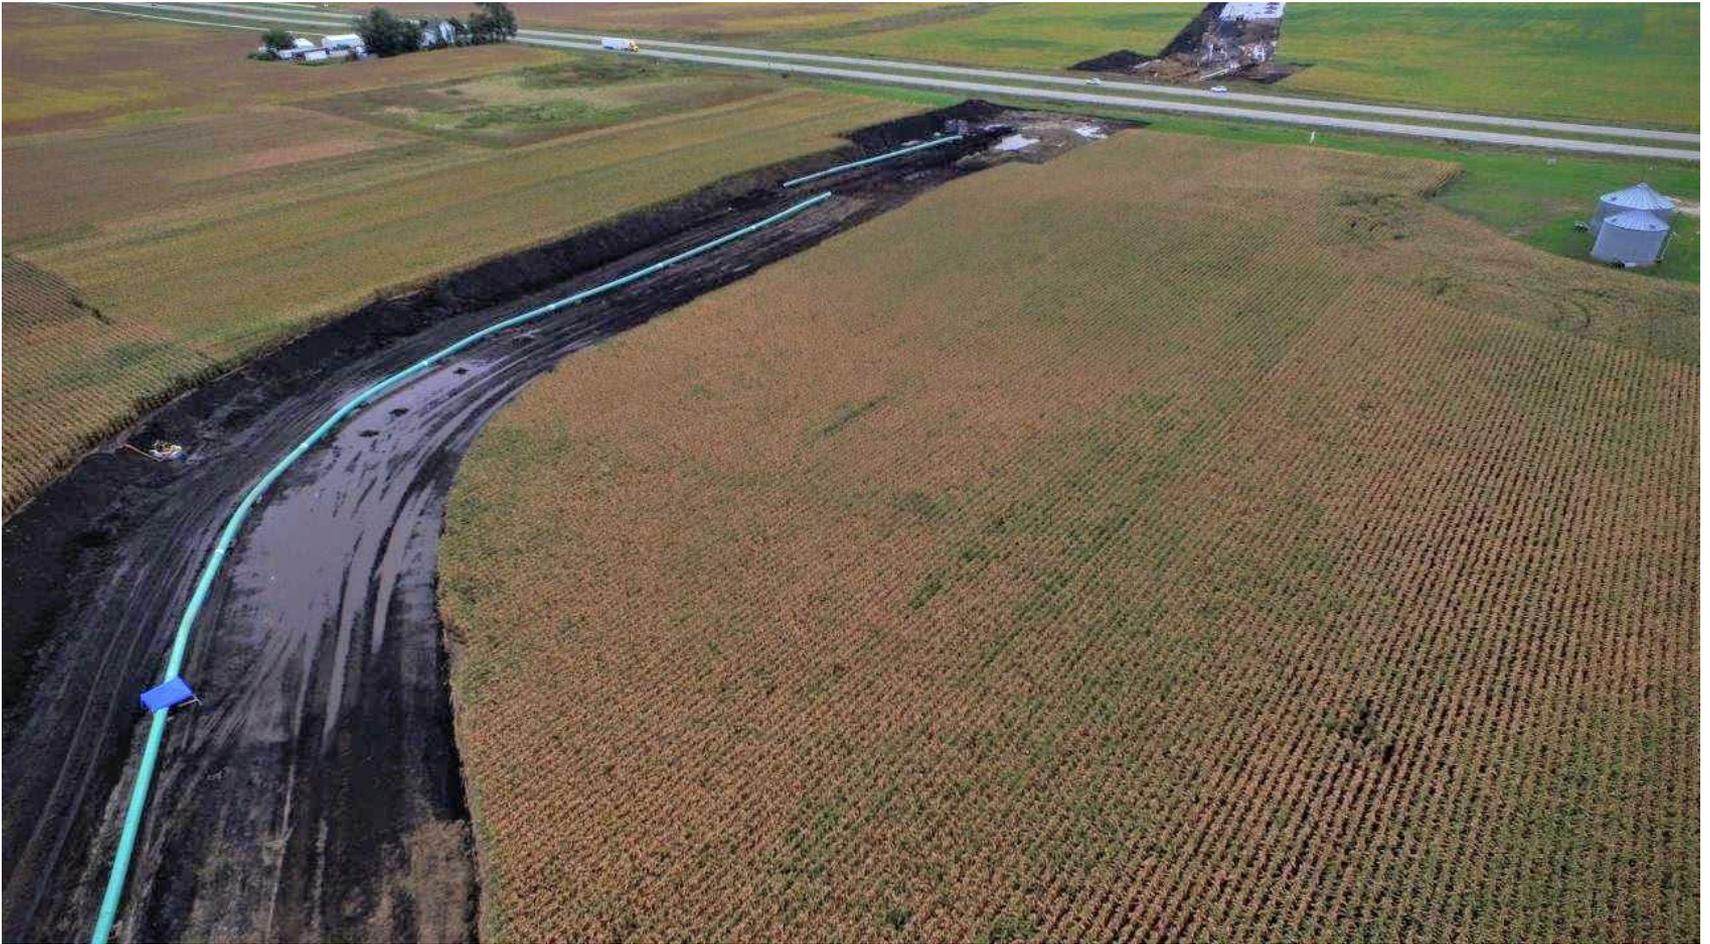
One year later same location as  
previous slide

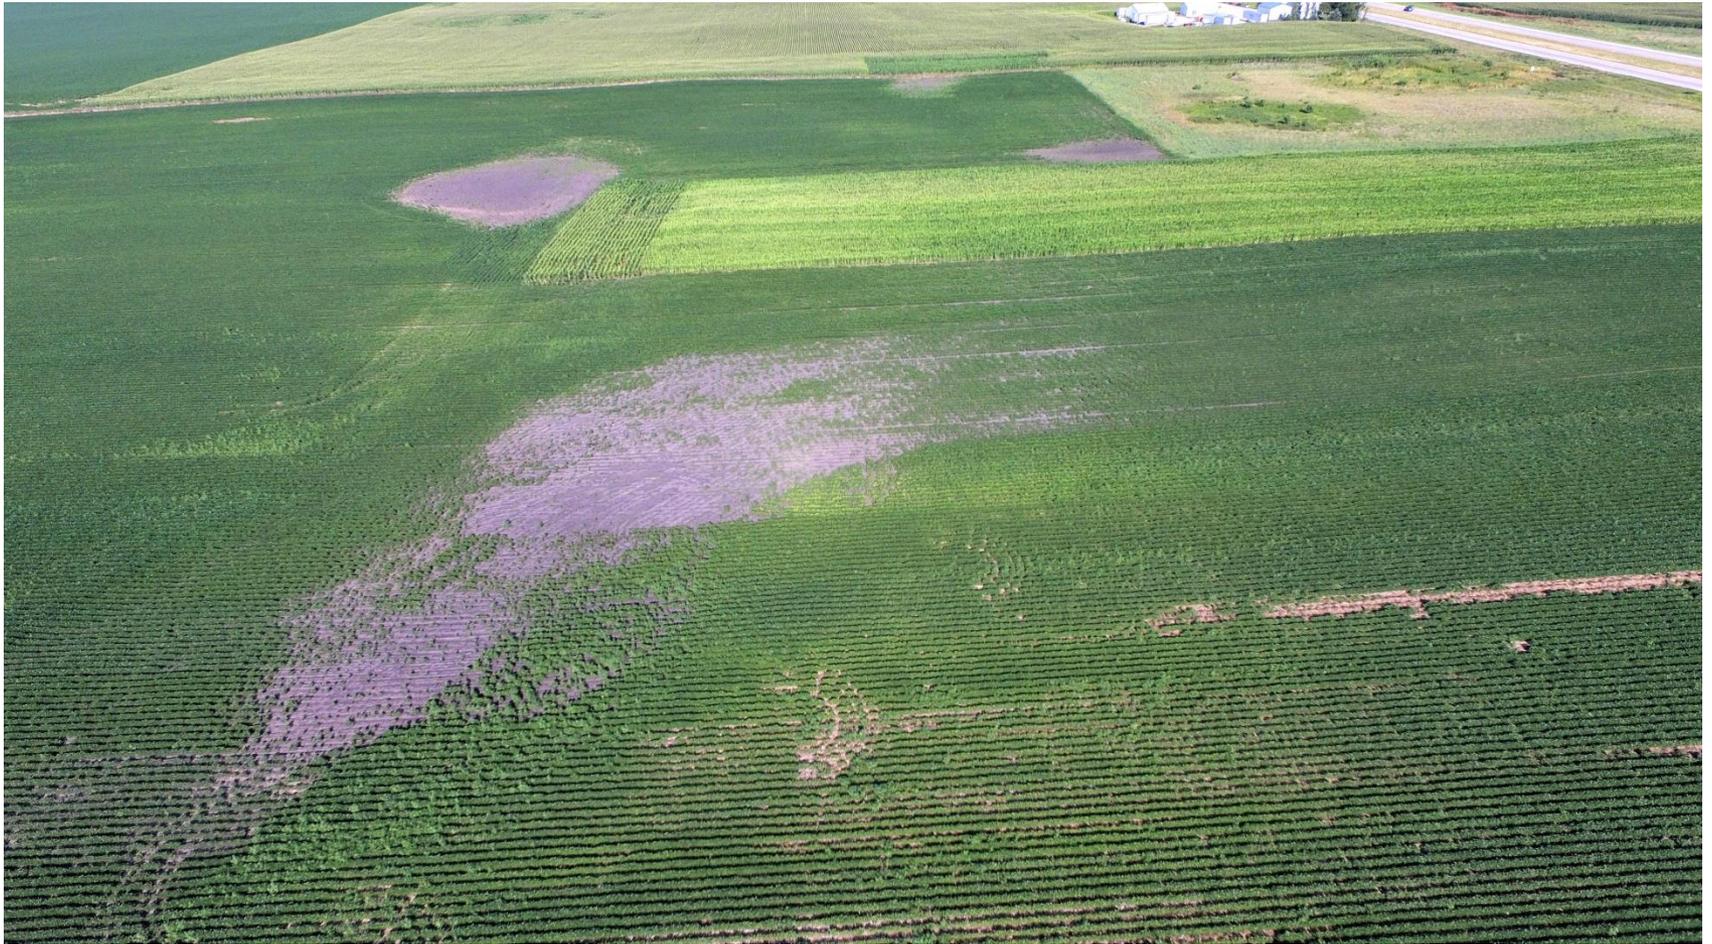
# Restoration efforts by DAPL. Soil is badly mixed and compacted

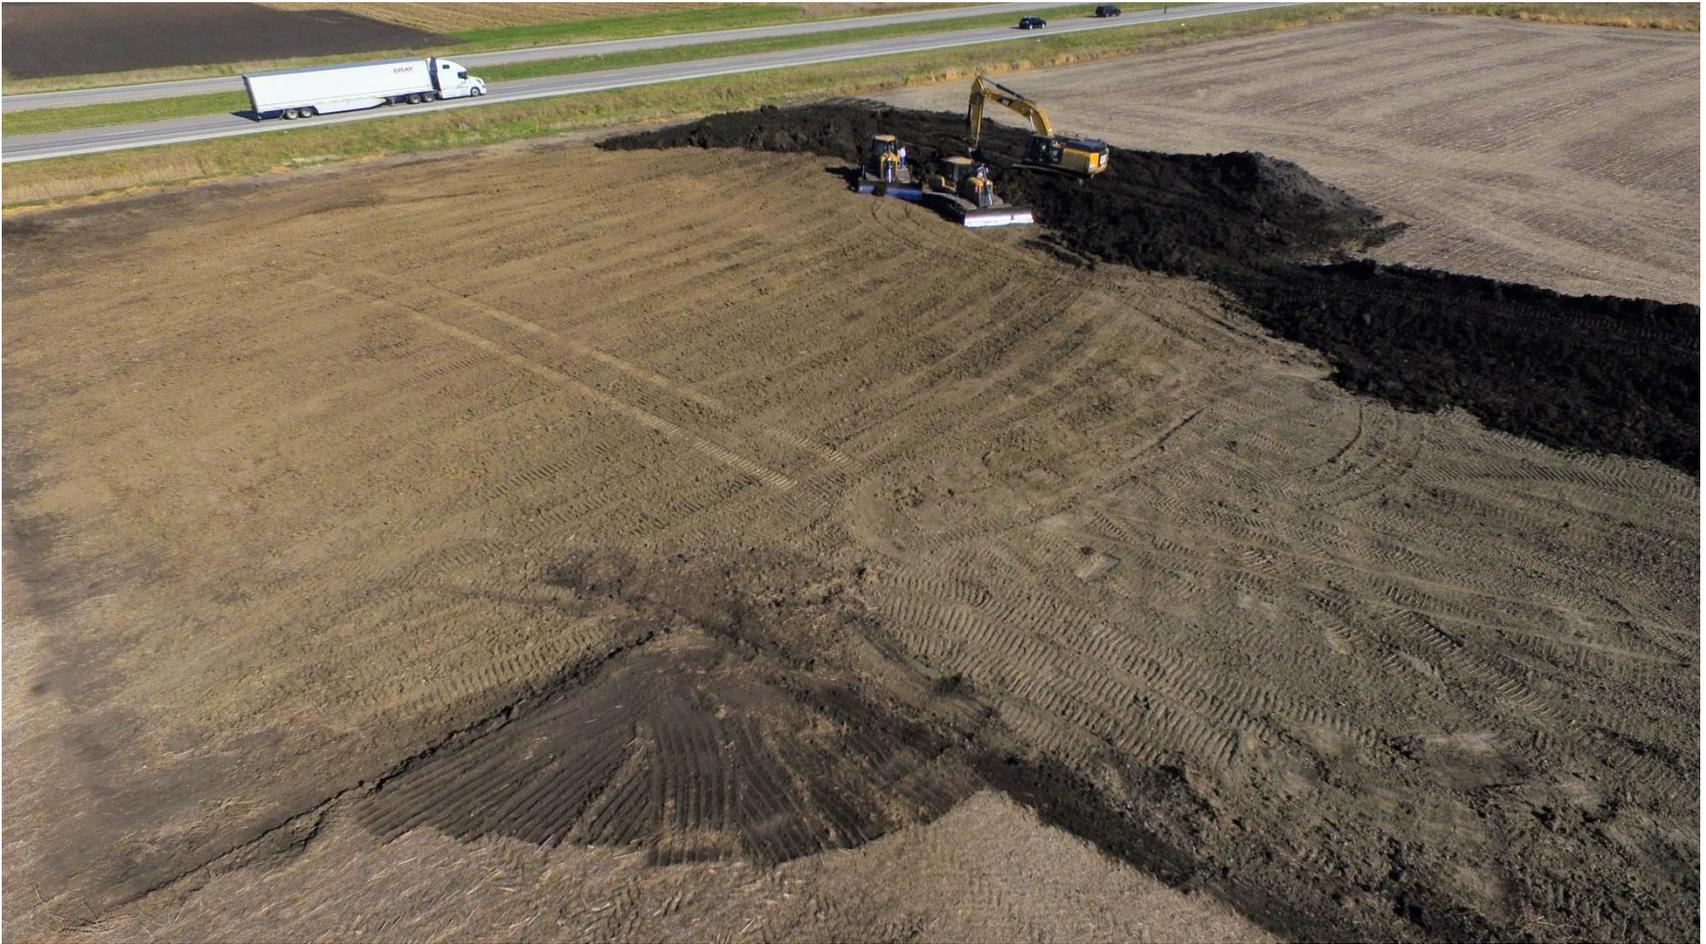
They will work the ground which will mix the parent material/clay with the upper soil.

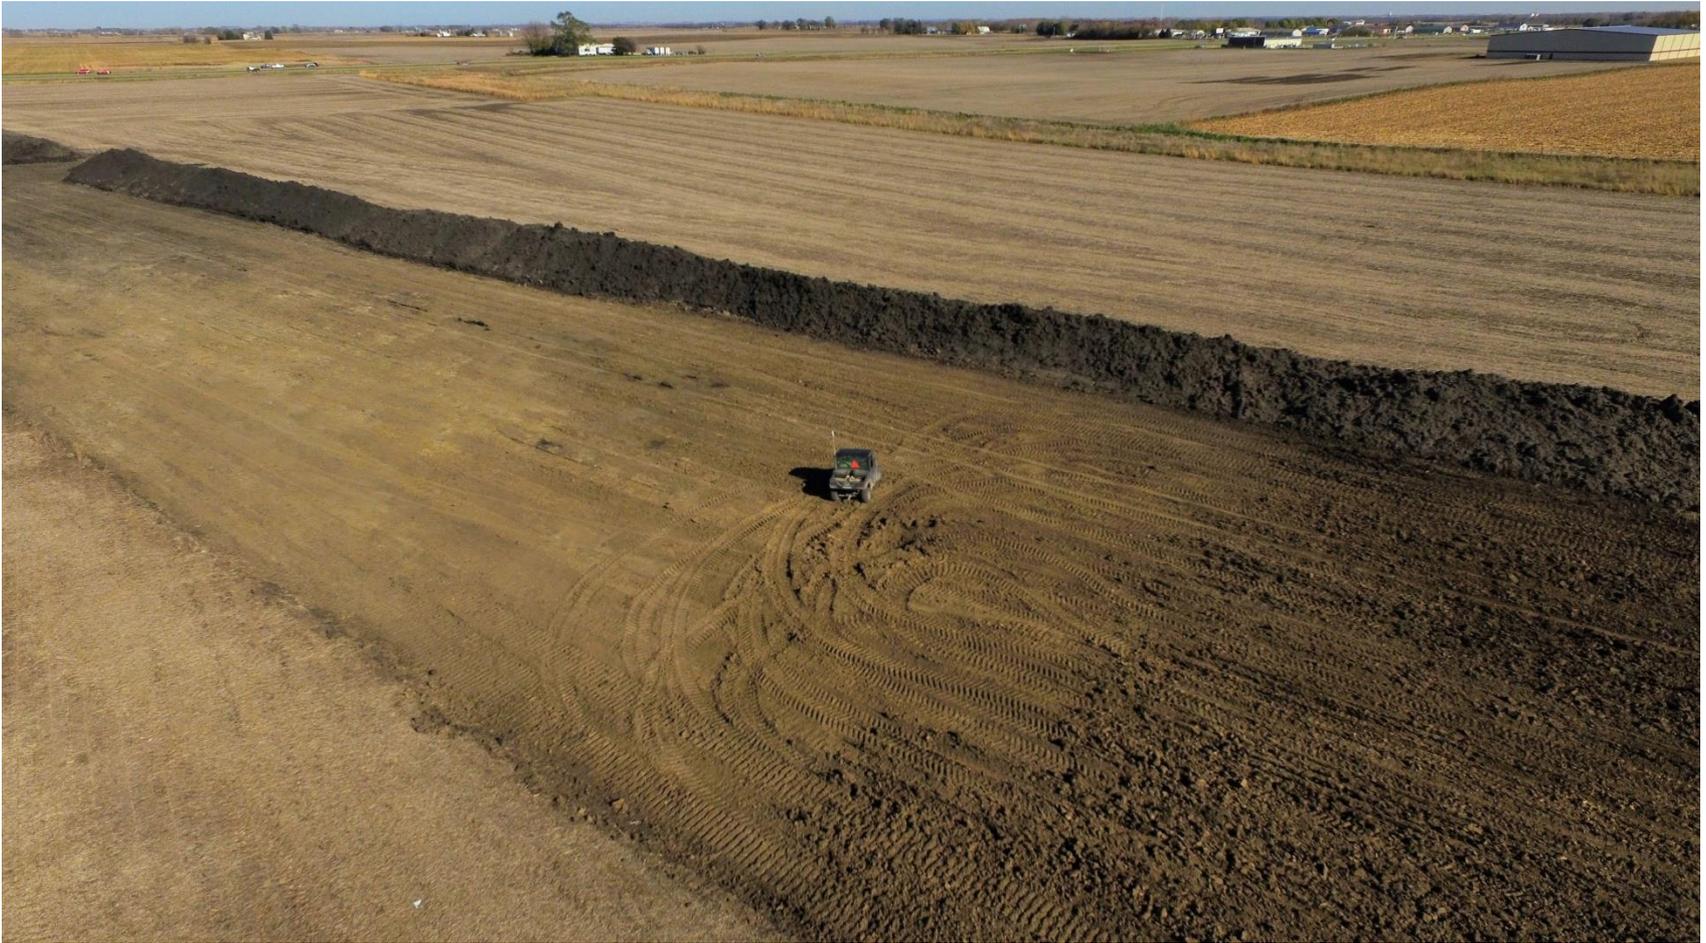
Restoration has mixing parent material/clay with upper layer or soil. Now they will place the top soil to make it look pretty.

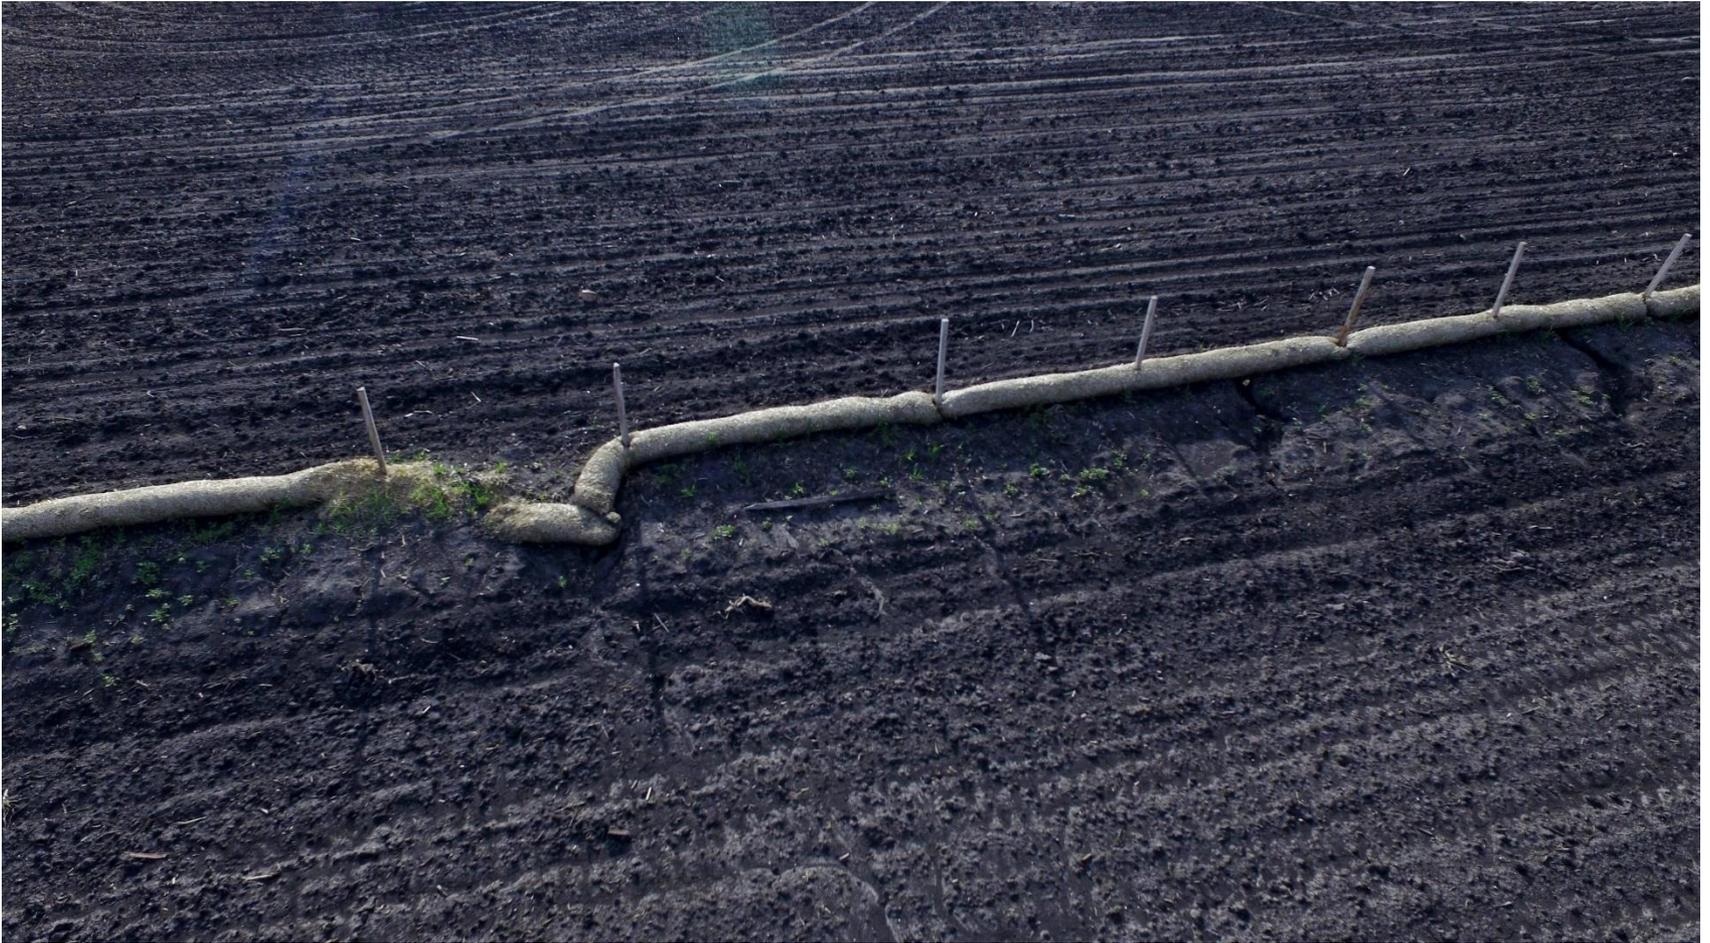
Puntenney  
WE-078  
Pic #1 E1  
5/27/17

Erosion
